SAFETY & EMISSION RECALL CAMPAIGN 2A97 2019 & 2020 Burgman 200 Fuel Hose Replacement Recall

Affected Models:	Certain 2019 & 2020 Burgman 200 (UH200AL9-M0) Scooter Models
Affected Departments:	Management, Service, Warranty, Sales, Parts, Accessories
Attachments:	Sales Bulletin 21-093 (Burgman 200 Stop Sales) & Customer Notification Letter
Reference:	Service Bulletins GV/AN/UH No. 056 UH200AL9-M0 Safety Recall Campaign 2A97 & GV/AH/UH No. 055 UH200AL9-M0 Speedometer Recall Campaign 2A96

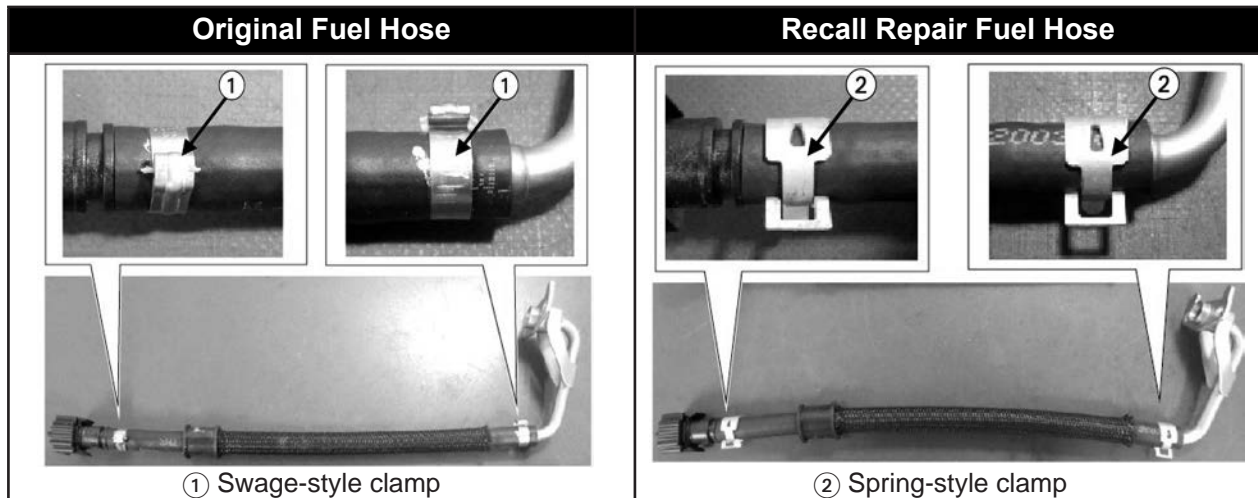
Identification of recall campaign parts (new fuel hose set):

Part Name	Part Number	Quantity	Includes
FUEL HOSE SET	15800-29810-RX0	1	Fuel hose (15810-29K10) x 1
			O-ring (15721-26J00) x 1
			Seal ring (15722-21H00) x 1

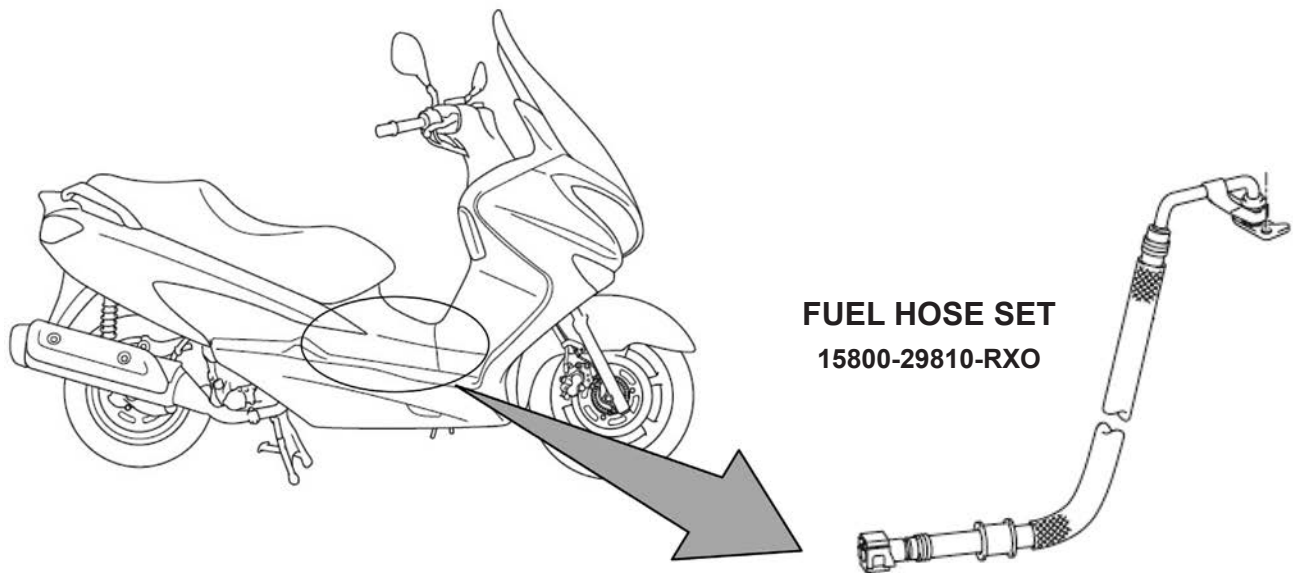
- Follow the repair procedure listed on the following pages to replace the original fuel hose with a new Fuel Hose Set that includes a new fuel hose plus a seal ring and O-ring for the fuel injector.

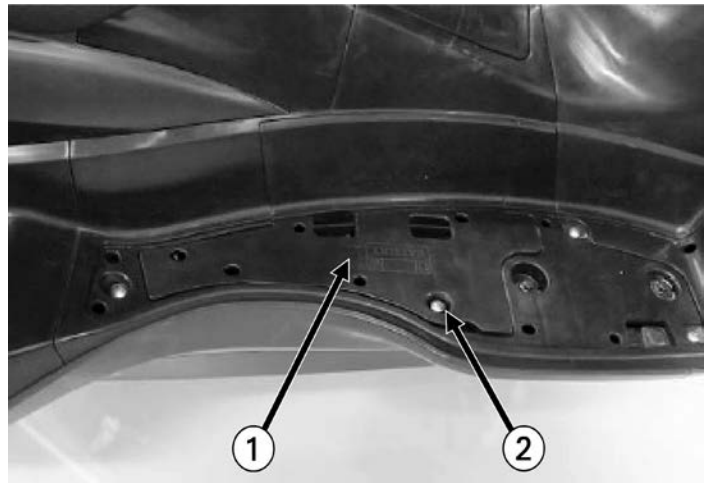
1. Remove the right floor mat ①.
2. Remove the battery cover by removing the screws ②.

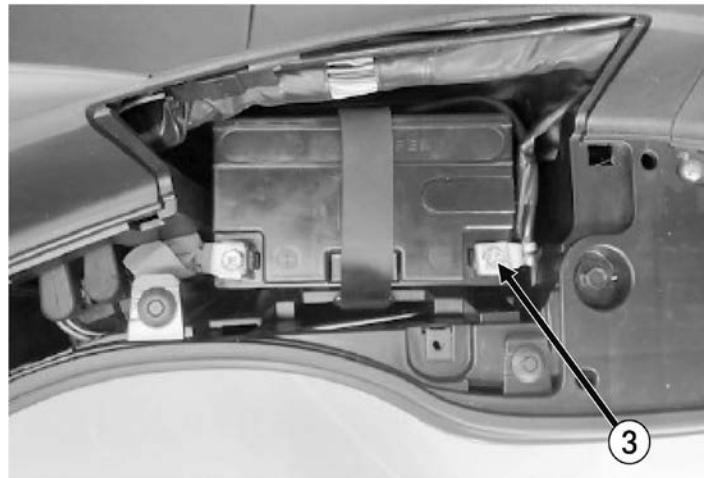
3. Disconnect the battery negative lead wire ③.

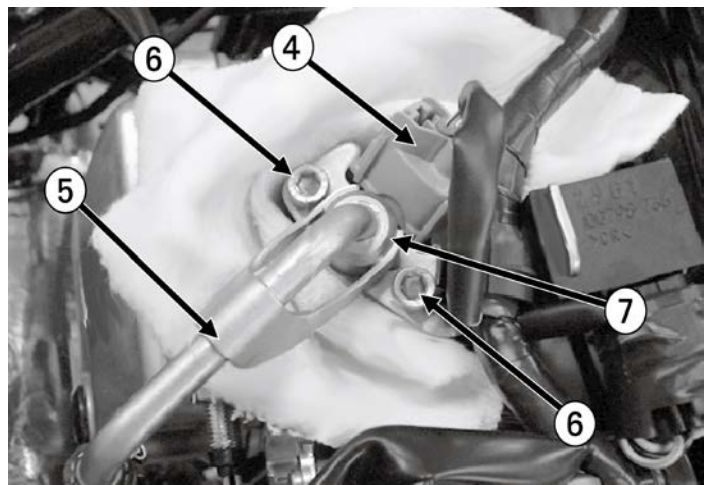
5. Disconnect the fuel injector coupler ④.
6. Place an absorbent cloth under the fuel hose ⑤ and disconnect the fuel hose from the fuel injector ⑥ by removing the two 6mm bolts ⑦ with a 5mm hex tool.
7. Remove the cloth that was placed under the fuel hose.

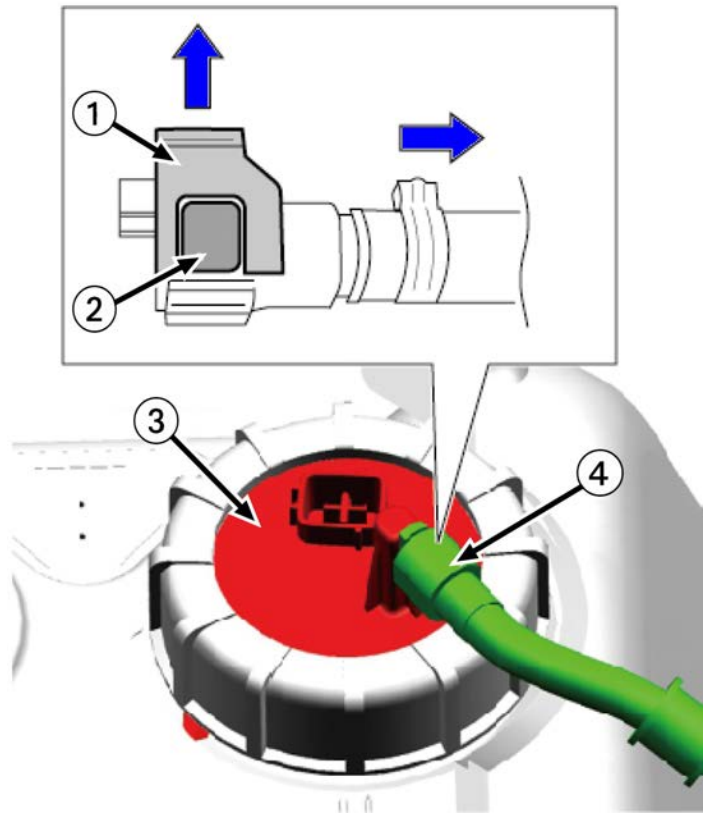
8. Unlock the fuel hose joint ④ by pulling the retainer ① outward.

Place an absorbent cloth under the fuel hose joint ④ to collect any gasoline that may come out of the hose.

9. Press the buttons ② on both sides of the fuel hose joint ④ and pull the fuel hose so it disconnects from the fuel pump ③.

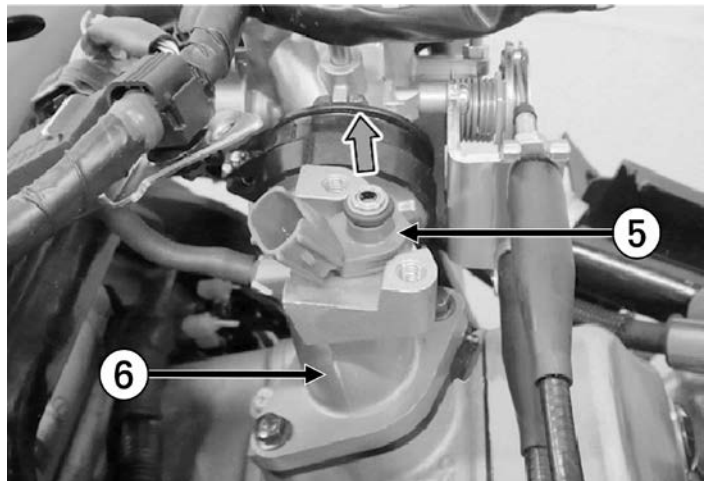
10. Remove the fuel injector ⑤ by pulling it upward (as shown in the illustration) from the intake pipe ⑥.

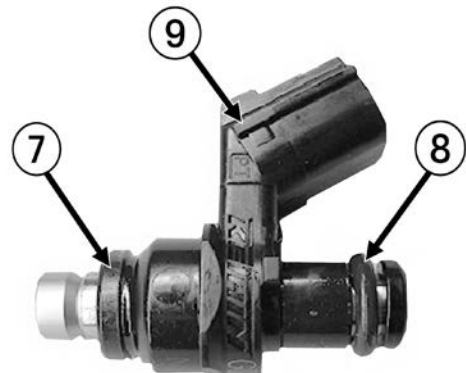
11. Remove the seal ring ⑦ and the O-ring ⑧ from the fuel injector ⑨.

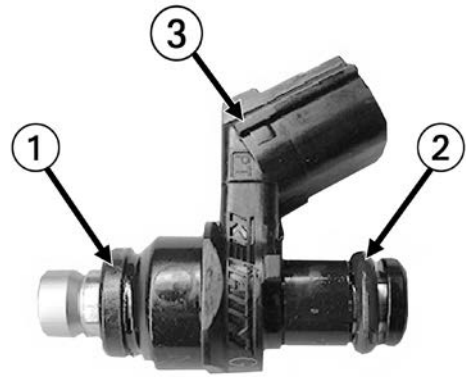
1. Install the new seal ring ① and new O-ring ② to the fuel injector ③. Apply a thin coat of clean engine oil to the seal ring and O-ring.

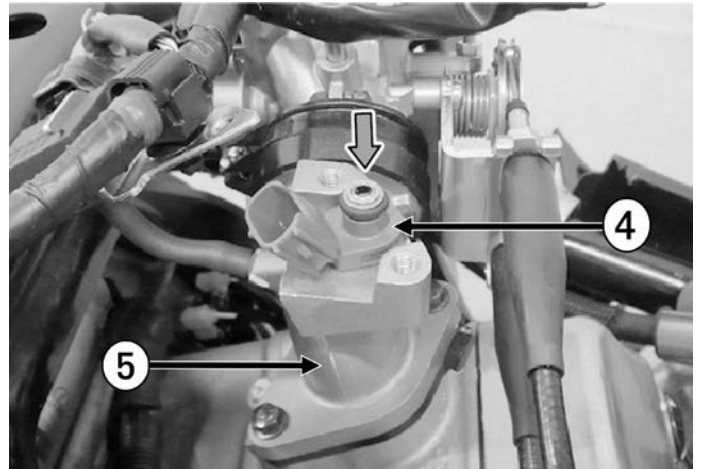
2. Install the fuel injector ④ by pushing it straight down into the intake pipe ⑤ (as shown in the illustration).

Never turn the fuel injector while pushing it into the intake pipe. Damage to the injector, the seal ring, or the O-ring may occur.

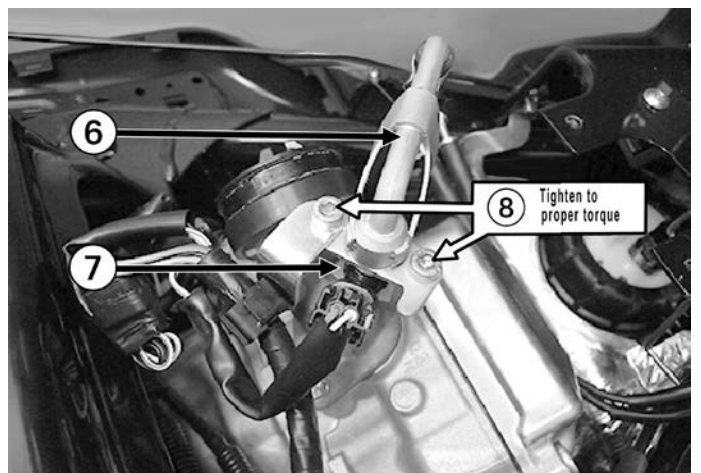
3. Install the new fuel hose ⑥ to the fuel injector ⑦ and tighten the bolts ⑧ to the specified torque.

Bolt ⑧: 7.5 lbf-ft (10.N.m, 10 kgf-m)

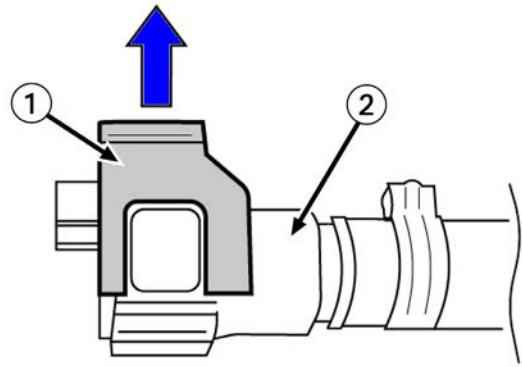
4. Pull the retainer ① out from the fuel hose joint ②.

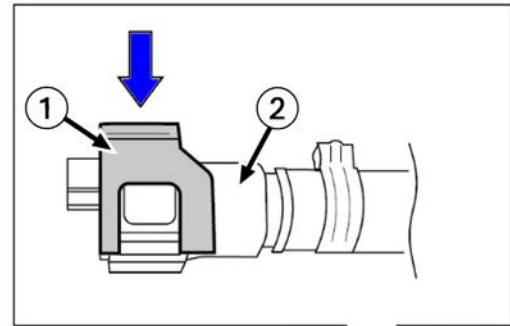
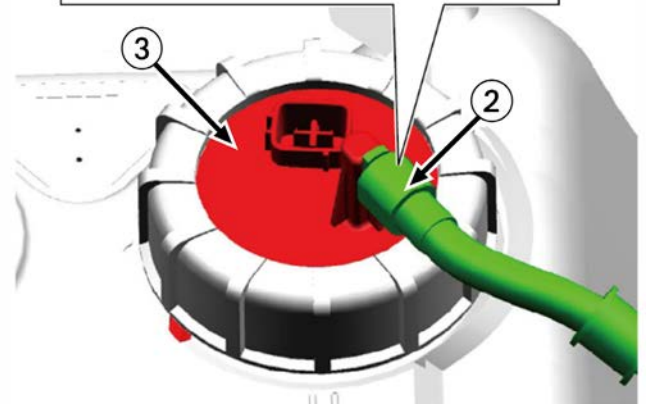
5. Connect the fuel hose joint ② to the fuel pump ③.
6. Lock the fuel hose joint by pushing in the retainer ①.
7. Pull on the fuel hose by hand to confirm that the fuel hose joint ② is securely attached to the fuel pump ③.

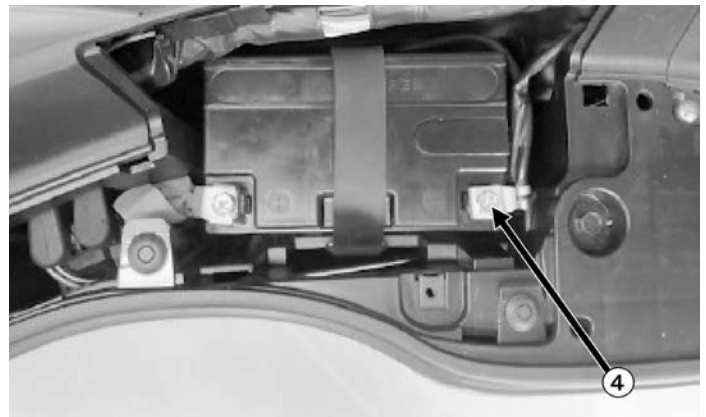
8. Connect the battery negative (-) lead wire ④.
9. Install the battery cover.
10. Install the right floor mat.

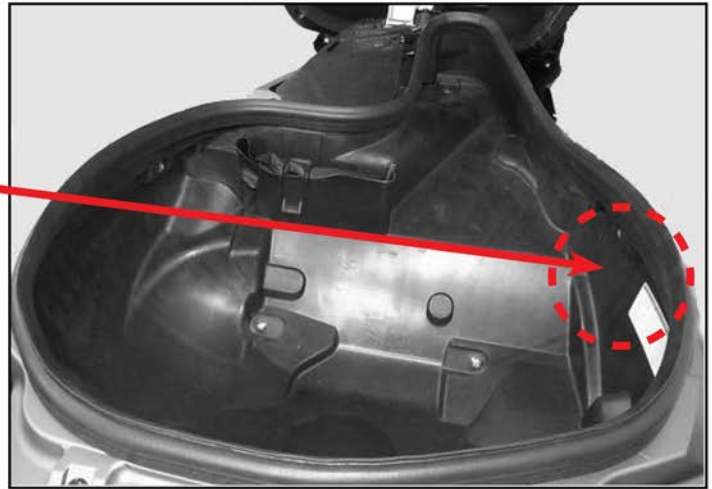
Attach the Repair Completion Sticker as shown.

Write your six-digit Suzuki dealer number on the bottom half of the Repair Completion Sticker using a permanent marker of pen with black in (for example, a Sharpie® brand marker with a fine point). Then apply the sticker to the inside of the under-seat trunk as shown below.
