**RECREATIONAL VEHICLE  
SAFETY RECALL NOTICE**

Safety Recall: 21V-250  
Safety Advisory: 21-407  
May 7, 2021

## Bullet Egress Window Crank Instructions

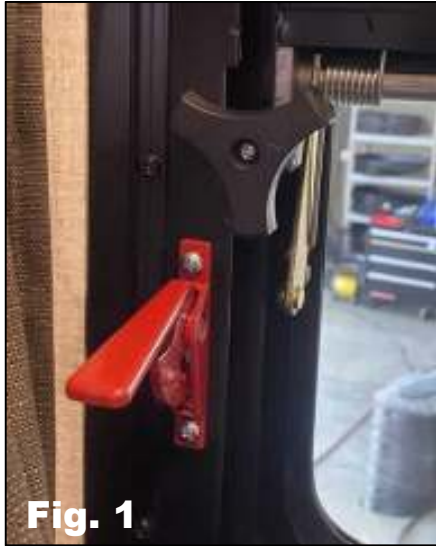
**Fig. 1**

Locate the bedroom egress window. Figure 1

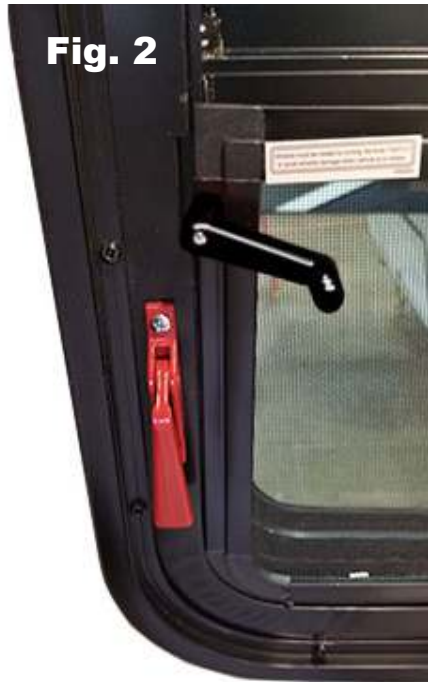
**Fig. 2**

It has been decided that the vehicles in the recall population have an egress window installed in the bedroom and did not have the correct crank handle installed. If an emergency situation arises the emergency exit may be difficult to open as the current black round knob may impede the ability to open the window, which could result in an increased risk of personal injury.

Remove the black round knob and install the narrow crank handle using KRV # 630481- Window - Crank - 3' - Black and an #8-32 x 2" screw. See Figure 2.
