IMPORTANT SAFETY RECALL

NHTSA Recall ID 21-V-624

HEHR 6400 SERIES WINDOW VENT RECALL

Recall Number:	21E047		
Product:	Hehr 6400 Series Window Vent		
Date:	Original: June 29, 2021 Revised: Aug. 12, 2021	Labor Rate:	Inspection 0.4 hour per unit Replacement 0.5 hour per vent

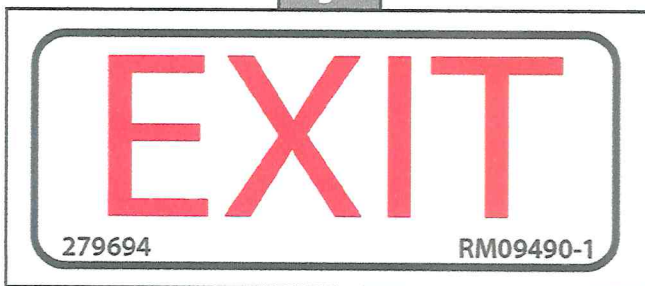
Fig. 1

- A. Inside the unit an EXIT sticker (Fig. 1) or red handle (Fig. 2A) will be present.
- B. Outside the unit the white backside of the EXIT sticker will be visible.

- A. Inside the unit a smaller INSULATED WINDOW sticker (Fig. 3) can be seen or the super spacer (Fig. 4) sandwiched between two panes of glass will be visible in addition to the EXIT sticker (Fig. 1) or red handle (Fig. 2A).
- B. Outside the unit the white backside of the INSULATED WINDOW sticker (Fig. 3) can be seen located above the white backside of the EXIT sticker (Fig. 1).

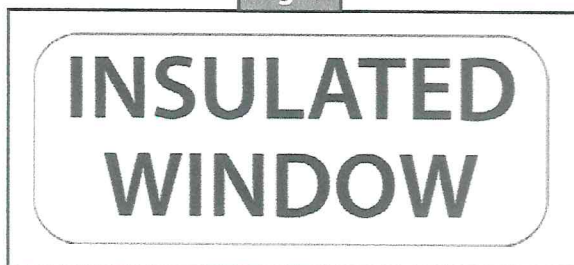
Fig. 3

- A. Inside the unit a smaller INSULATED WINDOW sticker (Fig. 3) or a super spacer (Fig. 4) sandwiched between two panes of glass can be seen.
- B. Outside the unit the white backside of the INSULATED WINDOW sticker (Fig. 3) is seen.

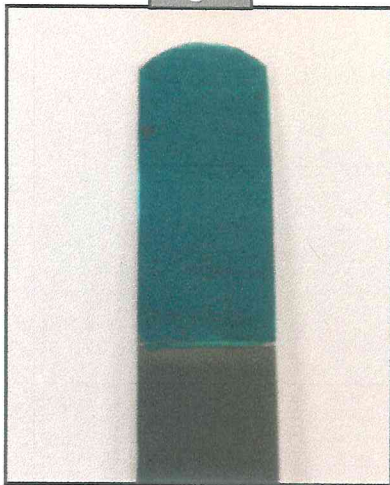
Fig. 5

The provided gauge has a colored segment at one end (Fig. 5). Use the gauge as outlined in the instructions below to determine any possible break in the seal.

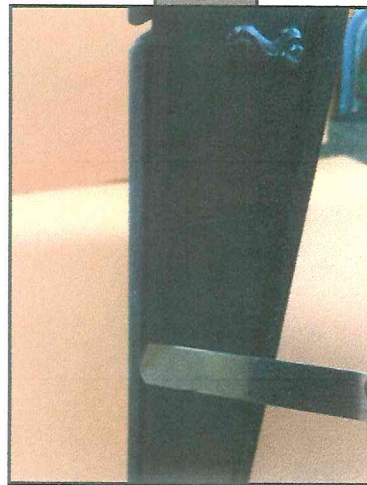
Fig. 6

1. Be sure window is in closed position.
2. Lightly insert the gauge into the gap between the glass and the frame (Fig. 6) starting near the hinge on the exterior side of the window.
3. The gauge should stop within the colored segment (Fig. 7).
4. Continue reinserting the gauge at different points, working around the glass.

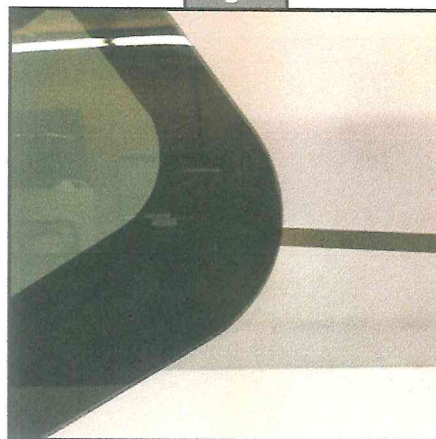
Fig. 8

NOTE: If the gauge inserts beyond the colored segment (Fig. 8) this indicates a possible break in the seal and the vent of the window will need replacing.
