TECHNICAL BULLETIN – TSB #021-001

This technical bulletin describes the proper inspection procedure for TSE OMNI Brake type 24 parking chambers with potential diaphragm longevity issues.

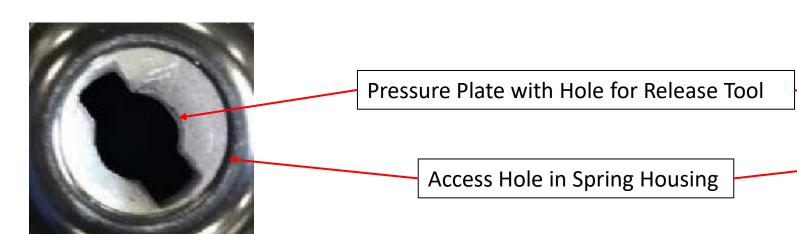
- Make sure the vehicle is on a flat surface and the wheels are chocked to prevent rolling.
- Release the parking brake before inspecting each chamber.
- Remove the dust plug from each chamber to check for centering of the pressure plate.
- If the pressure plate is shifted off center, then there is a potential issue with the chamber that could result in reduced chamber life.
- If the pressure plate is shifted far enough to prevent insertion of the release tool, then the chamber needs to be replaced.
- The picture below on the left shows a well centered pressure plate that will result in optimum light of the parking diaphragm.
- The picture to the below on the right shows a pressure plate that is severely shifted and may result reduced diaphragm life.
