Dealer Service Instructions for:

Equipment Safety Recall

Y56 / NHTSA 21V-632

Side Air Bag Inflatable Curtain Inflator

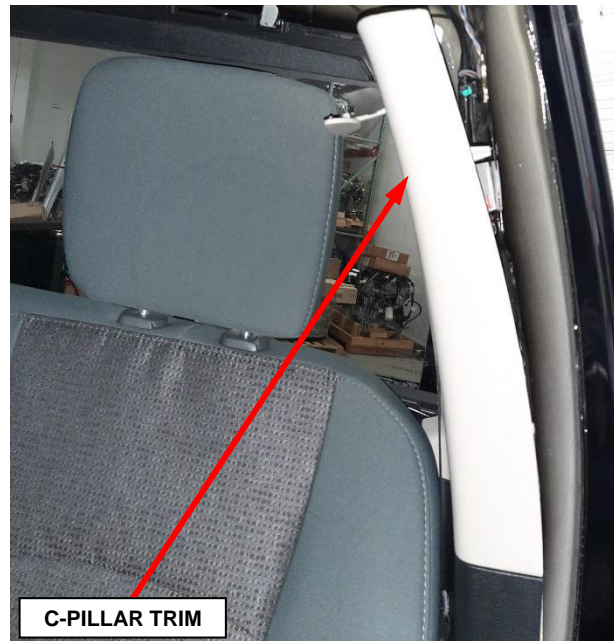
Figure 28 – C-Pillar Upper Trim Panel

- Release the retaining clips and tilt the top of the C-pillar upper trim panel inward (Figure 28).

49. Position the upper trim to the C-pillar then engage the retaining clips (Figure 28).
50. Install and tighten the screw that secures the C-pillar upper trim panel. Then install the airbag applique (Figure 27).
51. Remove and **DISCARD** the bolt retainer and bolt from the seat belt turning loop, save the spacer washer for reuse (Figure 42).

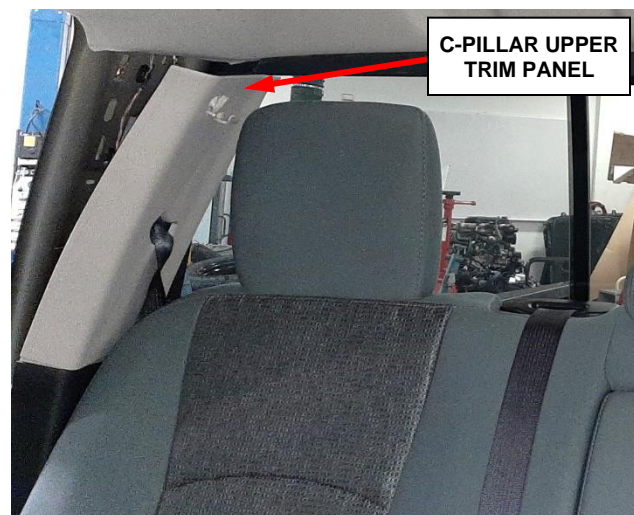
Figure 52 – C-Pillar Trim Panels

14. Release the retaining clips and tilt the top of the C-pillar upper trim panel inward (Figure 52).

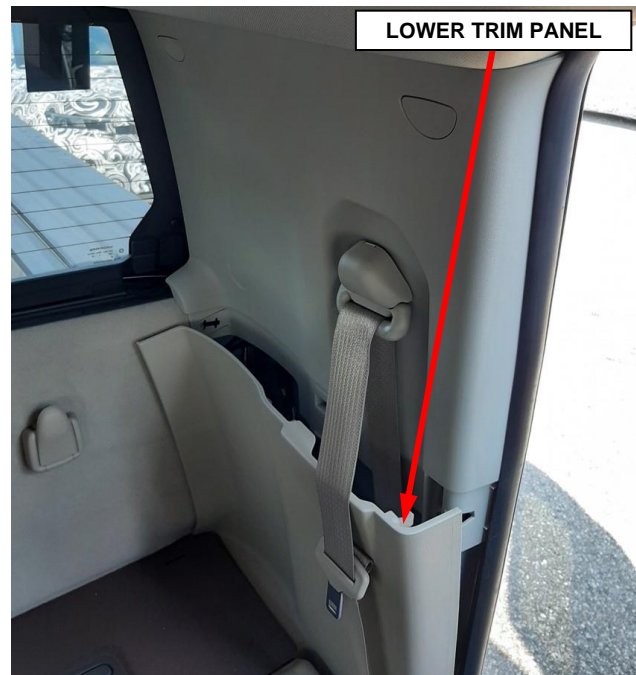
**Figure 73 – C-Pillar Lower Trim Panel**

11. Fold the rear seat backs down.
12. Release the upper retaining clips of the lower C-pillar trim panel to allow for removal of the upper C-pillar trim panel (Figure 73).
