Equipment Safety Recall

Y56 / NHTSA 21V-632

Side Air Bag Inflatable Curtain Inflator

Remedy Available

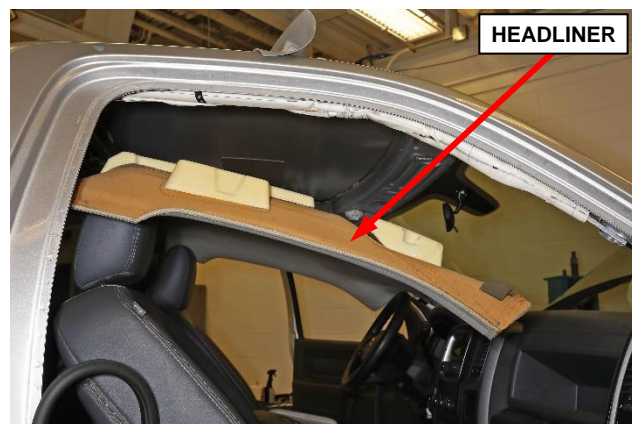
Figure 11 – Headliner

15. As necessary, release the headliner wiring harness clips (3) from the A-pillar to allow enough wiring harness slack for lowering the headliner (Figure 10).
16. Release the door seals from the door openings to allow for lowering of the headliner.
17. Carefully lower the headliner allowing it to rest on the seat backs and instrument panel (Figure 11).

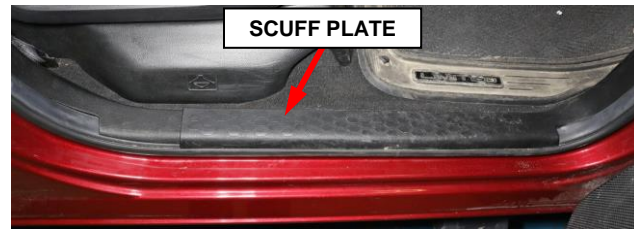
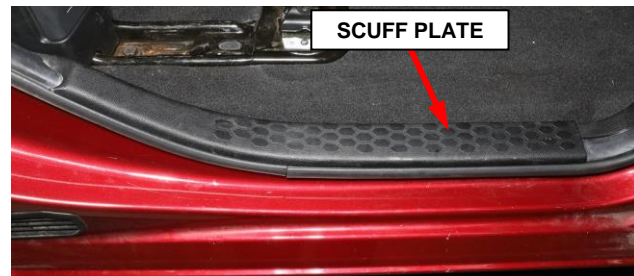
**Rear Door Sill****Figure 21 – Door Sill Scuff Plates**

6. Release the front and rear door sill scuff plates on either side of the B-pillar lower trim panel to allow for removal of the B-pillar lower trim panel (Figure 21).

57. Remove and **DISCARD** the bolt retainer and bolt from the seat belt turning loop, save the spacer washer for reuse (Figure 43).
58. Using a **NEW** bolt and reusing the spacer washer, install the turning loop then tighten the bolt to 40 N·m (30 ft. lbs.) (Figure 23).
59. Install the seat belt turning loop cover (Figure 29).
60. Position the B-pillar lower trim panel and engage the retaining clips fully (Figure 22).
61. Position the front and rear door sill scuff plates and engage the retainers (Figure 21).

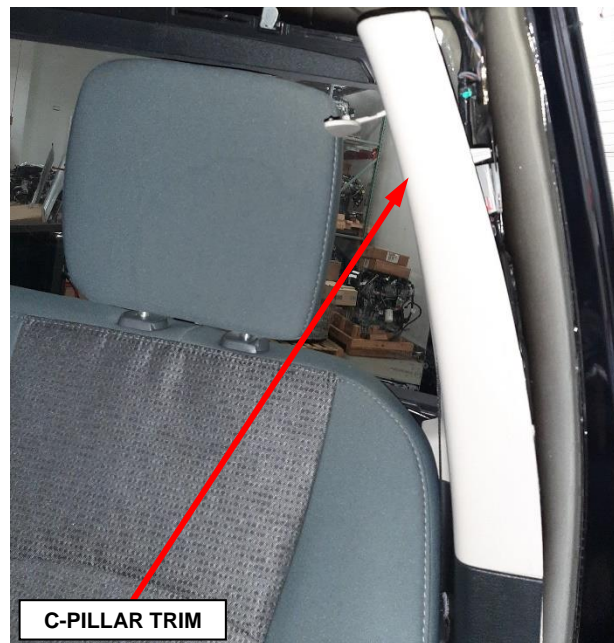
Figure 28 – C-Pillar Upper Trim Panel

15. Release the retaining clips and tilt the top of the C-pillar upper trim panel inward (Figure 28).

49. Position the upper trim to the C-pillar then engage the retaining clips (Figure 28).
50. Install and tighten the screw that secures the C-pillar upper trim panel. Then install the airbag applique (Figure 27).

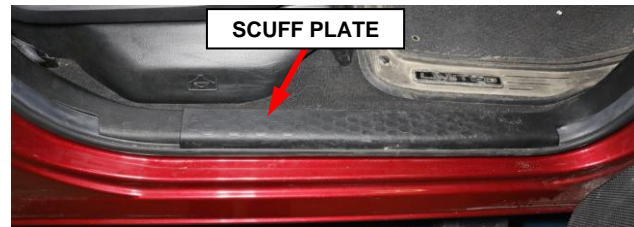
**Rear Door Sill****Figure 46 – Door Sill Scuff Plates**

6. Release the front and rear door sill scuff plates on either side of the B-pillar lower trim panel to allow for removal of the B-pillar lower trim panel (Figure 46).

51. Install the B-pillar upper trim panel (1) and engage the retaining clips fully (Figure 49).
52. Install the grab handle bolts (3) and tighten to 5 N·m (44 in. lbs.). Close the fastener covers (2) (Figure 49).
53. Remove and **DISCARD** the bolt retainer and the bolt from the seat belt turning loop, save the spacer washer for reuse (Figure 66).
54. Using a **NEW** bolt and reusing the spacer washer, install the turning loop then tighten the bolt to 40 N·m (30 ft. lbs.) (Figure 48).
55. Install the seat belt turning loop cover (Figure 48).
56. Position the B-pillar lower trim panel and engage the retaining clips fully (Figure 47).
57. Position the front and rear door sill scuff plates and engage the retainers (Figure 46).

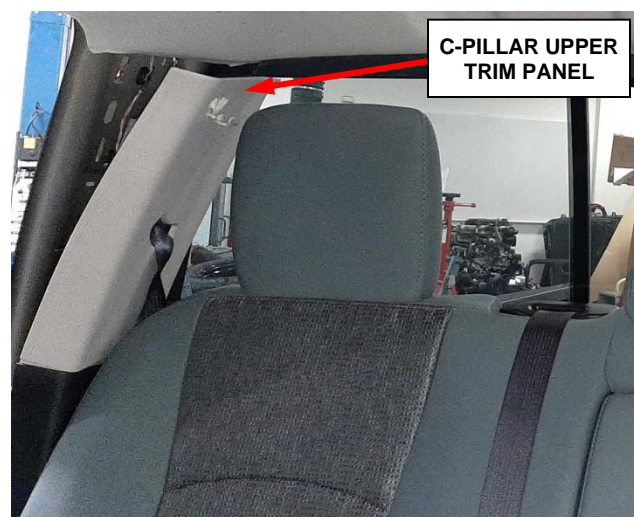
**Figure 52 – C-Pillar Trim Panels**

14. Release the retaining clips and tilt the top of the C-pillar upper trim panel inward (Figure 52).

48. Position the upper trim panel to the C-pillar then engage the retaining clips (Figure 52).
49. Install and tighten the screw that secures the C-pillar upper trim panel. Then install the airbag applique (Figure 51).

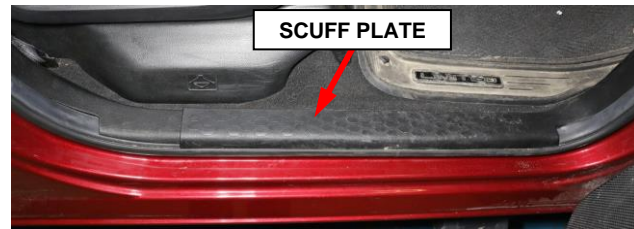
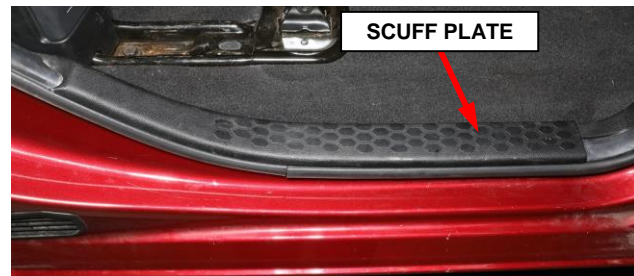
**Rear Door Sill****Figure 69 – Door Sill Scuff Plates**

5. Release the front and rear door sill scuff plates on either side of the B-pillar lower trim panel to allow for removal of the B-pillar lower trim panel (Figure 69).

72. Position the front and rear door sill scuff plates and engage the retainers (Figure 69).

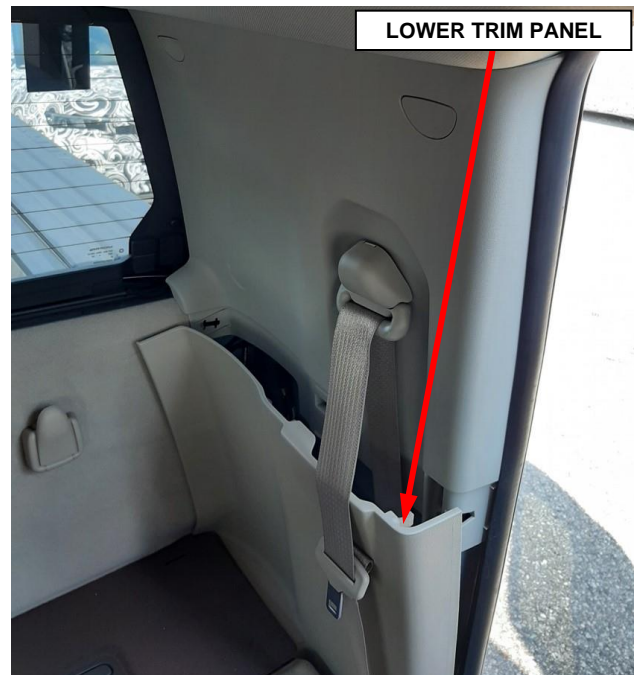
**Figure 73 – C-Pillar Lower Trim Panel**

11. Fold the rear seat backs down.
12. Release the upper retaining clips of the lower C-pillar trim panel to allow for removal of the upper C-pillar trim panel (Figure 73).

59. Raise the front seat backs and position the seats forward.
60. Install the C-pillar upper trim panel (1) and engage the retaining clips fully (Figure 76).
61. Install and tighten the screws that secure the C-pillar upper trim panel then install the airbag applique covers (Figure 75).
62. Remove and **DISCARD** the bolt retainer and the bolt from the seat belt turning loop, save the spacer for reuse (Figure 90).
63. Using a **NEW** bolt and reusing the spacer washer, install the turning loop then tighten the bolt to 40 N·m (30 ft. lbs.) (Figure 74).
64. Install the seat belt turning loop cover (Figure 74).
65. Position the lower C-pillar trim panel and engage the retaining clips fully (Figure 73).
