Recall Campaign Bulletin

Campaign No.2021020004, February 2021

SUBJECT: Model CLA-Class and A-Class vehicles (118 and 177 platform) Model Year 2021 Check ISOFIX Bracket

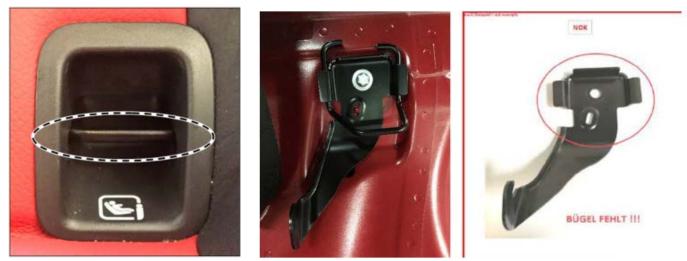
Figure 1

1. Check whether the bracket for right rear holder of the ISOFIX child seat anchor is present (Figure 1).

(Figure 2) shows the exposed (with the seat removed) bracket and (Figure 3) without (NOK circled in red) the bracket.

- a. Bracket of right holder for ISOFIX child seat anchor present: End measure.
- b. Bracket of right holder for ISOFIX child seat anchor NOT present: Carry out work procedure.

2. Replace the right holder bracket for the ISOFIX child seat anchor.
