SIB 34 03 21

RECALL 21V-XXX: BRAKE DISC

This Service Information Bulletin (Revision 1) replaces SI B34 03 21 **dated February 2021**.

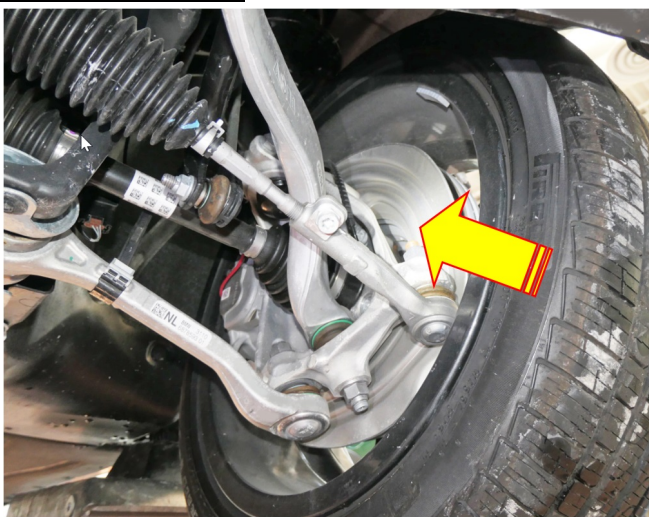
Inspect the left and right front brake disc rivet installation in the area of the arrow and if necessary, replacing the front brake discs.

Left front suspension shown, looking rearwards.

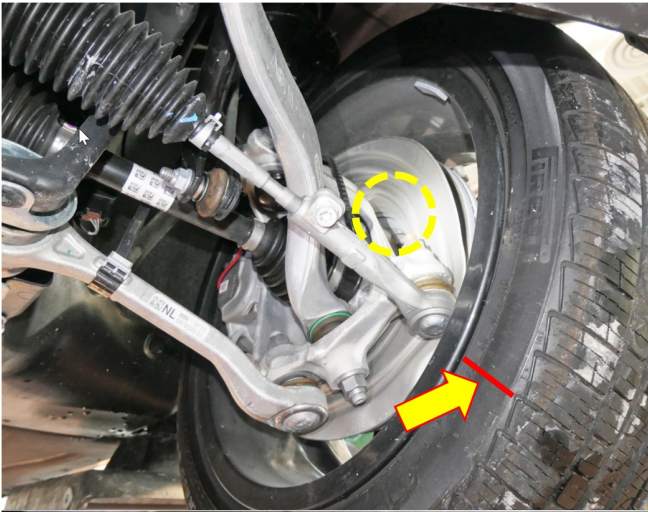
2. Carefully view into the front disc hub at the area circled.

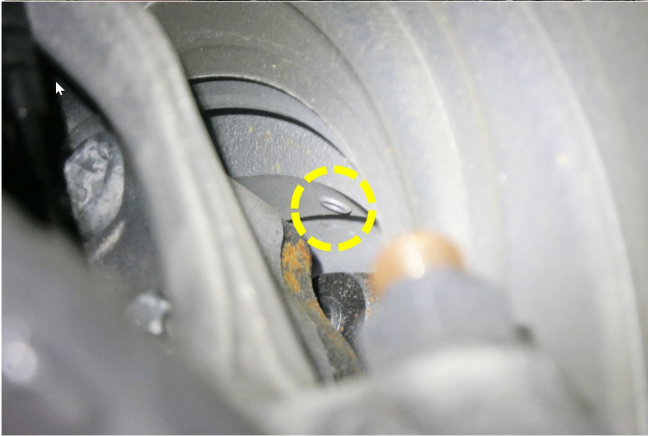
3. Mark the inner sidewall or wheel rim edge using a wax pencil (arrow) to ensure you rotate the tire one full revolution for the rivet inspection.

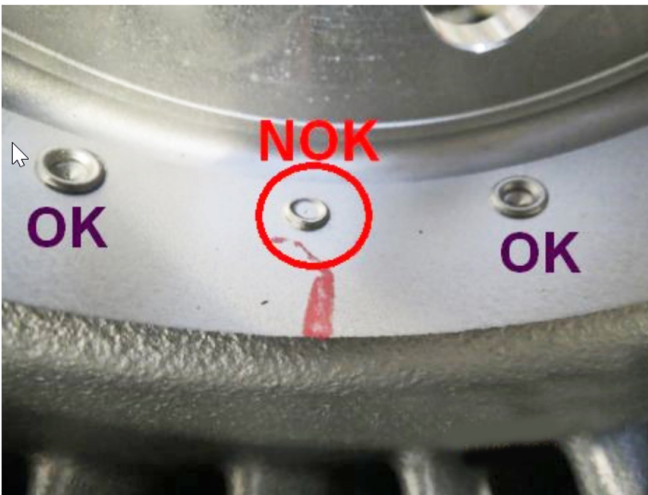
4. View each of the 18 rivets (circled) on each front disc using a flashlight.

Rotate the wheel to view each rivet, until the marked line comes back to the same spot as when first started.

Use a borescope if needed to obtain a close-up view.

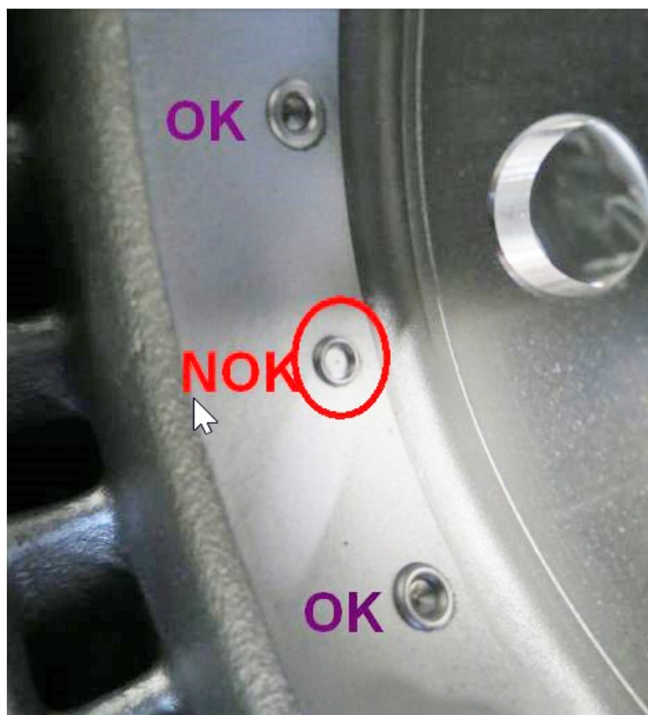
Determine if the rivet is correctly shaped per the 2 reference photos.

OK:

- The inner stem is sunken well below the outer "shoulder"
- The shoulder has a significant curvature
- Rivet is slightly larger diameter

NOT OK ("NOK"):

- Inner stem is nearly flush with the disc surface
- The shoulder is "peaked"
- Smaller diameter

- All rivets OK on BOTH discs: No more work needed.
- At least ONE rivet is NOT OK on either disc: Replace **BOTH** discs. Refer to AIR Repair instructions **34 11 220**.
 - **Because of the almost new condition of these vehicles, the existing brake pads can be reused for this repair when the brake discs require replacement**
