## SERVICE BULLETIN INSTRUCTIONS FOR RECALL 21V-166

**Units Involved: Chassis produced between the dates of December 2019 and March 2021. A list of suspect vehicles is attached part of this service bulletin.**

**Topic: Inspection and replacement of suspected defective Bendix SL-4 Stop Light switches.**

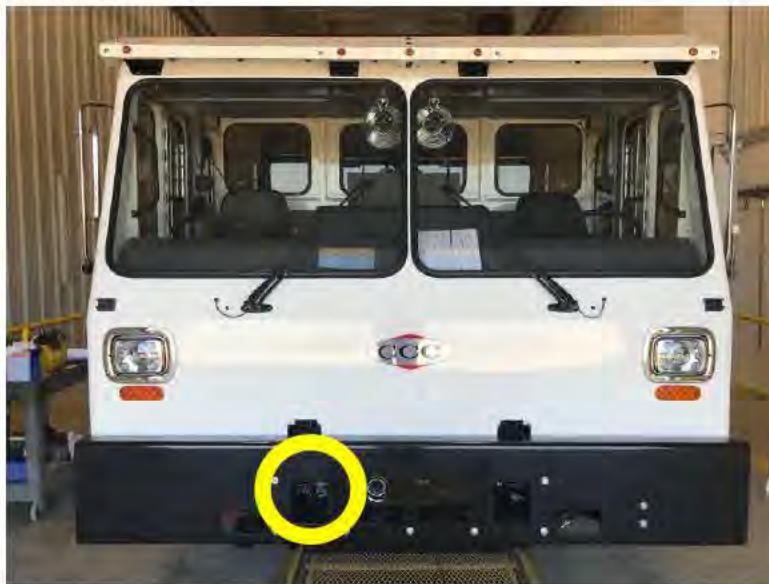
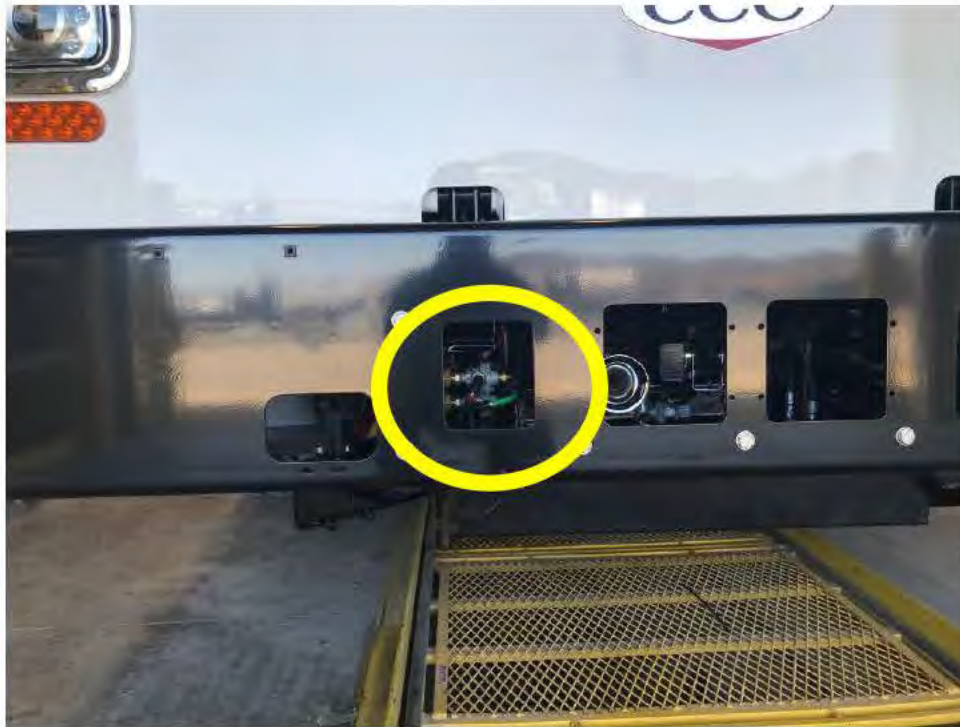
2. Locate the stop light switches located on the down valves, under the right side of the cab on the inside of the frame rail.

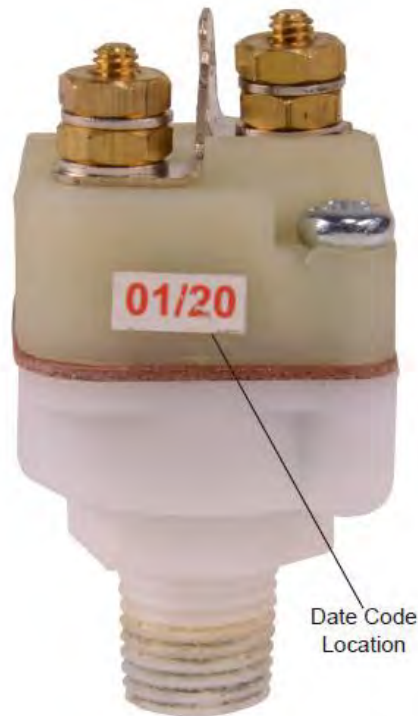
3. Inspect the switches to determine if the date code can be found, and if it is shown as “12/19” or “01/20”. The Bendix® SL-4™ stop light switch includes a date code printed on a white Bendix label affixed to the unit. The date code, featuring a “Month/Year” format, appears in red type. Stop light switches covered by this campaign would have a date code of either 12/19 or 01/20. For example, an SL-4 stop light switch manufactured in December of 2019 will have a date code of “12/19” in red type, and an SL-4 stop light switch manufactured in January of 2020 will have a date code of “01/20” in red type. Verification of the date code is required to determine if the stop light switch is a part of the recall campaign.

4. If the date code can be determined and is not in the specified range, no further action is required. If one or both switches is within the specified range OR the date range cannot be determined, proceed to step 5.
5. Remove the two wires from the suspect switch. Remove the switch from the manifold utilizing the appropriate size wrench.
6. Reinstall the new switch utilizing the reverse procedure from step 5.
7. Verify the operation of brake lights by building up a minimum of 120 psi air pressure, release the parking brakes, and applying the service brakes. Brake lights should come on with the service brakes applied and go off with the service brake released. Ensure the wheels are chocked before releasing the parking brake.
