Mercedes-Benz

Campaign No. 2021040012, July 2021
Revision B: 04/30/2025

SUBJECT: **Models C-Class, CLK-Class, E-Class, and CLS-Class (203, 209, 211, and 219 platform)
Model Years 2001-2011
Sliding Roof Bonding**

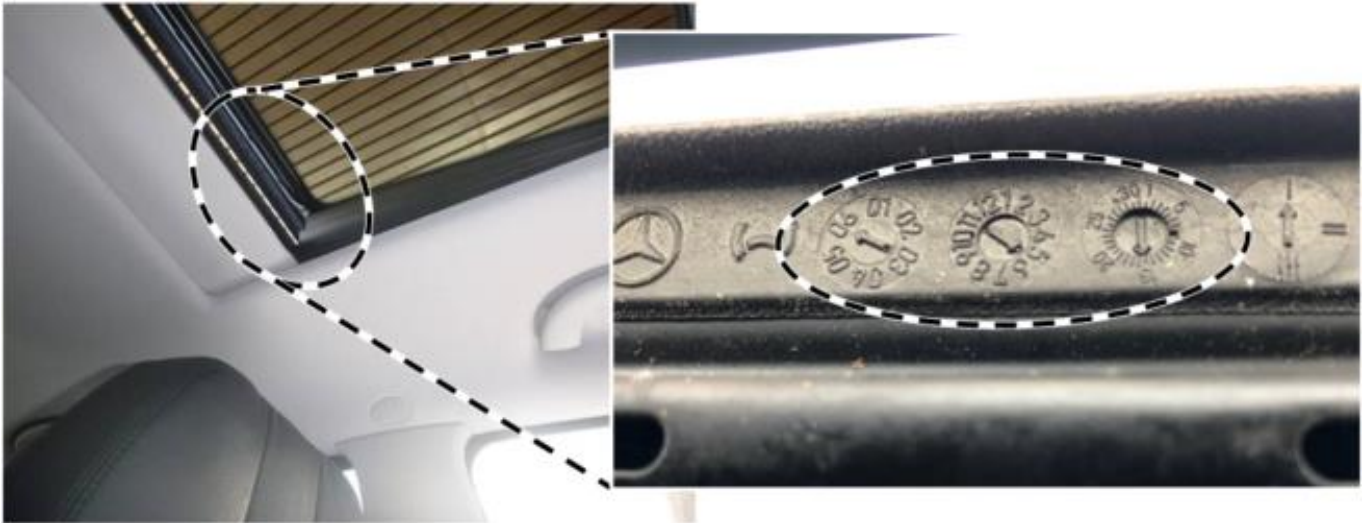
Figure 1 (The production date in the sample picture is **06 year / 5 month / 15 day**)(5-15-2006)

1. Move sliding sunroof to tilt position and check production date (**Figure 1**).

i The production date **must** be on or **after 11-25-2005** or on or **before 10-31-2007**.

i If the production date is **not** at the shown location (**Figure 1**), this vehicle is **not** affected.

- A. Production date between **11-25-2005** and **10-31-2007**: Carry out **Check/Test Procedure B**.
- B. Production date **not** between **11-25-2005** and **10-31-2007**: **End measure**.
- C. **No** production date present at shown location (Figure 1): **End measure**.

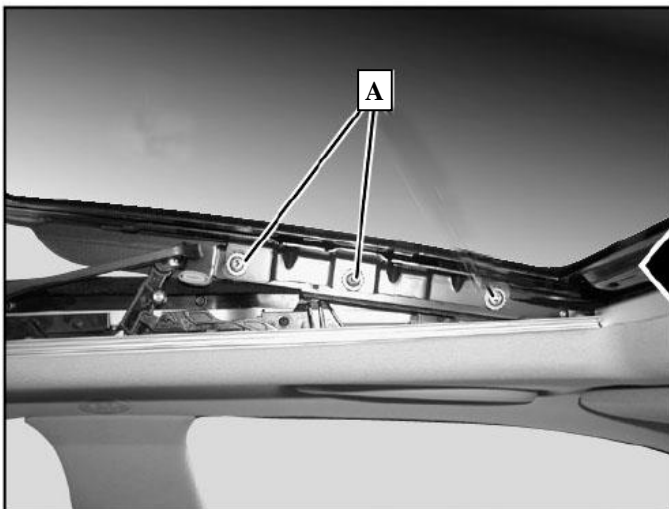
Figure 2

i If the sliding sunroof is **not** functional, loosen the two rear sliding sunroof panel screws (Figure 2, A), lift the sliding sunroof by hand and then read off the production date.

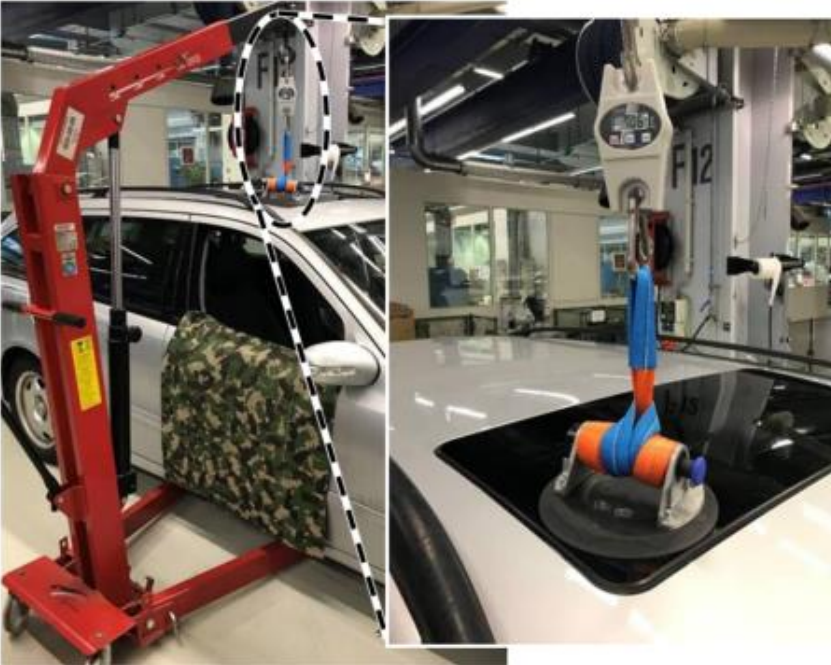
Figure 3

3. Position cup suction tool (**Figure 3**) and pull as **vertically** as possible (tolerance of ± 10 degrees) using lifting tool (hoist/crane).

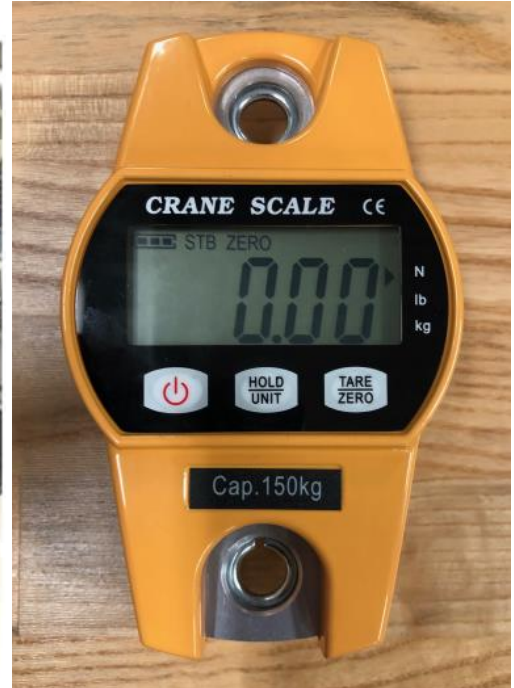
Figure 4 (Correct scale display)

i Before the start of the measurement, the "(auto) hold function" of the hanging scale **must** be deactivated and the measurement scale is set to N (see operator's manual). (**See Figure 4**) for correct scale display.

No "hold function" may be activated so that the current pulling force is always displayed.

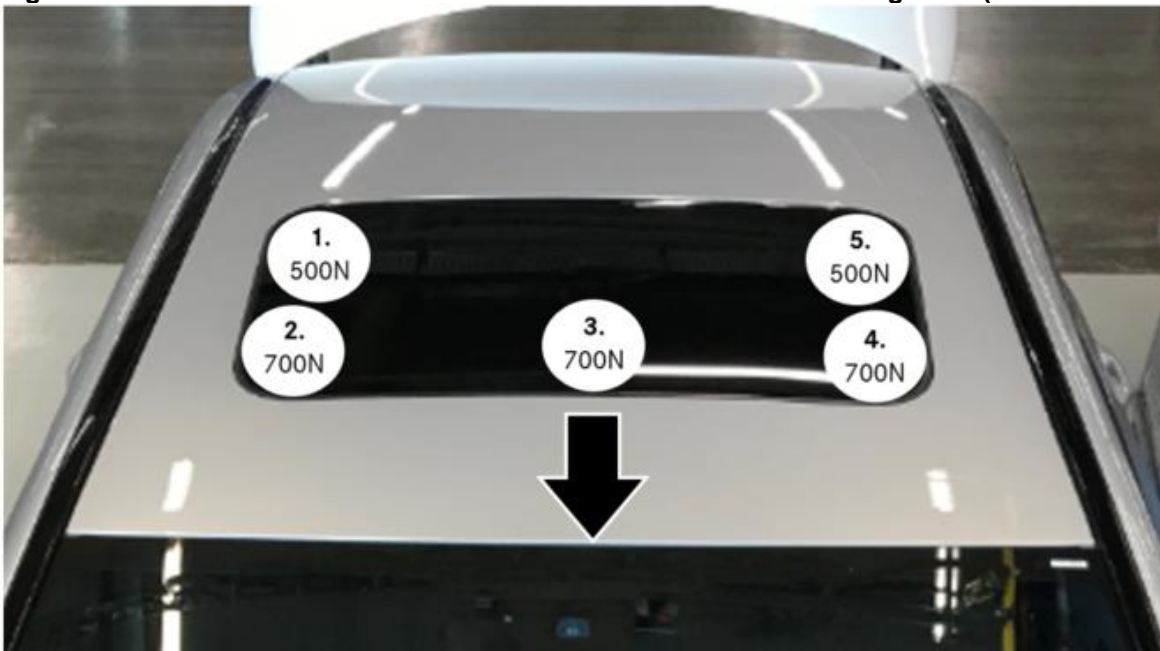
Figure 5 (test sequence 1, 2, 3, 4, 5 – arrow specifies front of vehicle)

i Specified force **500 N/700 N (Figure 5)**. **Please note that the scale is in N (newton) and should be measured in N. DO NOT attempt to convert to any other measurement. An incorrect conversion could result in an inaccurate test result and/or damage to the testing equipment and/or the vehicle. Any costs associated with an improper repair will be the responsibility of the repairing dealer.**

i Position cup suction tool at 5 positions in the sequence **1, 2, 3, 4, 5: (Figure 5)**.

i The specified force **must be monitored during the first minute** and adjusted if necessary (tolerance ± 10 N) **The specified force must not be exceeded**. Pull as vertically as possible (tolerance ± 10 degrees) at the specified force. There must not be a person inside the vehicle during the check, and the vehicle must not be touched if possible.

i The holding time per position must be exactly **10 min**.

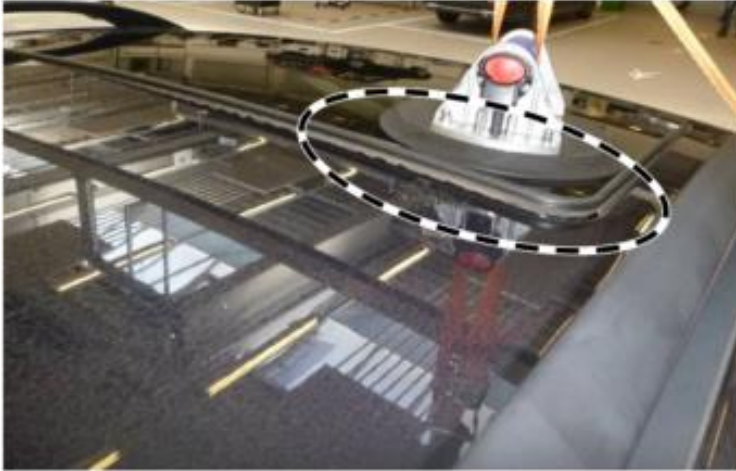
Figure 6

i The sliding roof panel is lifted out of the roof frame noticeably at the rear test positions 1 and 5 (**Figure 6**).

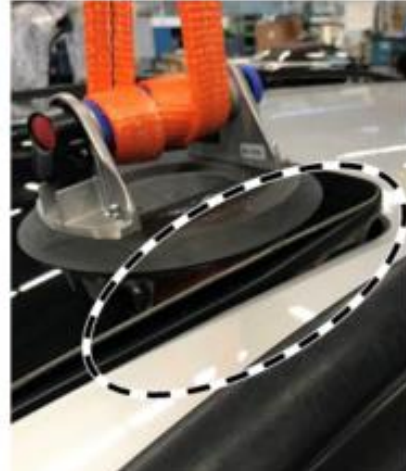
Figure 7 (NOT OK)

i If the sliding roof panel detaches from the padding of the tilting/sliding roof frame at one of the test positions (see **Figure 7**), the sliding roof panel must be replaced.

- A. If the sliding roof panel detaches from the padding: Carry out **work procedure**.
- B. If the sliding roof panel does **not** detach from the padding: **End measure**.

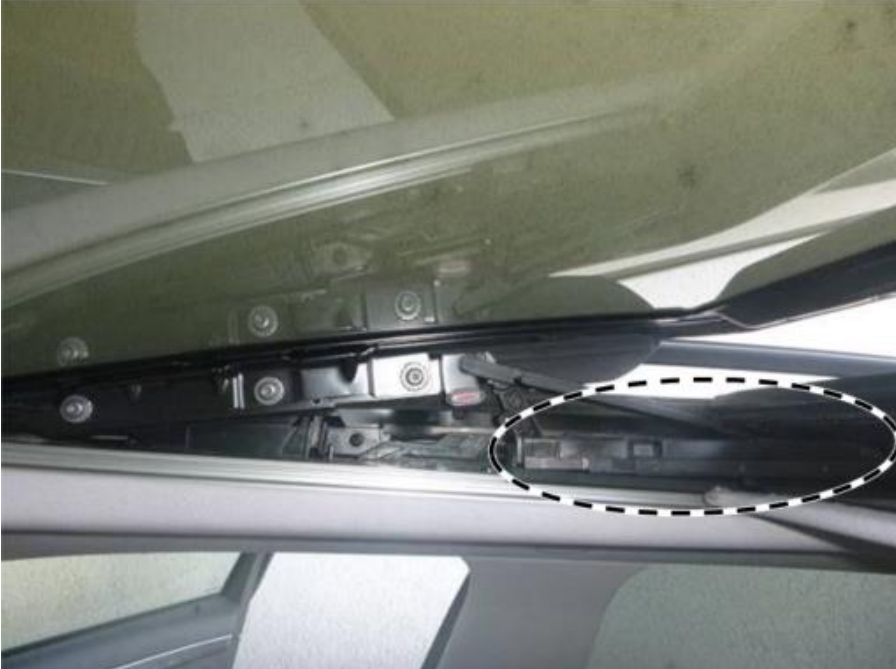
Figure 8

1. Replace sliding sunroof.
 - i** The accordion boot **need** not be removed completely. It is sufficient to slide it back (**Figure 8**).
 - i** It is not necessary to prepare the strip of cardboard.

Model 203: **AR77.20-P-1000P**
 Model 209: **AR77.20-P-1000Q**
 Model 211: **AR77.20-P-1000T**
 Model 219: **AR77.20-P-1000TX**
