RECALL 21V219 REMEDY INSTRUCTIONS

Models affected: BEA37A-380, BEA40C-380, BEA40D-380, BEA40E-380, BEA45A-450 and BEA45CA-450.

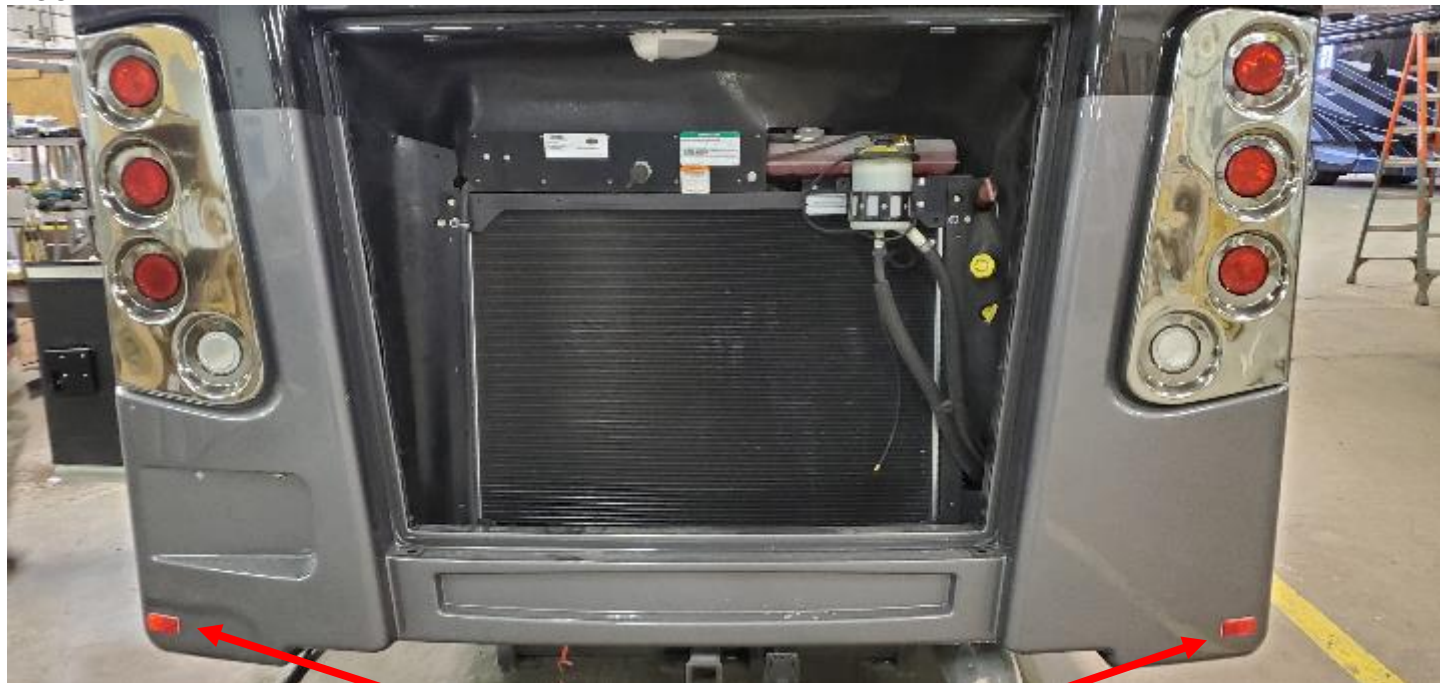
FIGURE 1

ROAD SIDE
DRIVERS SIDE

NEWLY INSTALLED REFLECTORS
(REAR OF VEHICLE)

CURB SIDE
PASSENGERS SIDE

STEP 1: REFERENCE THE PHOTO BELOW OF THE REAR CAP (FIGURE 1);

STEP 2: CLEAN THE CAP SURFACE EXTREMELY WELL ON THE REAR CURB SIDE AND REAR ROAD SIDE (AS DEPICTED IN THE PICTURE BELOW) WHERE THE STICK ON REFLECTORS WILL BE INSTALLED;

STEP 3: PEEL THE BACKING OFF THE REFLECTOR DOUBLE SIDED TAPE, ORIENTATE THE REFLECTOR (AS DEPICTED IN THE PICTURE BELOW) AND PRESS THE REFLECTOR FIRMLY AGAINST THE CAP, HOLDING IN PLACE FOR A SHORT TIME TO PROMOTE COMPLETE ATTACHMENT;

STEP 4: REPEAT STEP 3 ON THE OPPOSITE SIDE, THEN CLAIM THE REPAIR CODE LISTED ABOVE.
