Dealer Service Instructions for:

Safety Recall Y15 / NHTSA 21V-221

Side Curtain Air Bag

2021 (GU) Alfa Romeo Stelvio

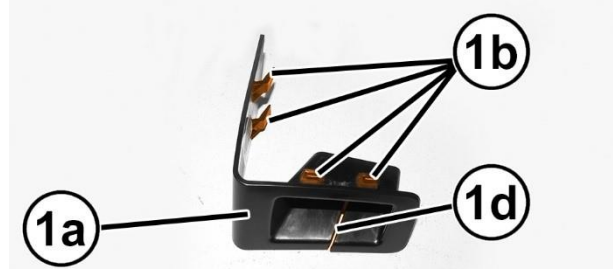
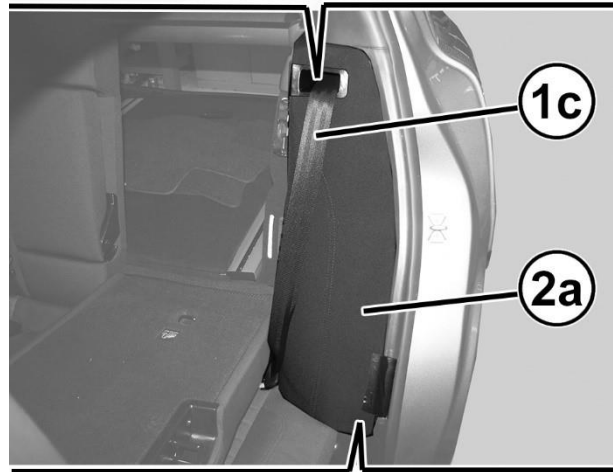
Figure 2 – Rear Seat Bolster

5. Remove the seat belt bezel (1a) by releasing its retainers (1b) then guide the seat belt (1c) out through the slot (1d) (Figure 2).

6. Release the retainers (2b) of the rear seat bolster (2a) (Figure 2).

7. Remove the rear seat bolster (2a) by guiding the seat belt (1c) out through the slot (3a) (Figure 2).

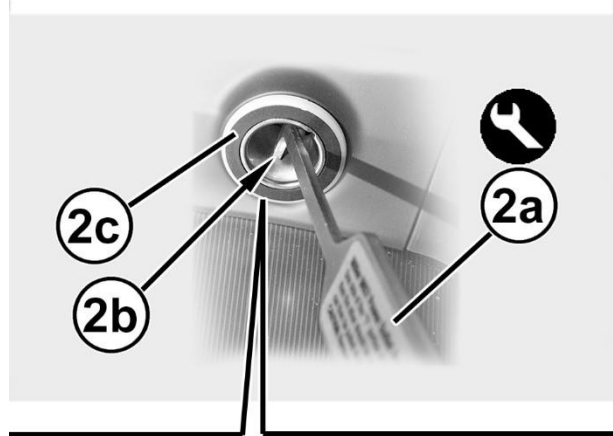
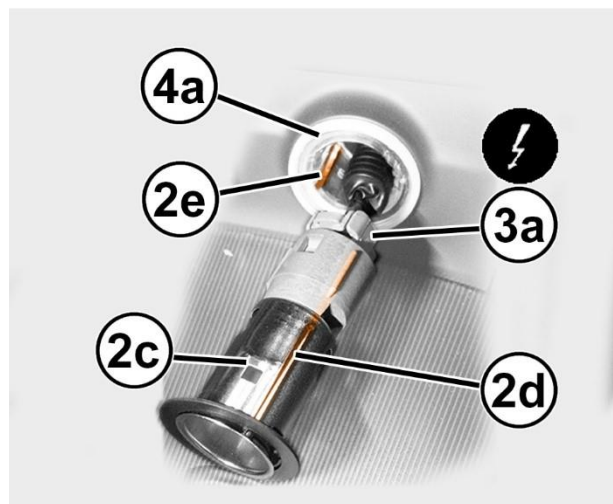
Figure 5 – Power Socket

12. Open the cover (1a) of the power socket (Figure 5).

13. Engage the power outlet remover tool 9857 (2a) in the recesses (2b) of the power socket and carefully extract the power socket (2c). During the removal of the power socket (2c), its ridges (2d) must slide in the housing (2e) (Figure 5).

14. Disconnect the electrical connection (3a) and remove the power socket (2c) without removing the ring (4a) (Figure 5).

- 36. Connect the electrical connection of the power socket, insert the power socket in its housing respecting the mandatory position and close the cover (Figure 5).

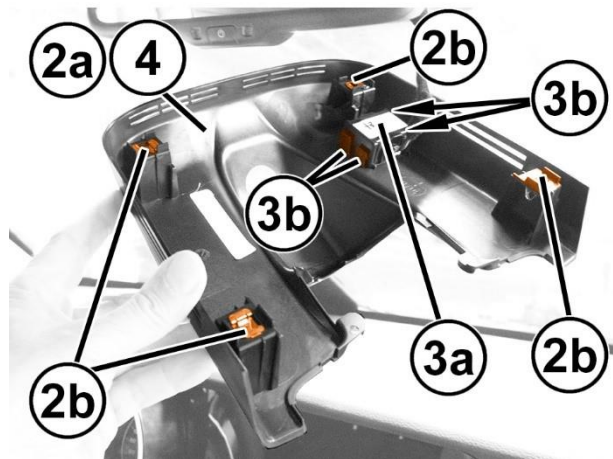
Figure 7 – Mirror Trim

20. With a trim stick, lift up the upper area (1a) and remove the mirror trim (1b) releasing its retainers (Figure 7).

21. Move the outer mirror trim (2a) aside, releasing its retainers (2b) (Figure 7).

22. Release the sensor (3a) from the four retainers (3b) (Figure 7).

23. Remove the outer mirror trim (2a) (Figure 7).

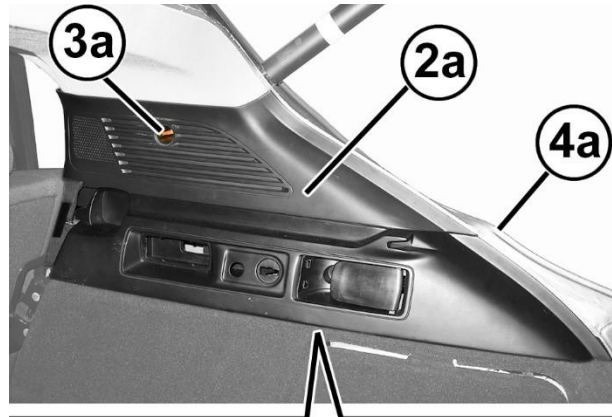
Figure 31 – C-Pillar Trim Panel

- 31. Check that the C-pillar trim panel (2a) is not damaged (Figure 31).
- 32. Install the cable end (4b) and clip the cable ferrule (4a) of the rear seat backrest release handle cable (1c) to the C-pillar trim panel (Figure 31).

- 33. Install the C-pillar trim panel (2a) and engage the various inner retainers (2b) (Figure 31).

- 34. Tighten the screw (3a) and then engage the cover (Figure 31).

- 35. Engage the tailgate frame weather strip (4a) (Figure 31).
