TECHNICAL INSTRUCTIONS

FOR SAFETY RECALL 21TA01

NON-DEPLOYMENT OF SIDE AND CURTAIN SHIELD AIRBAGS MAY OCCUR

CERTAIN 2009 – 2010 VENZA

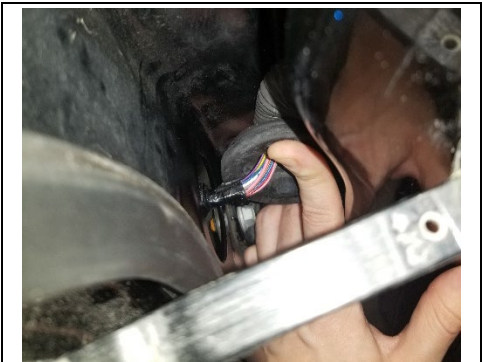
- a. Open the driver side door
- b. Remove rubber grommet from the wire harness attachment point on driver's door
- c. Stand between the door and body as shown in the image

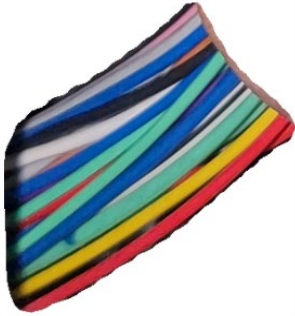
Example 1:
One or No Yellow Wires Present – Replacement Not Required

At least one yellow wire detected

Our system has detected the presence of one yellow wire and has marked the appropriate selection below. Review the photo and confirm selection. If you disagree with the system's selection, please enter the correct selection and continue.

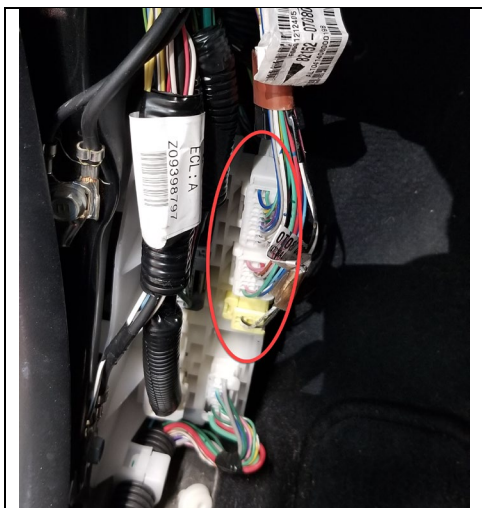
5. DISCONNECT DOOR WIRE HARNESS CONNECTOR FROM JUNCTION BLOCK
 - a. Disconnect the 3 connectors shown in the image

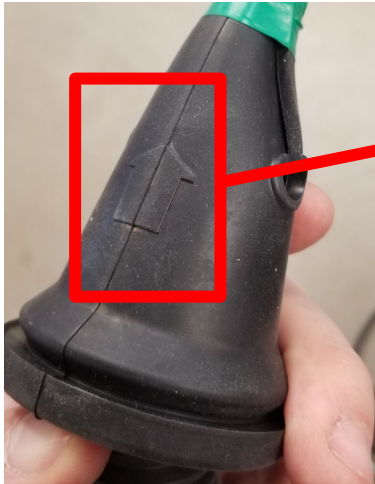
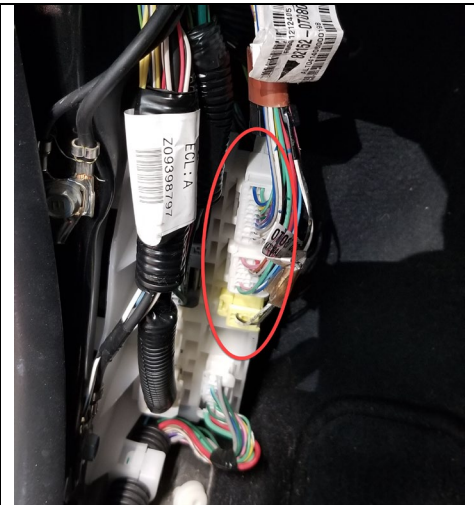
- a. Route the wire harness through the door and body.
- b. Secure the rubber grommets to the door and body with the arrow on the grommet facing up.

It is critical that the wire harness grommets be installed with the arrow pointing upward. Otherwise, the wire harness will be twisted and can be damaged.
