Volvo Cars Service Business

QB Instruction I10093

Title	Rear Seat display 4 seater	Page:	1 (3)
Action	Remote SW Update	Operation number:	97773-2

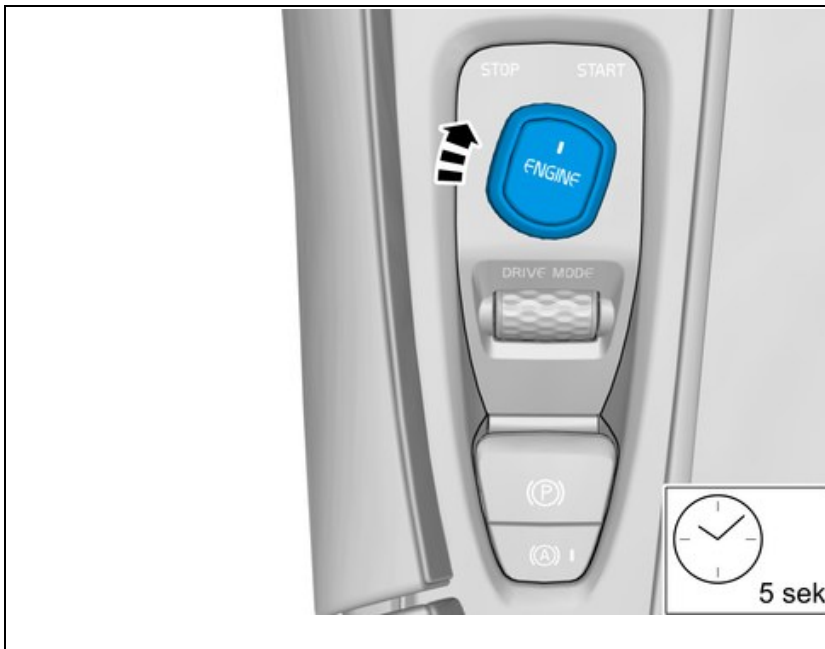
Preparation

- Connect Power Supply to the battery
- Set the car in Active mode, see Vida for more information

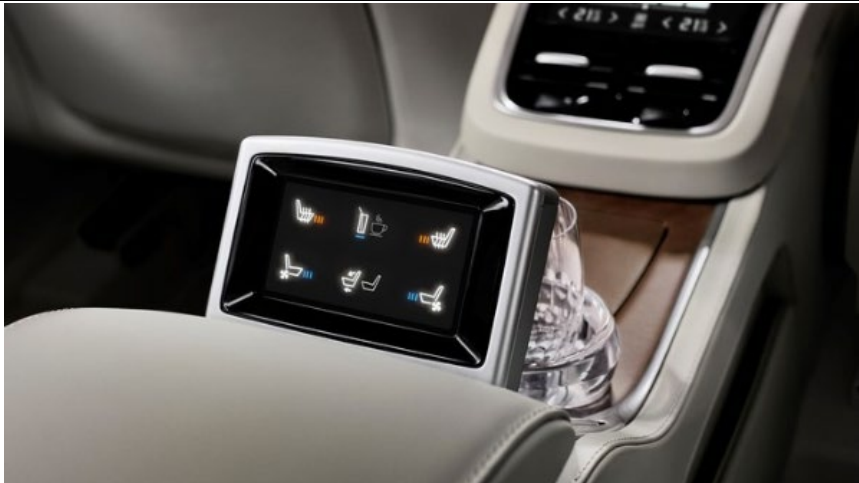
Function Control- To be performed after software update by helpdesk

- From the Touch Display Rear Module run front passenger seat to any end position, keep the seat adjustment button pushed for more than 4 seconds, check so the seat stops after 2 seconds. When releasing the button and pushing it again the seat will move again.

(Some functions on the display are "greyed out"/deactivated until car is in usage mode "Driving")
