GROUP  
Safety Recall Campaign

MODEL  
2022MY  
Carnival (KA4)

NUMBER  
SC211 (Rev 1, 04/28/2021)

**MPI FUEL RAIL LOT INSPECTION  
AND REPLACEMENT (SC211)**

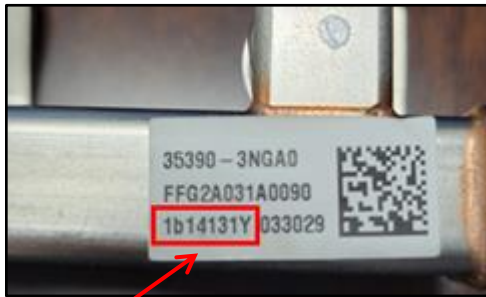
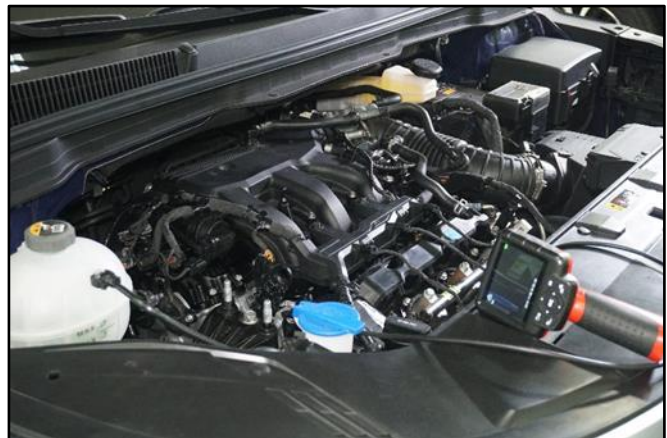
2. Using a video scope, check the Lot number of the MPI fuel rail (refer to the sample image/number below).

**1b14131Y = Produced 1/31 (January 31<sup>st</sup>.)**

- 3a. If the 5th through 7th digit value of Lot number **is between 120 and 215**, the MPI fuel rail will need to be replaced. Refer to page 3 for replacement.

- 3b. If the 5th through 7th digit value **is lower than 120 or over 215**, the vehicle does not require MPI fuel rail replacement. No further action is required.

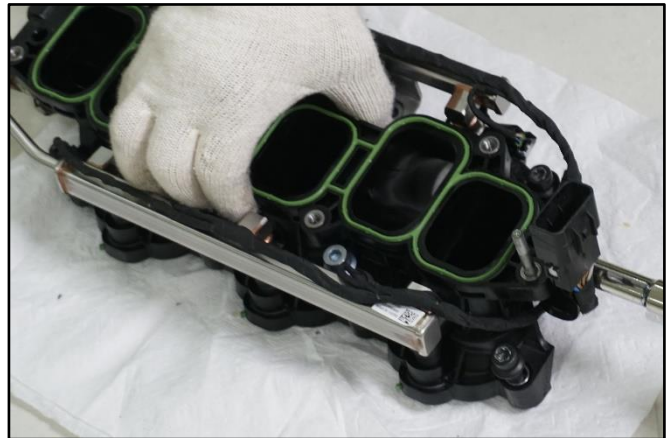
7. Remove the MPI fuel rail & injector assembly from the intake manifold after loosening the mounting bolt.

**Torque Specifications:**  
7.2 - 8.7 lb.ft (9.8 - 11.8 N.m,  
1.00 - 1.20 kgf.m)

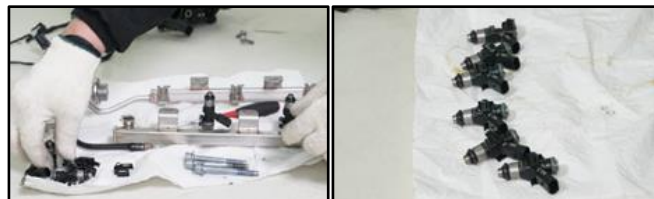
9. Remove the injectors from the delivery pipe after removing the fixing clip. Be sure to place injectors on a clean surface to prevent contamination.

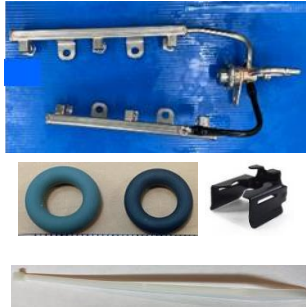
Part Name	Part Number	Figure	Qty.
Fuel Delivery Pipe Service Kit	35304 3NGCXQQK

<p>1</p> <p>Service Kit Includes 1 Fuel Delivery Pipe, 12 Injector O-Rings, 6 Injector Clips, and 6 Cable Ties</p>
