GROUP Safety Recall Campaign	MODEL 2022MY Carnival (KA4)
	NUMBER SC211	DATE April 2021
SAFETY RECALL CAMPAIGN		
SUBJECT: MPI FUEL RAIL LOT INSPECTION AND REPLACEMENT (SC211)

MPI FUEL RAIL LOT INSPECTION AND REPLACEMENT (SC211)

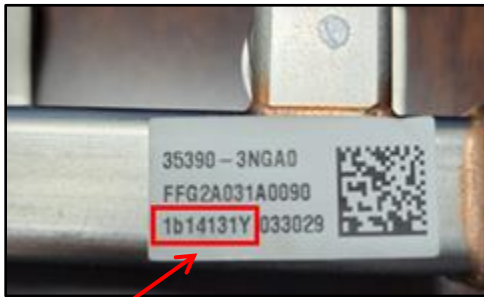
2. Using a video scope, check the LOT number of the MPI fuel rail (refer to the sample image/number below).

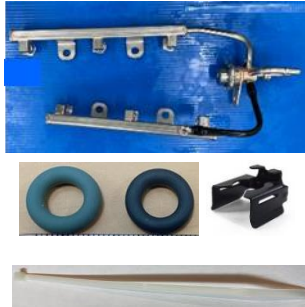
1 Service Kit Includes 1 Fuel Delivery Pipe, 12 Injector O-Rings, 6 Injector Clips, and 6 Cable Ties
