BR21-003
 NTB21-033
 April 22, 2021

# VOLUNTARY SAFETY RECALL CAMPAIGN 2021 ROGUE; REAR BRAKE CALIPER INSPECTION

CAMPAIGN ID #: PC804

**APPLIED VEHICLES:** 2021 Rogue (T33)

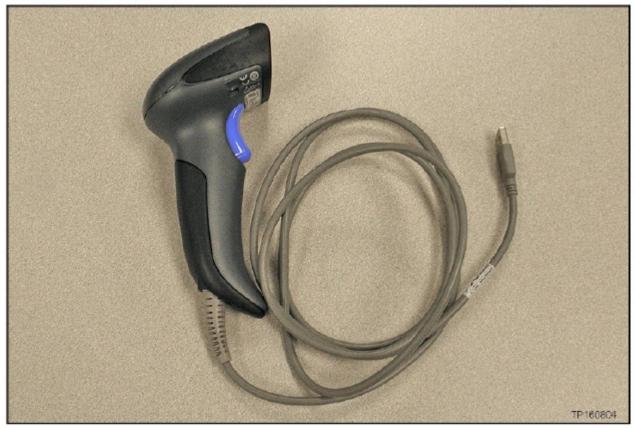
Figure 1

Each dealer has been shipped one Quick Scan Tool, special tool J-52352.

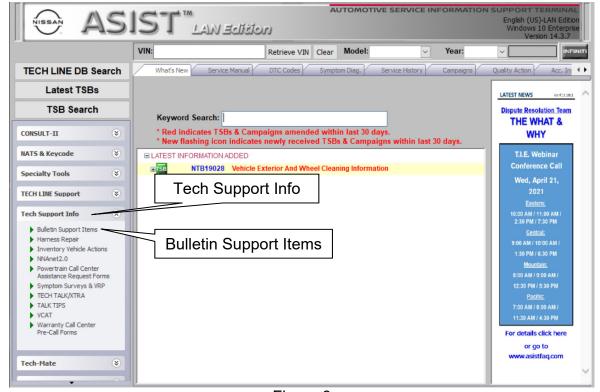
Figure 3

- 2. Open ASIST.
- 3. Select **Tech Support Info**, and then select **Bulletin Support Items**.

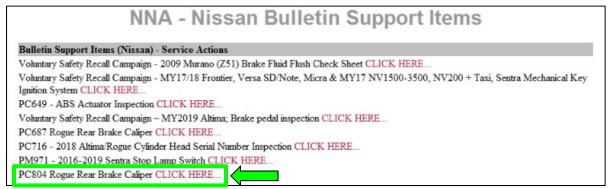
Figure 4

4. Select CLICK HERE... next to PC804 Rogue Rear Brake Caliper.

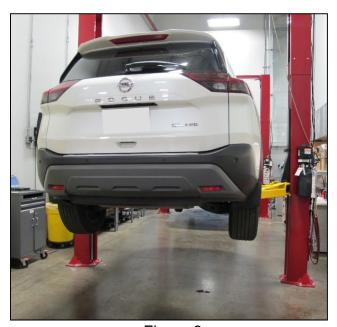
Figure 8

7. Place the vehicle on a lift and raise to a suitable height to remove both rear wheel and tire assemblies from the vehicle.

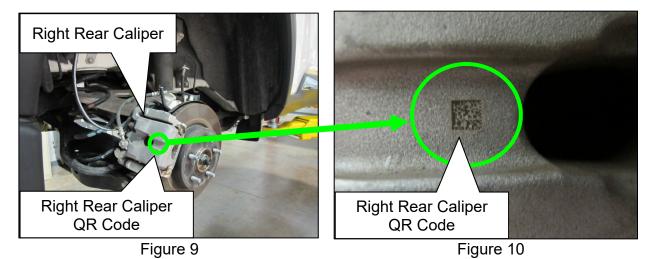
8. Locate the QR code on the right rear brake caliper (Figure 9 and Figure 10).

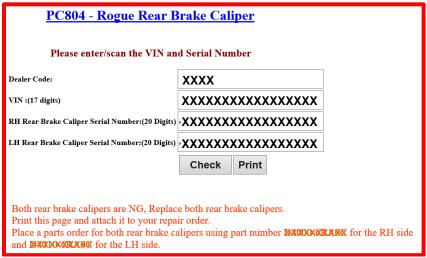
Figure 16

- If a **NG** result is displayed (Figure 16):
  - Print the inspection result and attach it to the repair order.
  - Replace the identified **NG** rear brake caliper(s) with the part number(s) displayed on the screen.
  - Proceed to step 14 on page 9 for rear brake caliper replacement.

- 14. Replace the rear brake caliper.
  - For rear brake caliper replacement, refer to the ESM section below.
    - BRAKES > BRAKE SYSTEM > REMOVAL AND INSTALLATION > REAR
       DISC BRAKE > BRAKE CALIPER ASSEMBLY > Removal and Installation
      - Follow all Cautions and Warnings in the ESM for rear brake caliper replacement.
- 15. Install both rear wheel and tire assemblies.
  - Wheel nut torque: 112 N·m (11 kg-m, 83 ft-lb)
- 16. Lower the vehicle and remove it from the lift.

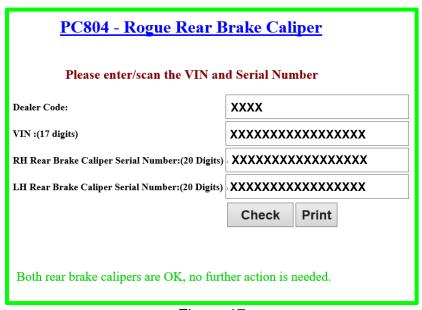
Figure 17

- If both rear brake calipers are OK condition (Figure 17):
  - o Print the inspection result and attach it to the repair order.
  - Skip to step 15 on page 9 to reinstall the rear wheel and tire assemblies.
