| HYUNDAI Technical Service Bulletin | GROUP RECALL | NUMBER 22-01-042H |
| SUBJECT: | NU 2.0L ATKINSON ENGINE INSPECTION AND REPLACEMENT (RECALL 203) | |

Description: On certain vehicles listed below, the engine may have been assembled using piston oil rings that were out of specification. This can cause abnormal scuffing of the engine cylinder bores due to chipped piston oil rings which can also result in accelerated engine oil consumption.

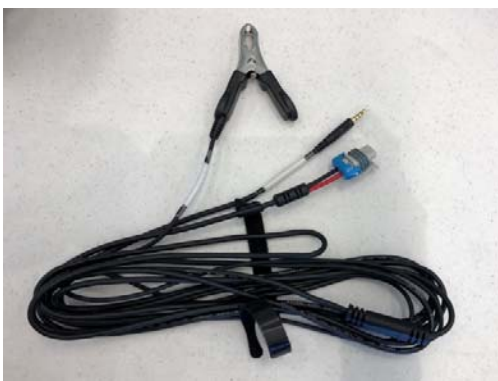
| TOOL NAME | FIGURE / TOOL NUMBER | NOTE |
|---|---|---|
| Knock Sensor Cable | <p>G1XTD-CP200-QQH</p> | <ul style="list-style-type: none"> • This tool has been initially supplied by HMA through MPA. Each dealer will receive one at the start of this recall. • A Galaxy tablet device equipped with a headphone / microphone port is required. Certain models without this port (such as the Samsung Galaxy Tab S6) are not compatible to use with this tool. Do not use a USB Type C-to-3.5mm Headphone Jack Adapter. |

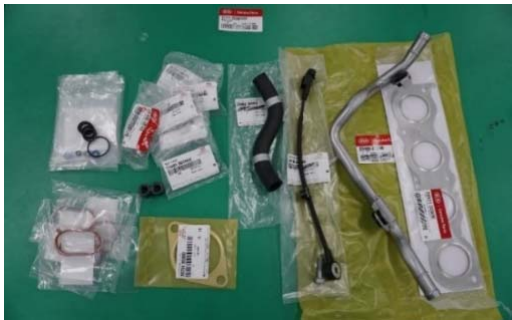
| PART NAME | FIGURE / PART NUMBER | NOTE |
|--|--|---|
| Engine Service Kit | <p>21102-N20AKQQH</p> | (For use with above engine long blocks) |

NOTES: Engine long block and service kit are for engine R&R if the inspection result is a "NO PASS".

- During engine R&R, install the applicable Engine Long Block and Service Kit part numbers.
- Reuse other parts not listed under the Service Kit parts list.
- After installing the engine in the vehicle, fill the engine oil level to the top of "F" position.
 - (Engine Oil Fill Capacity: 4.5 liters with 5W20 engine oil)

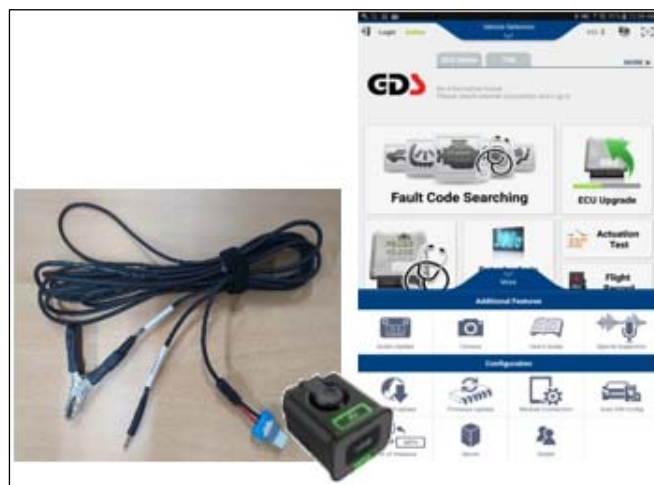
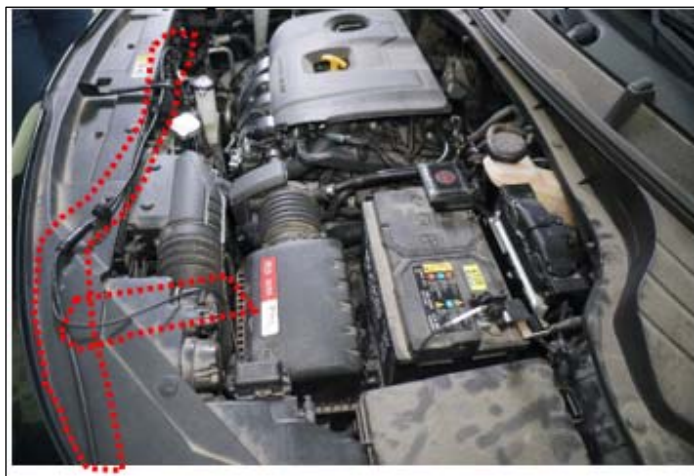
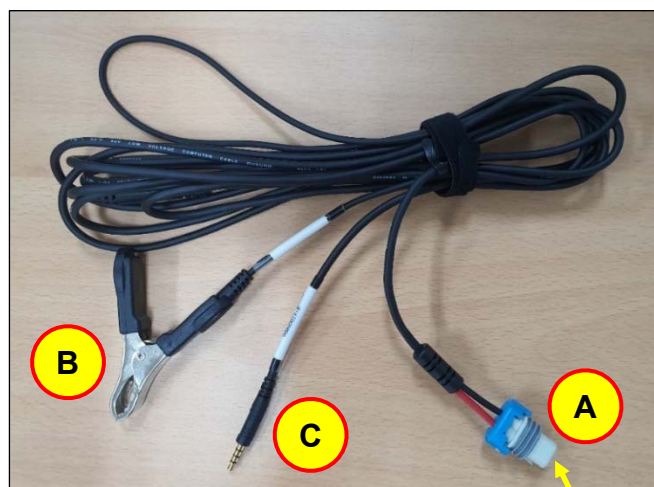
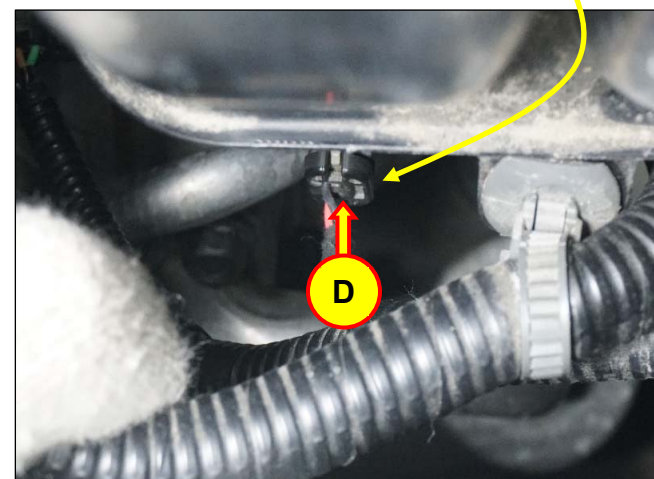
1. Prepare the engine vibration inspection tool and GDS-M.
 - Inspect the vehicle in an area where the ambient noise and vibration levels are minimal.
 - Using the latest GDS-M software update, the VCI must be updated with the latest firmware also.
2. Connect the knocking sensing connector (A) of the engine vibration inspection tool to the knock sensor connector (D).
3. Connect the ground clamp (B) to the battery '-' terminal.
 - Position the vibration inspection tool harness to avoid interference and vibration from the engine components which may affect the inspection result.
 - Route the wiring harness around the engine compartment as shown below.

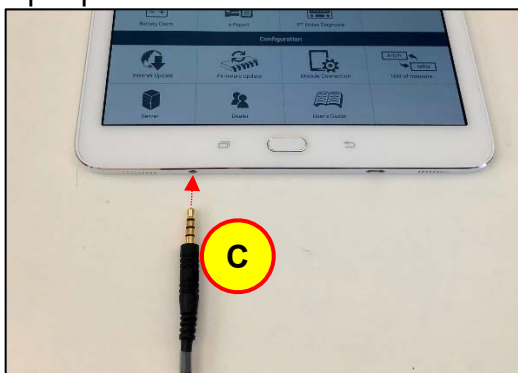
4. Connect the signal jack (C) to the GDS-M stereo input port.

A Galaxy tablet device equipped with a headphone / microphone port is required. Certain models without this port (such as the S6 tablet) are not compatible for this inspection. Do not use a USB-C jack adapter.

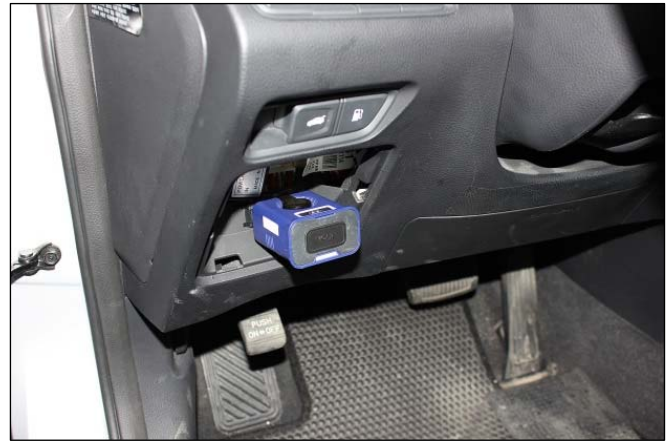
5. Connect the VCI to the vehicle's DLC port and check the Bluetooth pairing condition between the VCI and GDS-M.

- Before pairing: White lamp light
- After pairing: Green lamp light

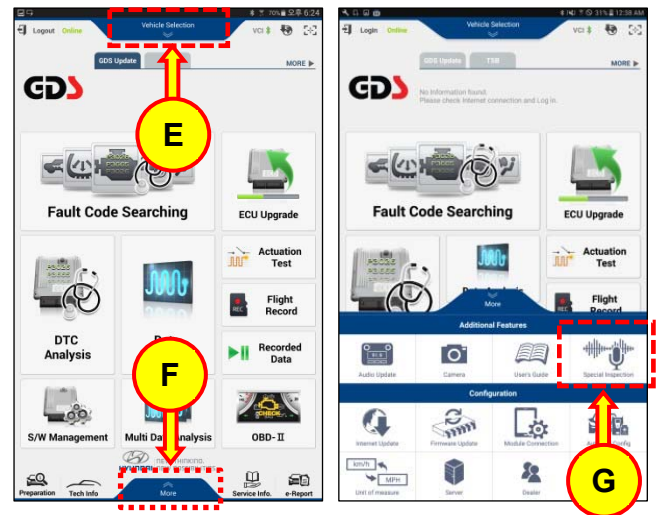
6. Turn the vehicle ignition 'ON' and prepare the GDS for the inspection procedure.

- Enter the vehicle info into the GDS (E).
- Swipe up on the "More" tab at the bottom of the GDS home screen (F).
- Select the "**Special Inspection**" function (G).

NOTE: If the vehicle is not supported by the inspection program (either wrong model, model year, or engine), then this inspection will not be made possible.

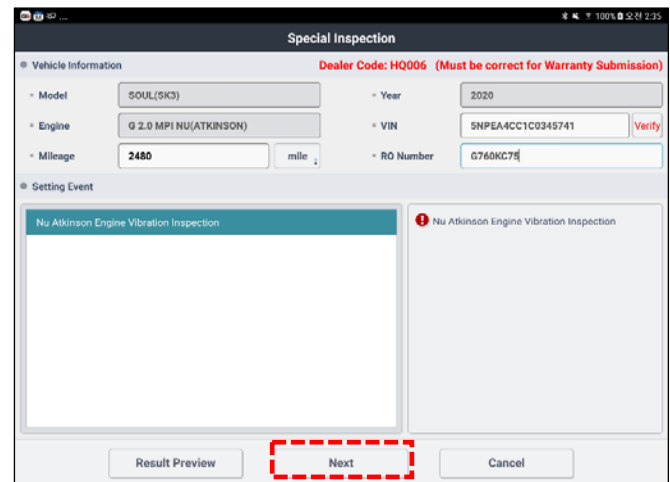
7. Enter the mileage and RO number of the vehicle accurately.

8. Select the "**Nu Atkinson Engine Vibration Inspection**" and press the 'Next' button to proceed.

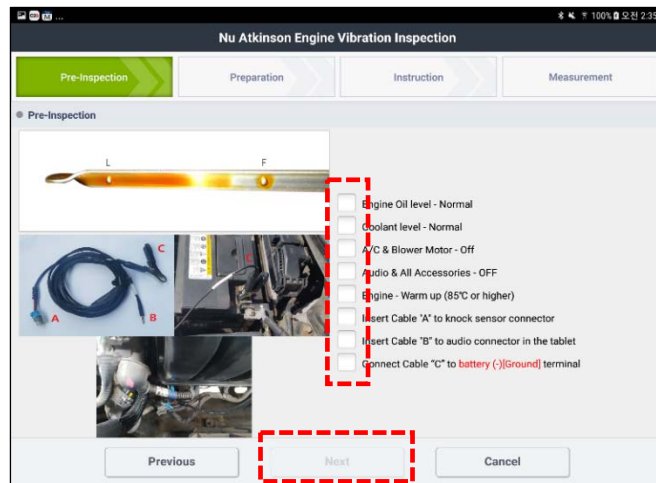
9. To obtain accurate inspection results, verify and acknowledge the check items that must be carried out before the inspection test.
 - Check all the precondition items on the list. (The actual monitoring of the Engine Coolant Temperature will be performed at the following screen.)
 - After all the precondition items have been acknowledged with checkboxes, press the 'Next' button to proceed.

- During the initial vehicle inspection, engine oil level that is abnormally low (**near or below “L” for relatively low miles since last oil change or top off**) due to a possible accelerated engine oil consumption condition will need further diagnosis.
 - Refer to HTSS “Fix it Right” under symptom “Campaign”
- If possible, the engine coolant temperature should be closer to normal operating temperature of 85°C / 185°F (or higher) to help expedite the actual engine inspection procedure.

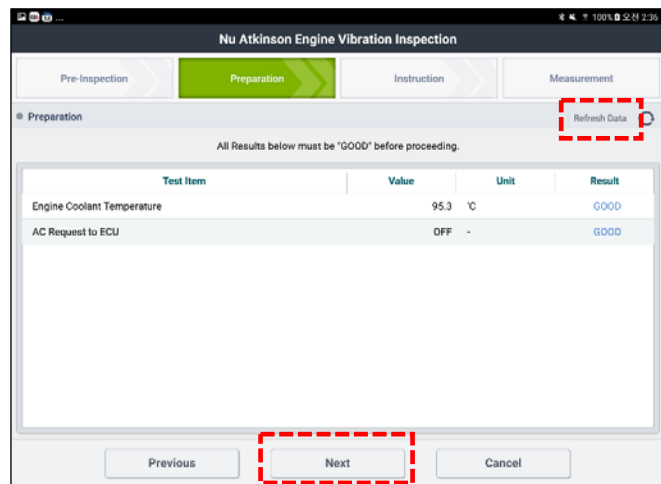
10. The inspection program automatically checks engine sensor data and enables the “Next” button when all conditions are satisfied.

NOTE: A “NOT GOOD” status is displayed if the conditions are not satisfied. Press the “Refresh Data” button to obtain new sensor data after warming the engine and turning off the A/C.

- If all conditions are satisfied, press the “Next” button to proceed.

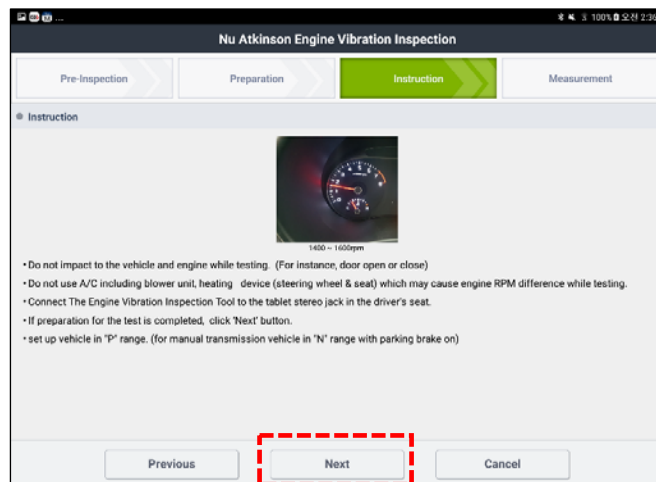
11. After reviewing the vibration inspection process explanation and precautions, press the “Next” button to proceed.

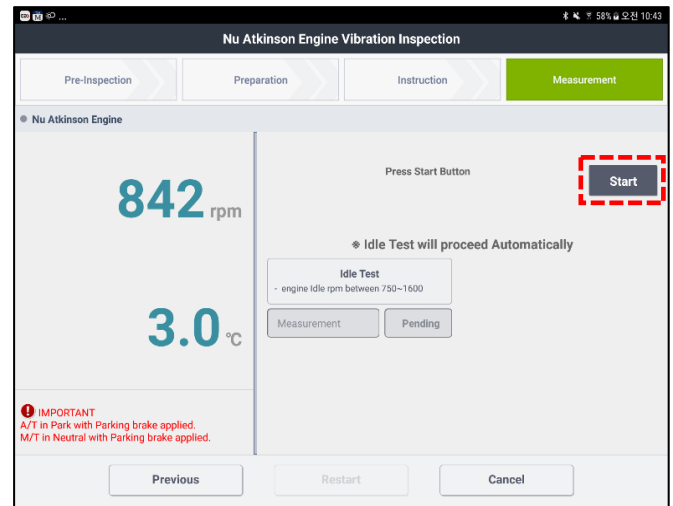
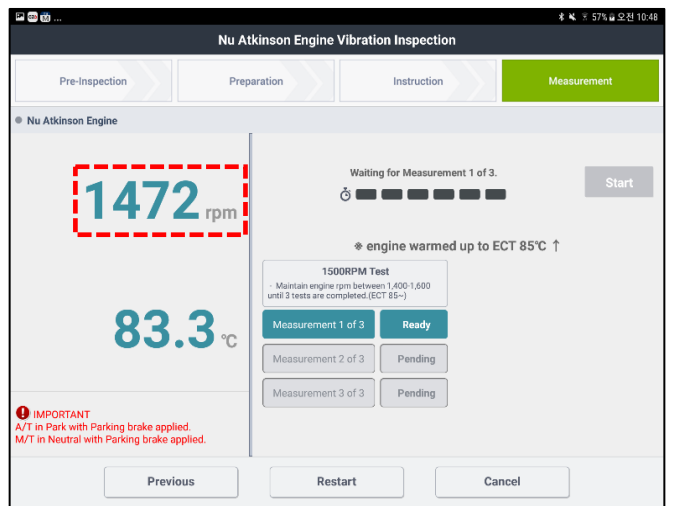
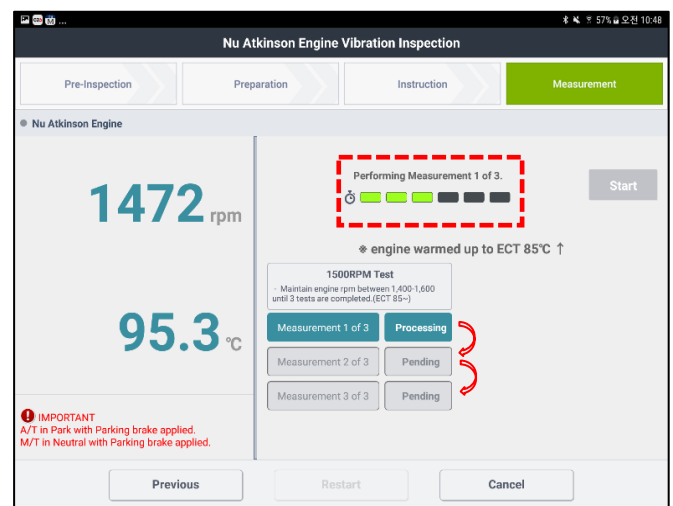
12. In this screen, the program will perform an internal diagnosis after the “Start” button is pressed while the engine is at **idle speed** and the KS signal is acquired for five seconds.

13. Press the accelerator pedal to maintain an engine rpm target of 1500 ± 100 rpm.

- Maintain a steady engine speed between 1400-1600 rpm for five seconds.

NOTE: If the engine rpm deviates from the specified target range, the engine speed value will be indicated in red color and the time count will be halted.

- When the engine speed is within the target rpm range, the green status bars will continue to illuminate for each measurement cycle.
- Repeat the 1500 ± 100 rpm engine speed test to complete the 3 measurement cycles.

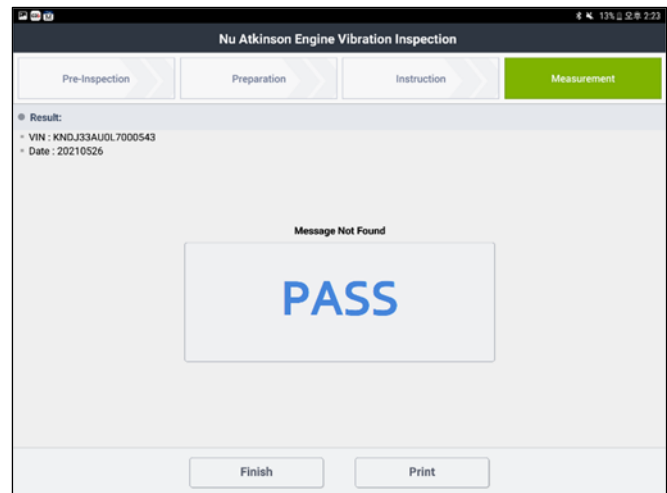
14. When the inspection test is completed, the result will be displayed. Save a screenshot of the results screen for records.

- If the test result is **PASS**, the measured engine vibration level is determined to be normal. The engine inspection is complete.

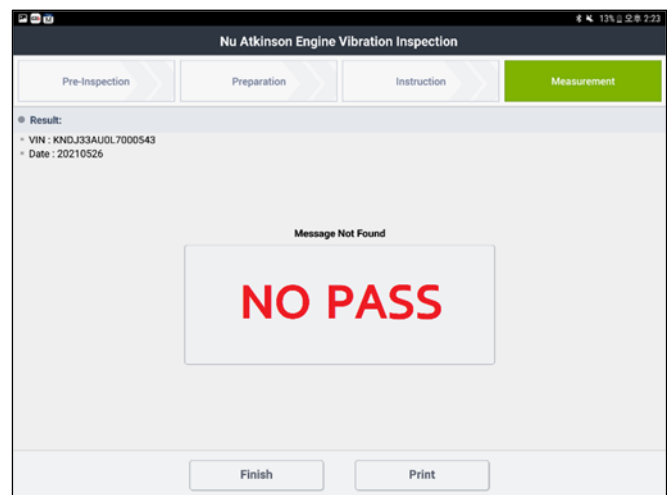
- If the test result is **NO PASS**, the measured engine vibration level is determined to be abnormal.
 - 1) The PA and Engine Diagnosis Worksheet will be automatically created and saved in DRAFT.
 - 2) Complete the information in the Engine Diagnosis Worksheet and apply the Service Manager's signature before submitting the PA.
 - 3) Refer to the service procedures in the appropriate Shop Manual to replace the engine long block with the service kit.

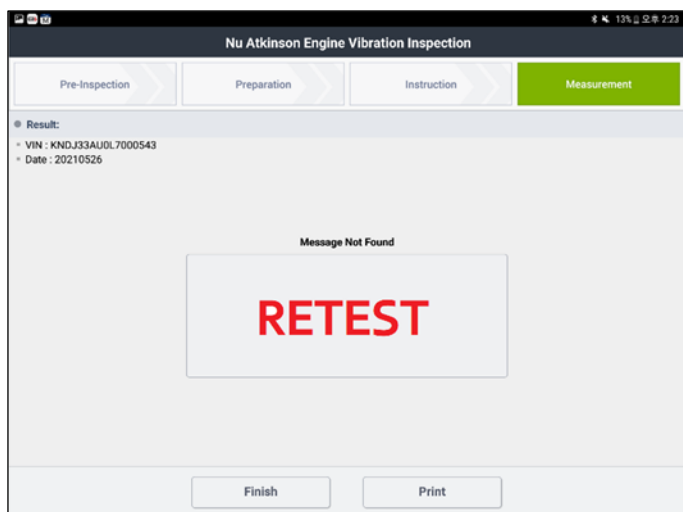
- If the test result is **RETEST**, there is an error detected in measuring the vibration value. Check the inspection tool connections and perform the inspection test again.

NOTE: It may require routing the inspection tool harness away from any interference, checking all connections, and/or restarting the tablet.
