<b>HYUNDAI</b> <b>Technical Service Bulletin</b>	<b>GROUP</b> <b>Recall</b>	<b>NUMBER</b> <b>21-01-050H</b>
	<b>DATE</b> <b>June, 2021</b>	<b>MODEL(S)</b> <b>Elantra (CN7a)</b>

**SUBJECT:** SEAT BACK INSPECTION & REPLACEMENT (RECALL 204)

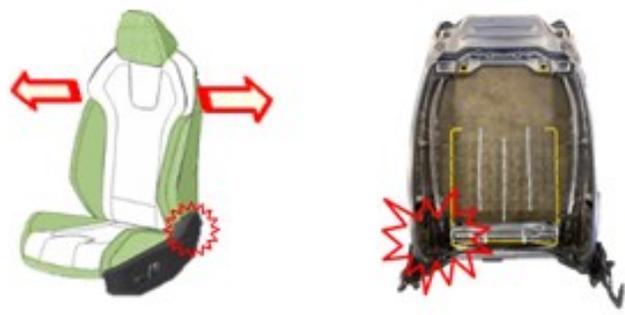
**Description:** On certain 2021MY Elantra (CN7a) vehicles, the driver/passenger seat back frame assemblies may have been assembled with seat back recliners that were improperly welded during manufacturing. An improperly welded seat back recliner could lead to separation of the seat back from the frame in the event of a crash, increasing the risk of injury to occupants. This bulletin describes the service procedure to inspect, and if necessary, replace the front seat back frame assembly.

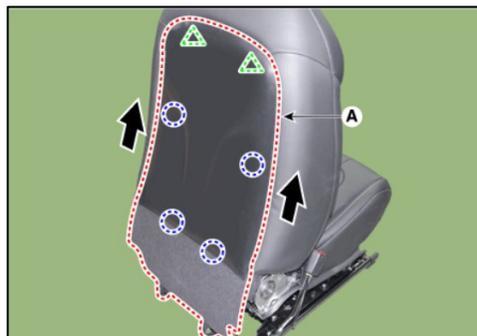
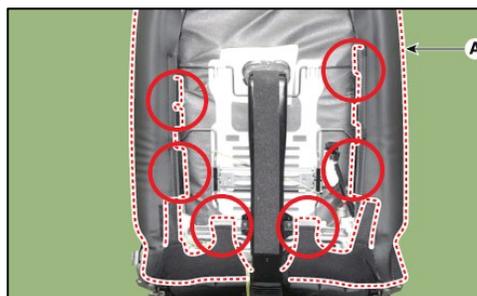
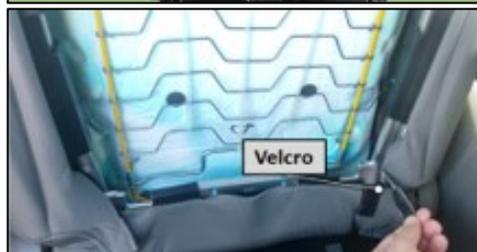
1. Remove the front seat back panels (A) on both LH and RH front seats by lifting in an upward motion while holding the top and bottom.
2. Loosen the seat covers on both LH and RH front seats by removing the J-clips and detaching the Velcro as shown in the photos.

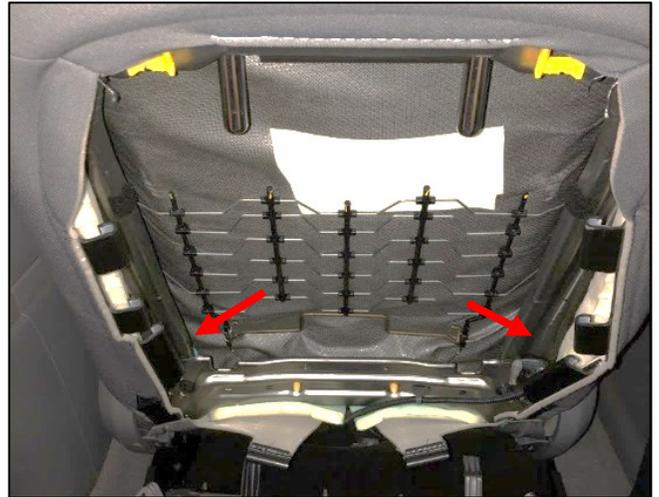
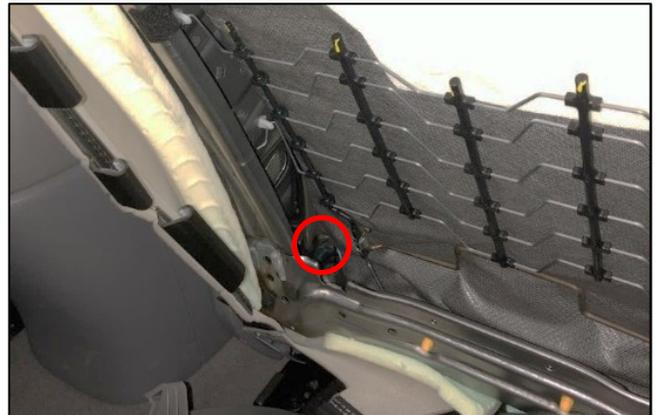
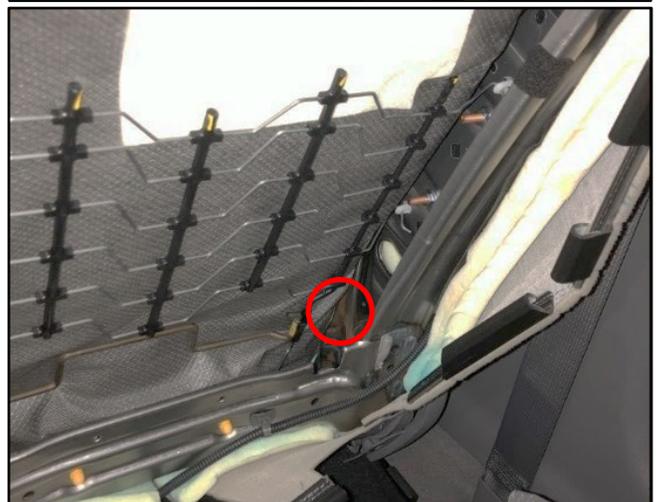
3. Inspect the heat markings on the side rails of both LH and RH front seats.

If necessary, recline the seats past the center console.

Refer to the inspection criteria in the next step to determine if replacement is necessary.

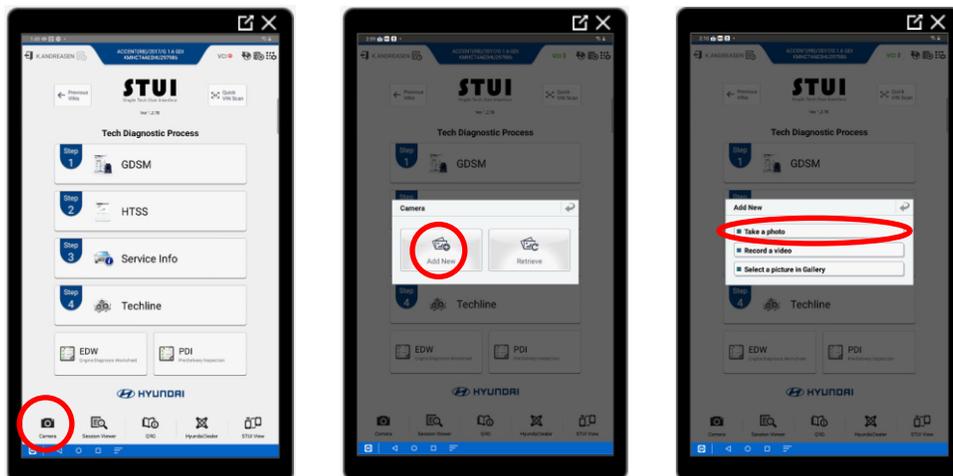
4. Review the inspection criteria below for No Good (NG) and Good (OK) seat back assemblies.

Using STUI, take clear picture(s) of the heat markings on both sides of the LH and RH front seats.

5. If a front seat back does not meet the inspection criteria, replace the front seat back frame assembly.
