<b>Tesla, Inc.</b> <b>Service Bulletin</b>		<h1>Inspect 1<sup>st</sup> Row Seatbelt Bolts</h1>	
<b>SB-21-20-001</b> May 13, 2023		<b>R1</b>	
<b>Classification</b> Recall Bulletin		<b>Section/Group</b> 20 - Safety and Restraint	<b>Mobile Service</b> Can Perform (where permitted)
<b>Model Year</b> 2018 - 2021	<b>Model</b> Model 3, Model Y	<b>Country/Region</b> All	<b>Version</b> All
<small>The model(s) and model year(s) listed are a general approximation of the affected VIN list. Refer to the VIN/Bulletin Tracker or Customer/Vehicle profile to determine applicability of this bulletin for a particular vehicle.</small>

On some Model 3 and Model Y vehicles, the 1st row LH and RH seatbelt D-ring to adjustable top loop bolt and/or adjustable top loop to B-pillar bolt may not have been secured to the correct specifications.

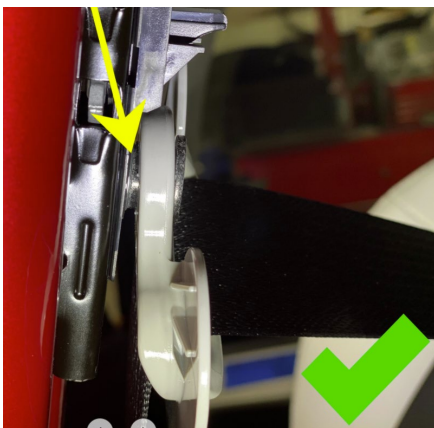
Figure 1 – LH shown; RH similar

2. Inspect the bolt that attaches the LH 1<sup>st</sup> row seatbelt retractor D-ring to the adjustable top loop.
  - If bolt threads are not visible between the retractor D-ring and adjustable top loop (Figure 1), the adjustable top loop does not require inspection; take note and skip to step 3

**NOTE:** Visible bolt collar (Figure 1, yellow arrow) is expected.

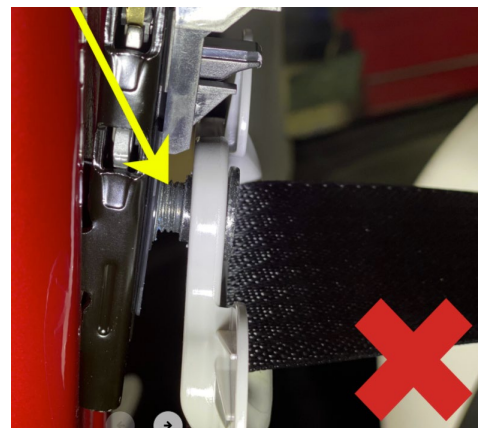
Figure 2 – LH shown; RH similar

- If bolt threads are visible between the retractor D-ring and adjustable top loop (Figure 2, yellow arrow), the bolt and adjustable top loop bolt hole threads require inspection; take note and continue to step 3.

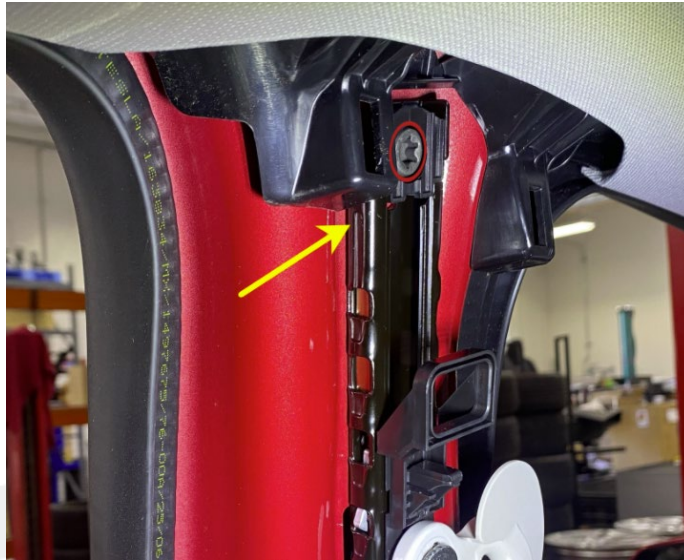
**Figure 3 – LH shown; RH similar**

3. Wiggle the LH adjustable top loop and inspect for a gap between the adjustable top loop and the B-pillar (Figure 3).

- If the adjustable top loop does not wiggle and is tight against the B-Pillar, the B-pillar bolt hole threads do not require inspection; take note and skip to step 4.
  - If the adjustable top loop wiggles or is not flush against the B-pillar, the adjustable top loop bolt and B-pillar bolt hole threads require inspection; take note and skip to step 5.
4. If steps 2 **and** 3 determine that no further inspection is required, torque both previously mentioned bolts (torque 20 Nm), take note, and skip to step 10. If further inspection is required, continue to step 5.
  5. If inspection is required, remove the bolt that attaches the LH 1<sup>st</sup> row seatbelt retractor D-ring to the adjustable top loop, and then set the retractor D-ring aside (Figure 4). If inspection is not required, skip to step 8.

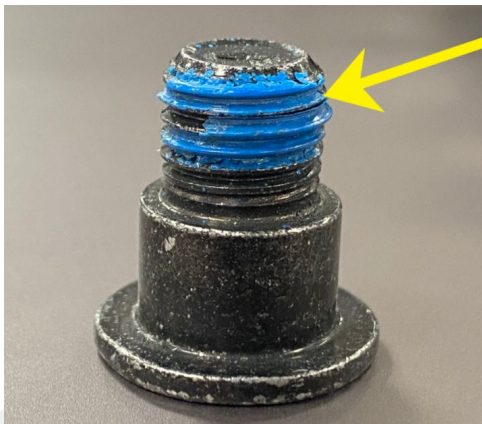
**Figure 5**

6. Inspect the bolt that attaches the LH 1<sup>st</sup> row seatbelt retractor D-ring to the adjustable top loop (Figure 5).

- If any of the bolt threads are damaged, discard the bolt and procure a new bolt.
- If none of the bolt threads are damaged, set the bolt aside for reuse.

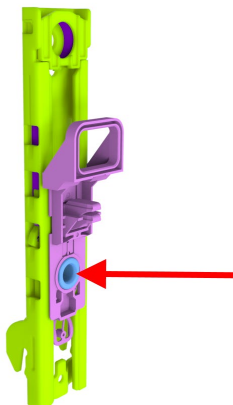
**Figure 6 – LH shown; RH similar**

7. Inspect the LH 1<sup>st</sup> row seatbelt retractor D-ring to adjustable top loop bolt hole (Figure 6).

- If the bolt hole threads are damaged, the adjustable top loop requires replacement; take note and skip to step 8.
- If the bolt hole threads are undamaged, the adjustable top loop does not require replacement; take note and continue to step 8.

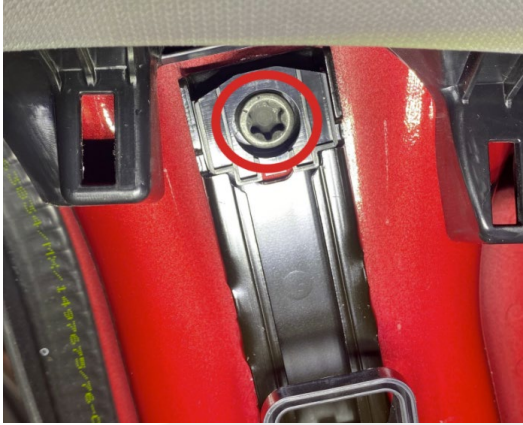
**Figure 7 – LH shown; RH similar**

8. If inspection is required, remove the bolt that attaches the LH adjustable top loop to the B-pillar (Figure 7) and inspect the B-Pillar bolt hole (Figure 8). If inspection is not required, skip to step 10.

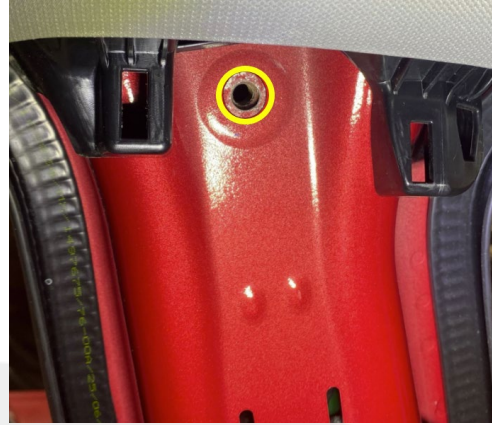
**Figure 8 – LH shown; RH similar**

- If the B-pillar bolt hole threads are damaged, repair is required; take note and skip to step 9.
  - If the B-pillar bolt hole threads are not damaged, repair is not required; take note and continue to step 9.
9. If the adjustable top loop is being reused, inspect the bolt that attaches the LH adjustable top loop to the B-pillar (Figure 9).

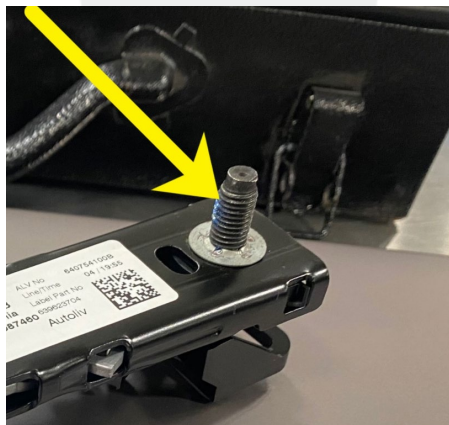
**Figure 9**

- If any of bolt threads are damaged, remove and discard the clip that attaches the bolt to the adjustable top loop, discard the bolt, and install a new bolt.
-

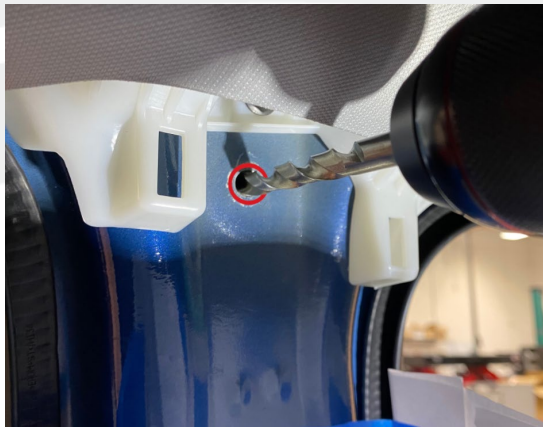
**Figure 10 – LH shown; RH similar**

1. Use the 8.3 mm drill bit from the thread repair kit, with cutting oil, to drill out the damaged threads (Figure 10).

**CAUTION:** Do not drill through the vehicle body. Only drill out the damaged threads.

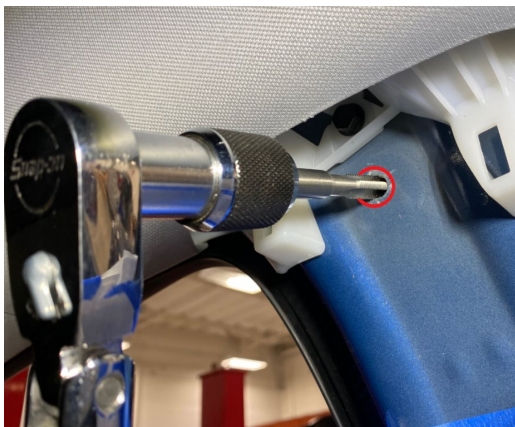
**Figure 11 – LH shown; RH similar**

2. Use the Heli-Coil tap, with cutting oil, to tap new threads on the B-pillar (Figure 11). Reapply cutting oil as needed.

**CAUTION:** Make sure the tap remains perpendicular with the bolt hole.

**CAUTION:** Do not tap past the weld collar nut. Refer to Figure 12 to visualize the depth of the weld collar nut.

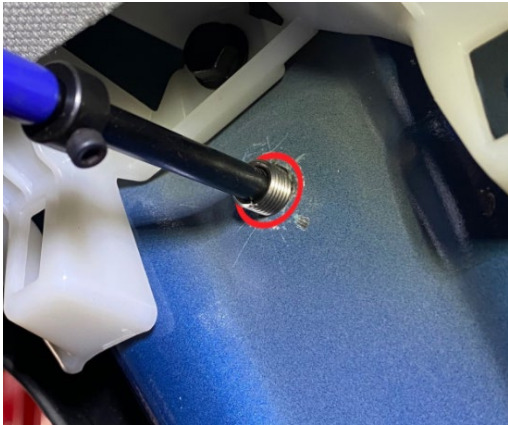
**Figure 13 – LH shown; RH similar**

4. Position a Heli-Coil insert on a threaded handle, and then install the insert in the B-pillar (Figure 13).

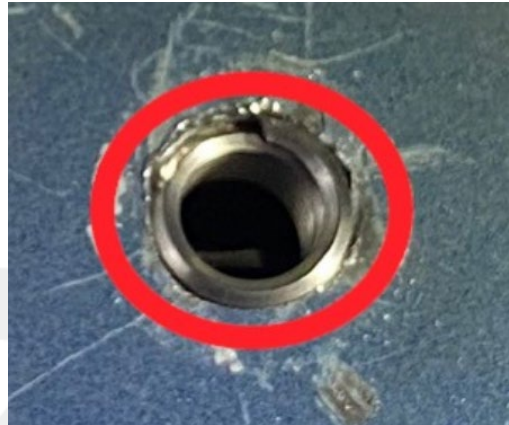
**Figure 14**

**⚠ CAUTION:** Make sure the insert is flush with the surface of the B-pillar and that tapped threads are not visible past the insert (Figure 14).

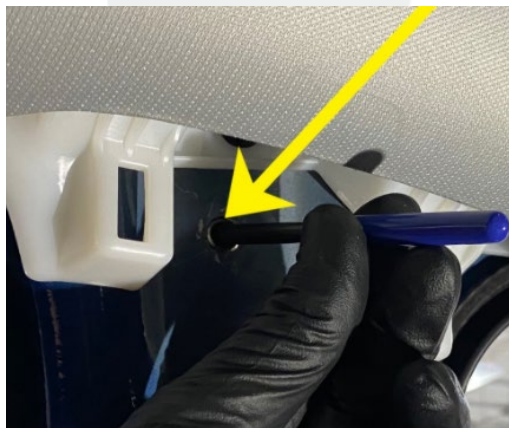
**Figure 15 – LH shown; RH similar**

5. Use the tang break-off tool and a deadblow hammer to break the Heli-Coil tang (Figure 15).
