Revision 4 June 2022

Dealer Service Instructions for:

Safety Recall Y36 / NHTSA 21V-398 Wheel Studs

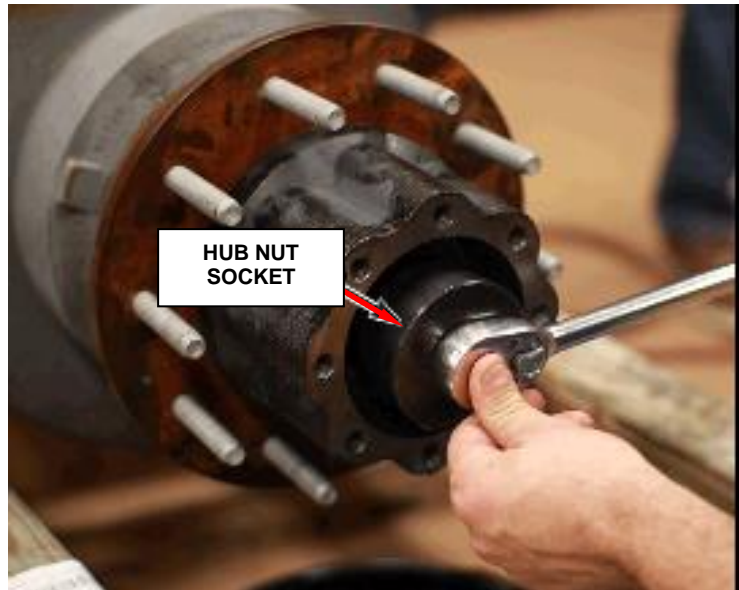
Figure 12 – Hub Nut

8. Using **Socket, Hub Nut 6 Pin 8954A**, or **Socket, Hub Nut 9 Pin 2029500030**, or **Socket, Hub Nut 12 Pin 2066600030** remove the hub nut (Figure 12).
