### SIB 65 09 21

RECALL 21V-401: DRIVER'S FRONT AIR BAG (NADI) INFLATOR

E-Series	Model Description	Production Date
E46	3 Series Sedan	June 5, 1998 – June 27, 2000

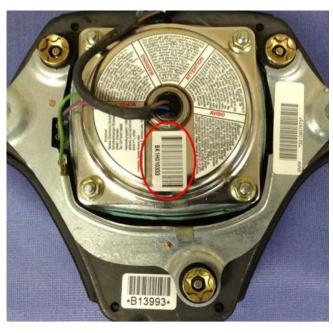
**Basic Driver's air bag,** showing the location of the parts label.

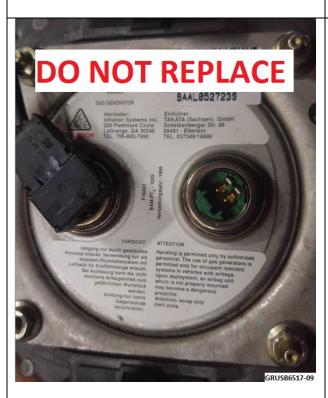
**Situation 1:** If the serial number is not legible and cannot be identified, or the driver air bag gas-generator is NOT a type BK; submit a Reply Requested TSARA case for support.

- Title the TSARA case NADI TAKATA RECALL 21V-401
- The case should include pictures of the gas generator and its serial number

You will be instructed by TSARA on how to proceed.

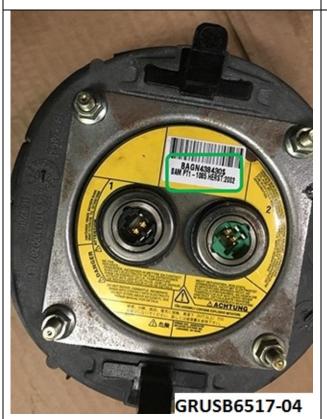
**Situation 2**: Some vehicles may have air bag control unit MRS III which was introduced in some models starting September 1999 and supports a dual stage gas generator.

**Standard steering wheel** gas generator pictured.

Takata air bags with different chemical compositions (DUAL STAGE IGNITOR with white label) are not affected by this recall and DO NOT need to be replaced.

Reinstall the driver's air bag.

Submit an INFO ONLY TSARA case with a picture of the gas generator serial number to document this repair.

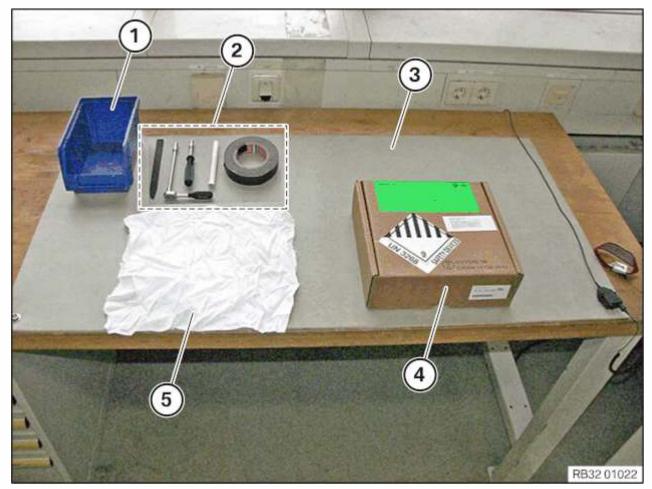
Workplace for replacement of the gas generator (E46)

- 1 Collection container for disposal of the nuts
- 2 Tools required for the exchange
- 3 Antistatic mat
- 4 New, packaged gas generator
- 5 Scratch-resistant cotton underlay

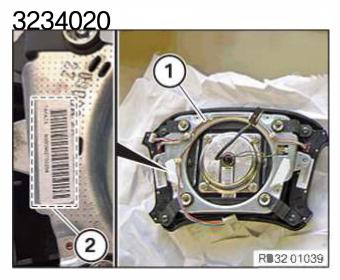
- Place the airbag unit (1) turned around as shown.
- Note the serial number (2) of the airbag unit (1) on the work order.

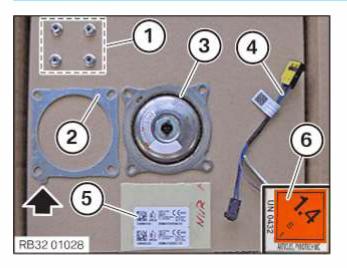
- Unpack the new nuts (1), reinforcement plate (2), new gas generator (3), cable (4) and sticker (5) and place it as shown.
- Make sure that the groove (arrow) of the reinforcement plate (2) is positioned correctly.
- USA only:

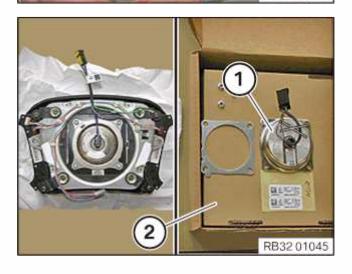
Insert the previous gas generator (1) in the packaging (2).

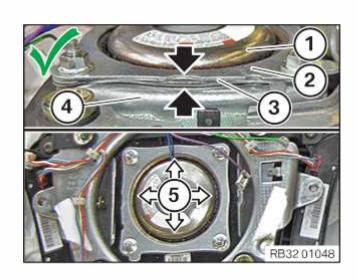
Visually inspect the gap (3) between the new gas generator (1), reinforcement plate (2) and airbag unit (4) on all four sides (5).

• If the gap (3) is not OK:

Release the screw connection and tighten again as described in the previous step. If the gap is still not OK, then cancel the repair. Install the new airbag unit in this case.

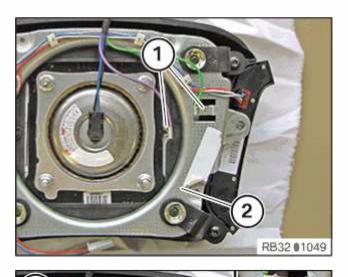
• Connect both the connectors (1) with the airbag unit (2).

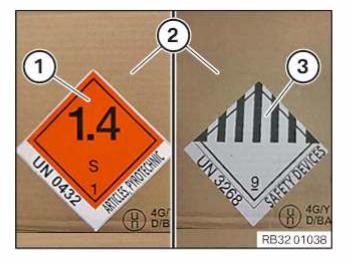
- Glue on the first sticker on the airbag unit (1) with the new number on the position (2).
- Glue on the second sticker on the work order.
