Mercedes-Benz

Campaign No. 2021060011, July 2021

SUBJECT: **Model GLB-Class vehicles (247 platform)**  
**Model year 2020**

**Replace Passenger Airbag Module**

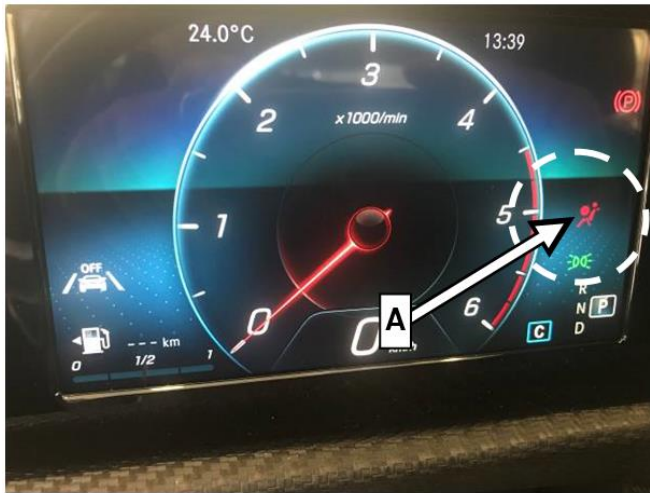
Figure 1

1. Disconnect ground line from on-board electrical system battery.
2. Replace front passenger airbag (AR91.60-P-0664MFB).
3. Connect ground line to on-board electrical system battery.
4. Switch ignition to position 1. To do so, press start button once without touching the brake pedal. Check whether airbag indicator lamp (A, figure 1) permanently goes off (B, figure 2) after a few seconds.
  - i** The SRS check after airbag replacement is thus completely ensured!
