## Metal Junction Box Grounding Instructions

<b>Bulletin Type:</b>	RCL	<b>Publication Date:</b>	July 2021
<b>Bulletin #(s):</b>	21V-449	<b>Make(s):</b>	Jayco
<b>Job Code(s):</b>	9901568	<b>Model(s):</b>	White Hawk
<b>Flat Rate(s):</b>	.50 / Hour	<b>Model Year(s):</b>	2021

<b>Incident:</b>	Metal junction box was not grounded
<b>Affected Units:</b>	2021 Jayco (4K) White Hawk M14K0262-M14K0304
<b>Parts List:</b>	<b>Parts List: (Purchase locally)</b> - MN cable (Copper Wire)
	<b>Parts Kit Contents: None</b>
<b>Misc. Tools &amp; Supplies:</b>	- Flathead Screwdriver - Wire Pliers/strippers

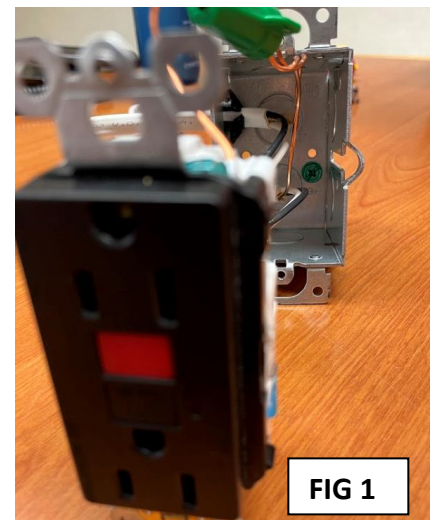
1. Disconnect unit from the 120V power source
2. Locate metal junction box with a GFCI receptacle at the kitchen.
3. Remove faceplate and receptacle (Fig. 1) to expose wires.
