# Safety Recall

## Code: 69CJ

**Subject** Driver Front Airbag Inflator

Exposure to moisture over time could cause the driver front airbag to not inflate properly in a crash, increasing the risk of injury.

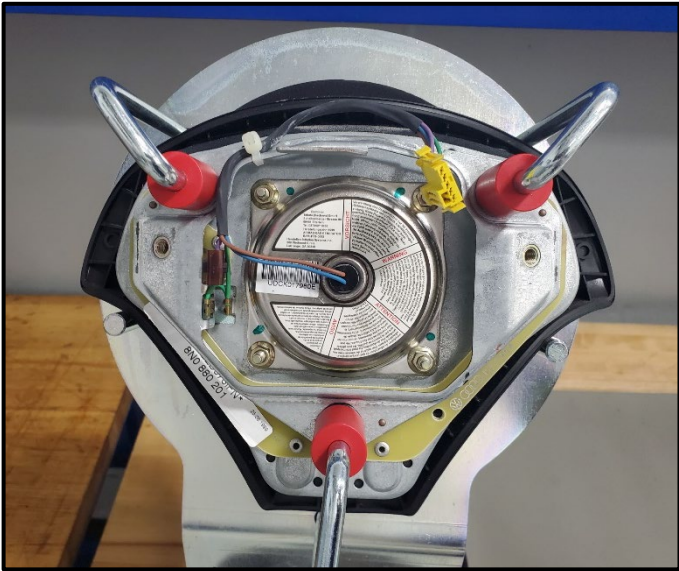
- Inspect driver airbag inflator and replace if necessary.

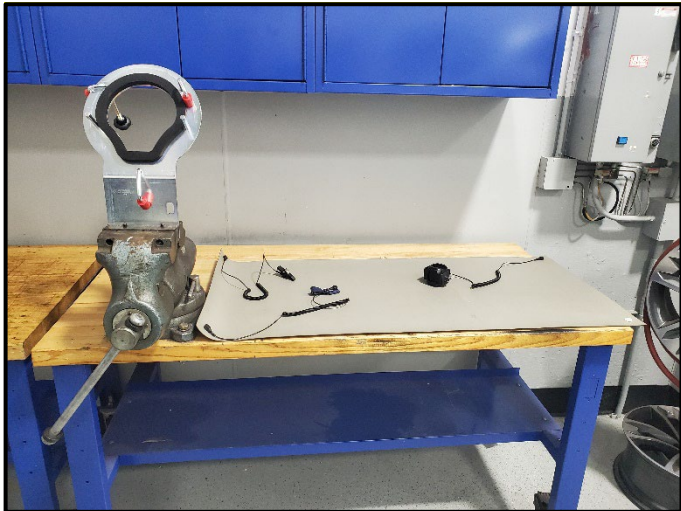
It is critical that a clean, uncongested work environment is utilized during the inflator replacement procedure. Extra tools, debris, etc... in the blast area of an airbag impose a danger in the event an airbag were to deploy. Ensure there are no loose components in the blast area of the airbag.

- Workbench that will support a vice.
- Work surface free of unnecessary tools, equipment and debris.

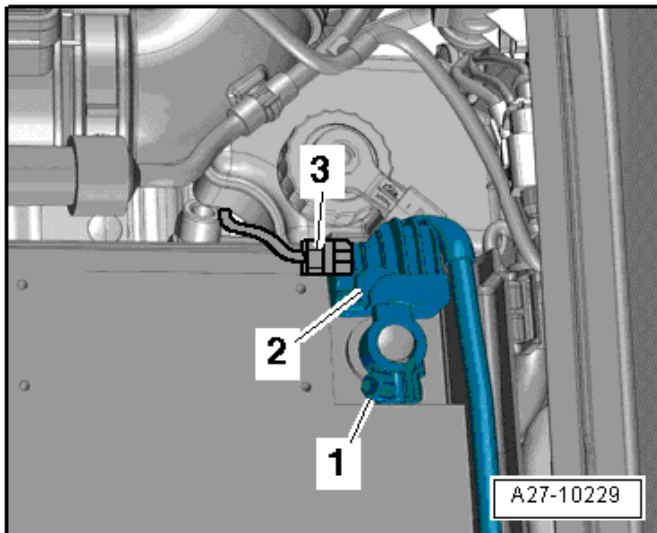
- Make sure the ignition is turned **ON**.
- Loosen the nut <1>.
- Remove and isolate the battery ground cable terminal <2> from the battery terminal.

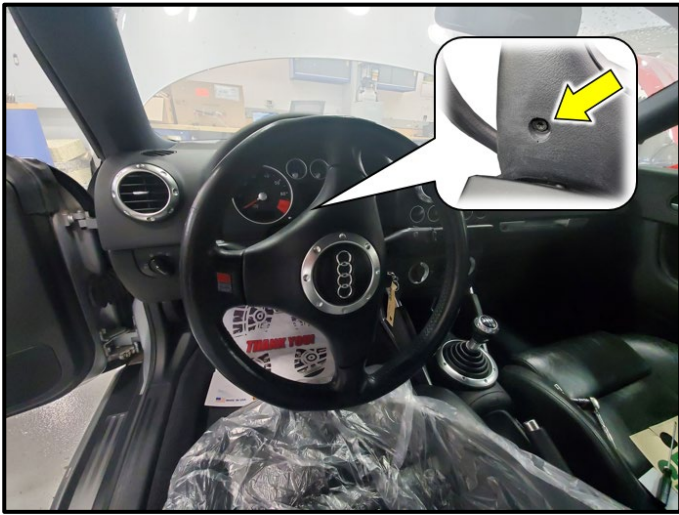
- With the front wheels straight, turn the steering wheel 90°, as shown.
- Loosen bolt <arrow>.
- Turn the steering wheel 180° in the opposite direction and loosen the bolt <arrow>.

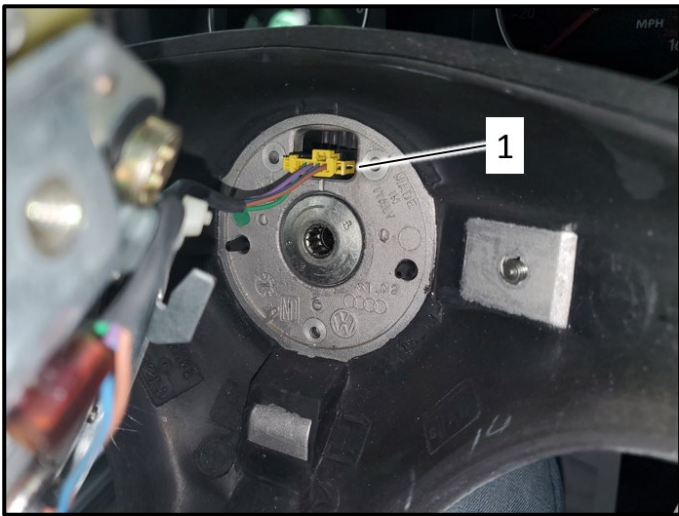
- Pull the airbag away slightly from the steering wheel.
- Disconnect wiring harness <1> using a pocket screwdriver or pick tool.

- Use extreme care when removing the connector <1> so that no damage to the spiral spring occurs.
- Due to the age of the vehicles, replacement parts may not be available!

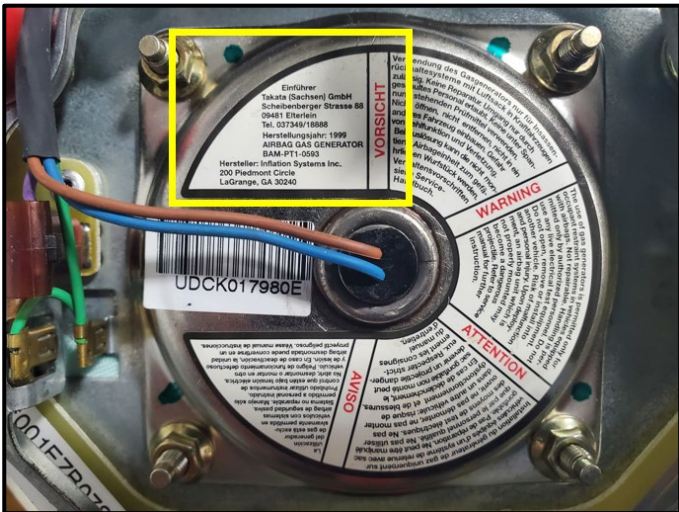
**Inspect the manufacturer of the airbag inflator:**

- If the inflator was manufactured by TAKATA:
  - The inflator must be replaced.
  - **Proceed to Section C.**
- If the inflator was not manufactured by TAKATA:
  - Reassemble airbag in the reverse order of removal.
  - Torque airbag securing bolts to 7 Nm.
  - Reconnect battery and torque the nut as follows:

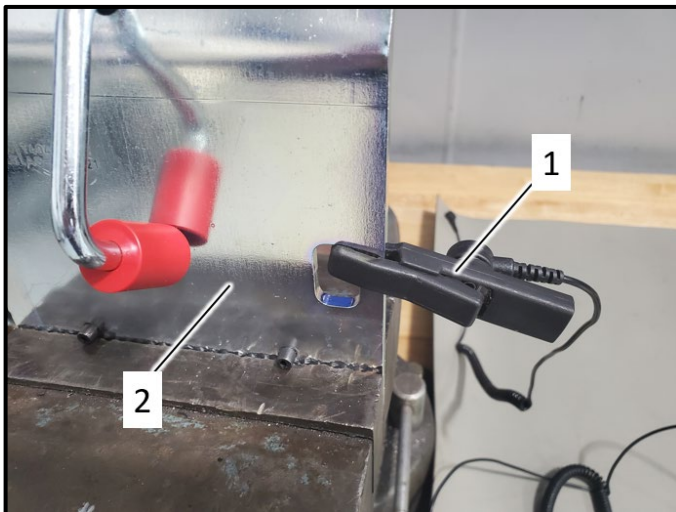
- Assemble ESD workplace -VAS6613-.
- Plug ESD workplace into a wall socket using plug <1>.

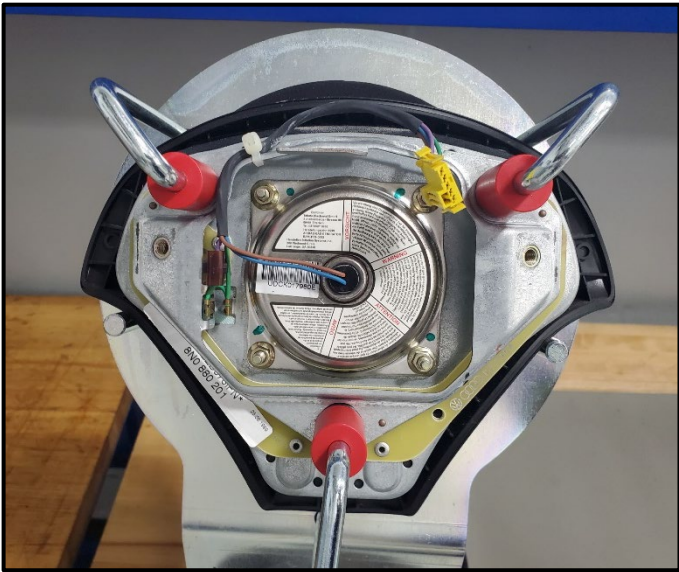
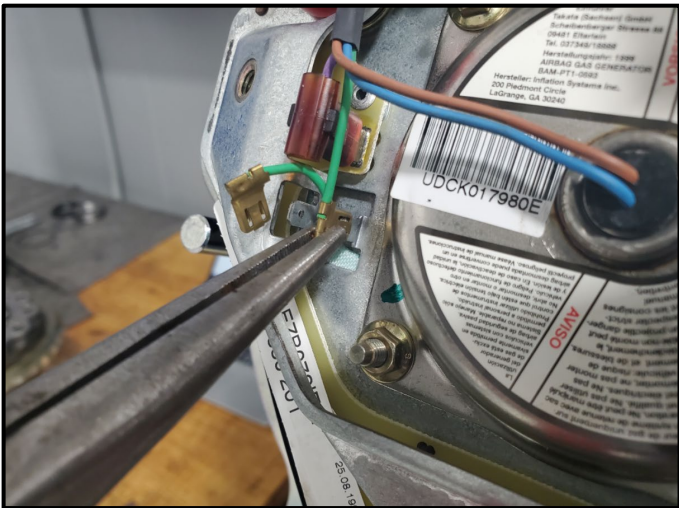
- Place the securing hooks <1> over the horn ring bolts <2>.
- Tighten the securing hooks carefully so the airbag is secured on the support.
- Do not overtighten.

- Use extreme care when securing the airbag.
- The face of the airbag must not be damaged.
- **DO NOT OVERTIGHTEN.**
- Due to the age of the vehicles, replacement airbags are not available!
