## SIB 52 08 21 RECALL 21V-521: CIS MAT

2021-10-15

**Safety Recall  
21V-521  
CIS Mat  
Model Year 2018-2019  
BMW X3 SAV / X4 SAC  
Issue Date: 07/08/2021**

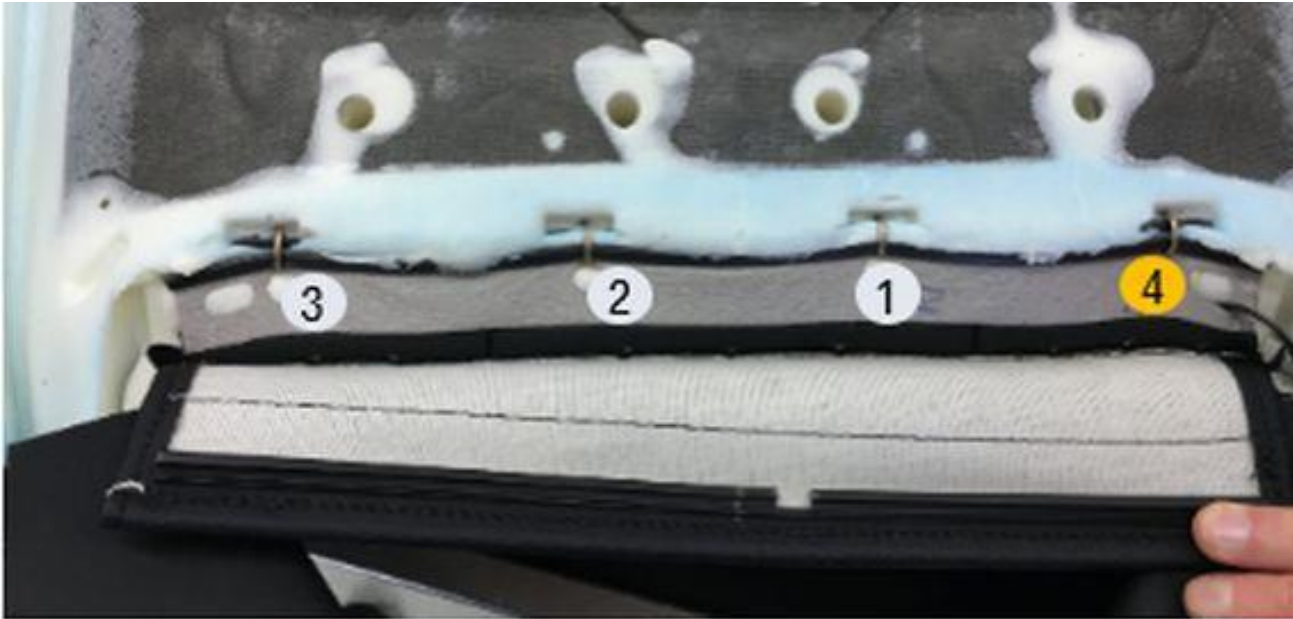
**New:** The sequence in which the hog ring clamps are installed must be observed.

**First clamp items 1-3, then clamp the area of the cable outlet 4** to prevent the seat heater line from being contacted and/or damaged by clamps.

For section: Installing the seat cover for the front seat REP-TAT-P-5216-02-G01\_3
