SAFETY RECALL CAMPAIGN 2A97

2019 & 2020 Burgman 200 Fuel Hose Replacement Recall

Affected Models:	Certain 2019 & 2020 Burgman 200 (UH200AL9-M0) Scooter Models
Affected Departments:	Management, Service, Warranty, Sales, Parts, Accessories
Attachments:	Sales Bulletin 21-093 (Burgman 200 Stop Sales) & Customer Notification Letter

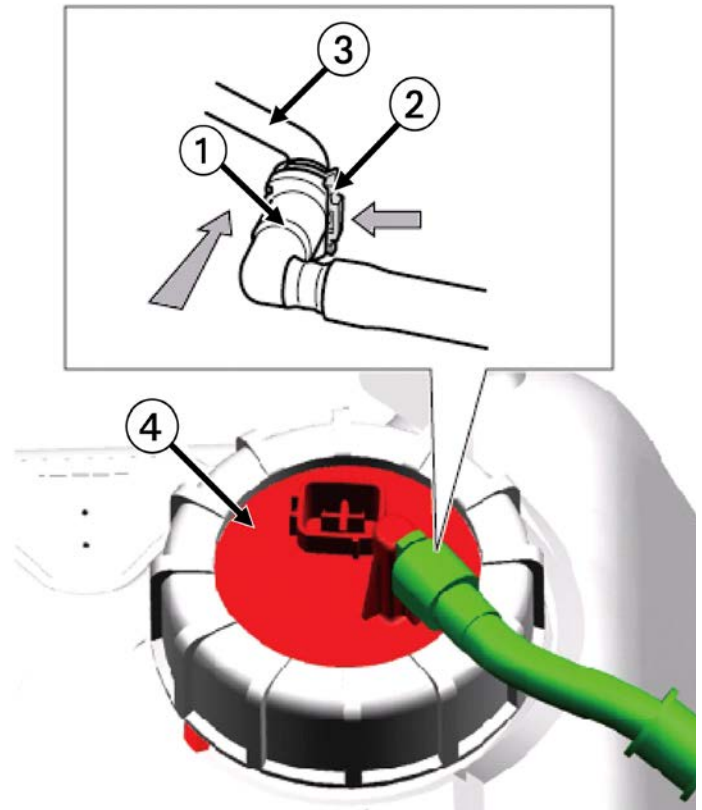
4. Connect the fuel hose joint ① to the fuel pump ④.
5. Lock the fuel hose joint by pushing in the retainer ②.
6. Pull on the fuel hose ③ by hand to confirm that the fuel hose joint is not disconnected.

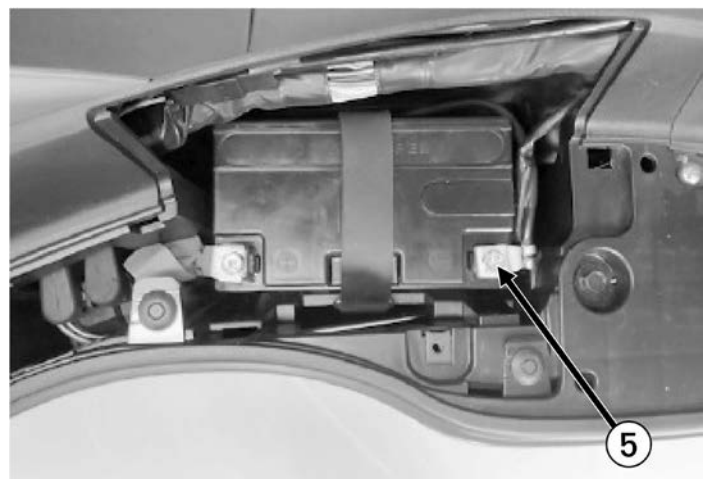
8. Connect the battery negative (-) lead wire ⑤.
9. Install the battery cover.
10. Install the right floor mat.
