Compliance Recall

Code: 69CR

Subject: Compliance Recall 69CR - Automatic Locking Seat Belt Retractors (ALR)

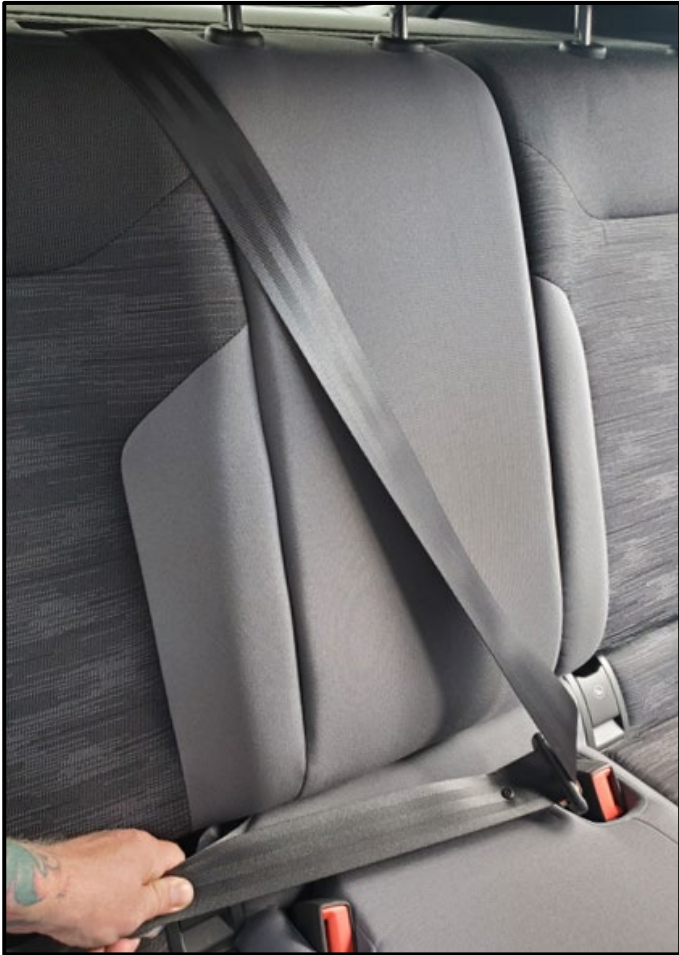
Testing the Automatic Locking Retractor (ALR) function on the rear center seat belt:

- Fasten and buckle seat belt over an empty seat.
- Extract 200 - 250 mm lower belt webbing, fold and fix with your hand (as shown).
- The seat belt remains buckled and the lower seat belt webbing remains held.

- Pull the webbing all the way out of the seat belt retractor. This will activate the ALR.
- Slowly retract the webbing back into the seat belt retractor. You will hear a ratcheting sound.

- Pull on the belt with uniform and steady pressure and verify the belt cannot be pulled out of the seat belt retractor.
- If the seat belt locks so the webbing cannot be pulled out of the retractor:

- Unfasten the seat belt and repeat the tests 5 times in succession.
- If the seat belt retractor locks without releasing for all tests:
 - No further work is required.

- Proceed to Section D.
- If the seat belt retractor does not lock during any of the tests:
 - The affected seat belt must be replaced.
 - Proceed to Section C.

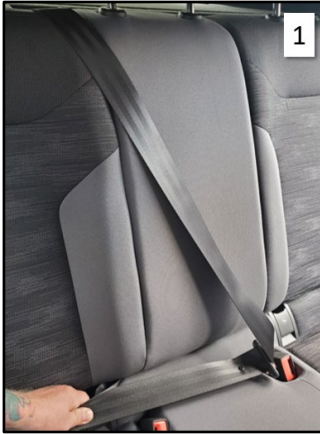
Step 1) Fasten seat belt over an empty seat and gather excess webbing.

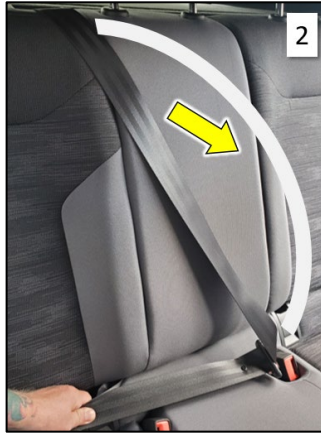
Step 2) Pull webbing all the way out of seat belt retractor to activate ALR.

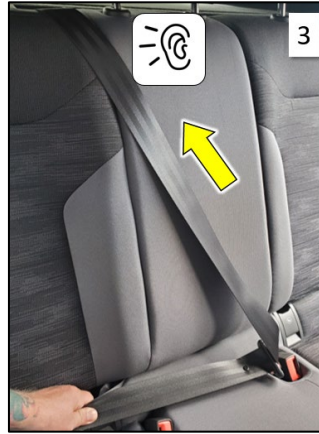
Step 3) Slowly retract the webbing all the way back into the seat belt retractor while the seat belt remains buckled. You will hear a ratcheting sound.

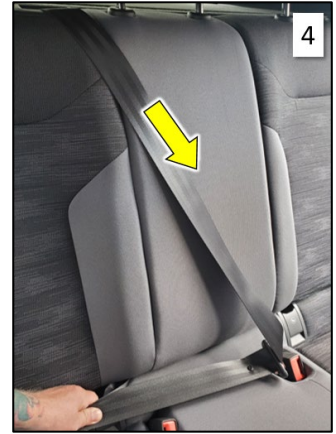
Step 4) Pull on the seat belt and verify it is locked and cannot be pulled out of the seat belt retractor.

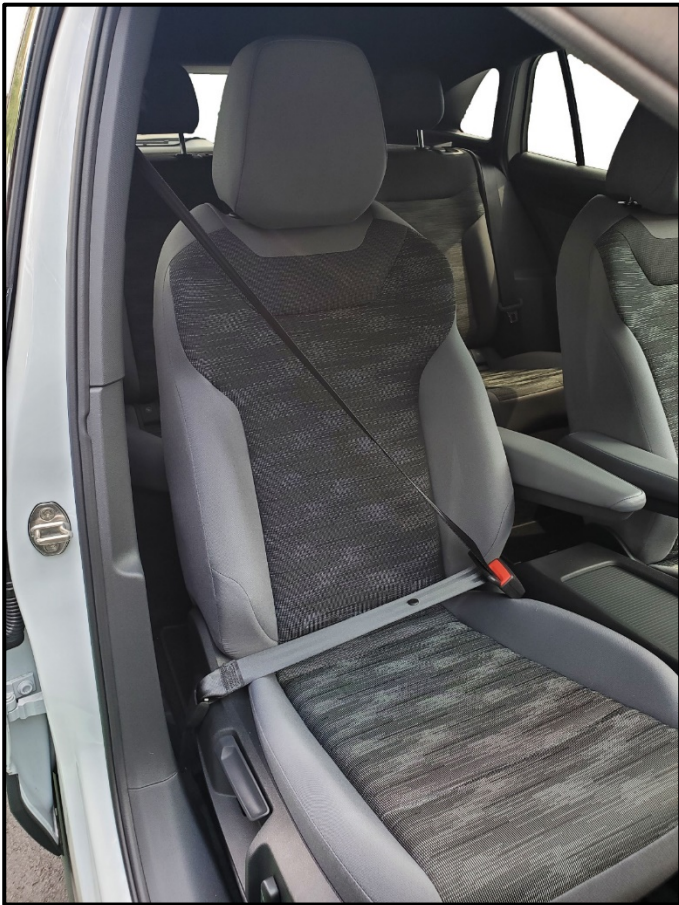
Testing the Automatic Locking Retractor (ALR) function on the front passenger seat belt:

- The seat must be empty.
- Fasten and buckle seat belt over the empty seat.
- The seat belt remains buckled.
- Pull the webbing all the way out of the seat belt retractor. This will activate the ALR.
- Slowly retract the webbing back into the seat belt retractor.
- You will hear a ratcheting sound.
- Pull on the belt with uniform and steady pressure and verify the belt cannot be pulled out of the seat belt retractor.
- If the seat belt locks so the webbing cannot be pulled out of the retractor:
 - Unfasten the seat belt and repeat the tests 5 times in succession.
- If the seat belt retractor locks without releasing for all tests:
 - No further work is required.
 - Proceed to Section D.
- If the seat belt retractor does not lock during any of the tests:
 - The affected seat belt must be replaced.
 - Proceed to Section C.

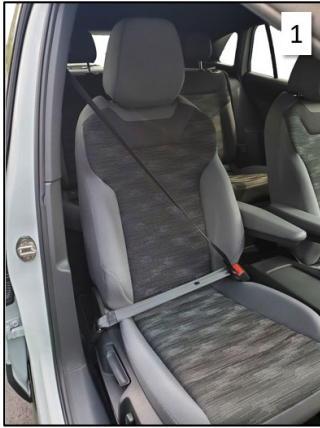
Step 1) Fasten seat belt over an empty seat.

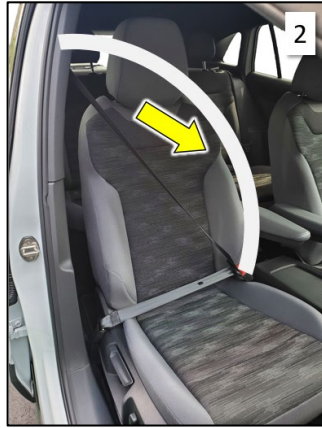
Step 2) Pull webbing all the way out of seat belt retractor to activate ALR.

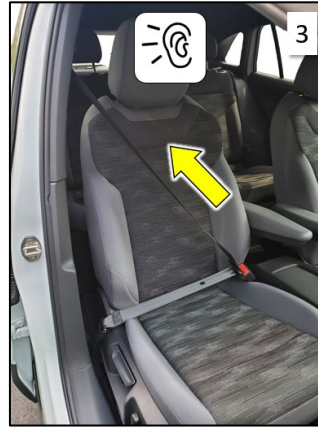
Step 3) Slowly retract the webbing all the way back into the seat belt retractor while the seat belt remains buckled. You will hear a ratcheting sound.
