AMB6 Recall Campaign – Check three-point belt and replace if necessary

Cayenne (9YA/9YB) - MY: 2021

A seat belt assembly supplier reported that seat belt assemblies in the subject vehicles may not meet one of the applicable Federal safety standards. Accordingly, the seat belt assembly must be inspected, and replaced if necessary.

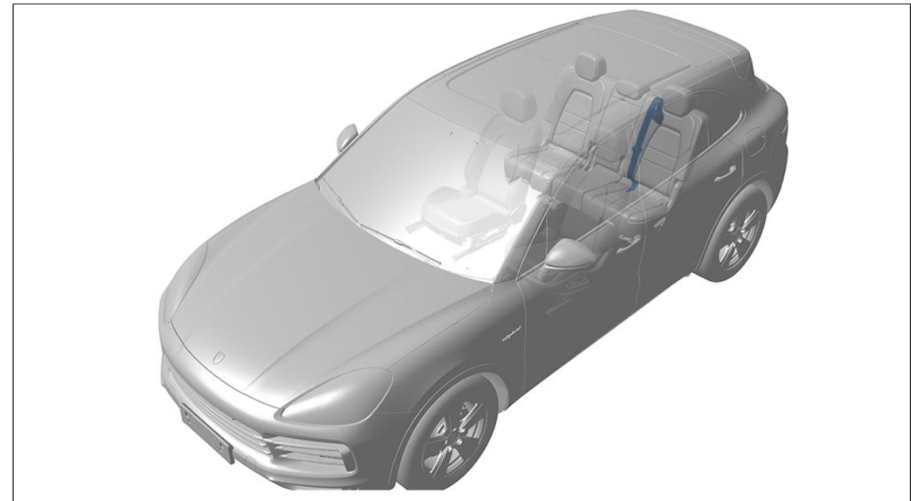
(1) Three-point belt on the **middle rear seat (check)**

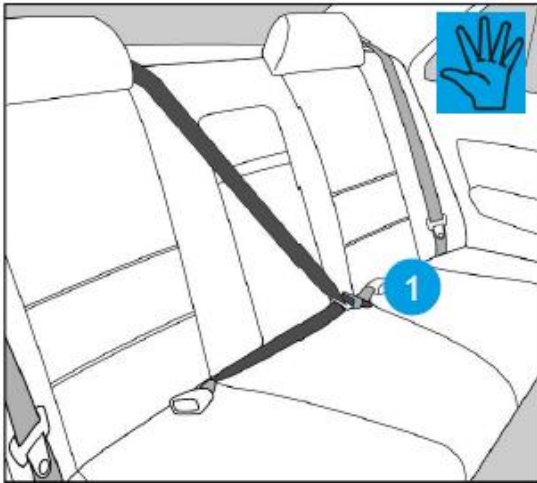
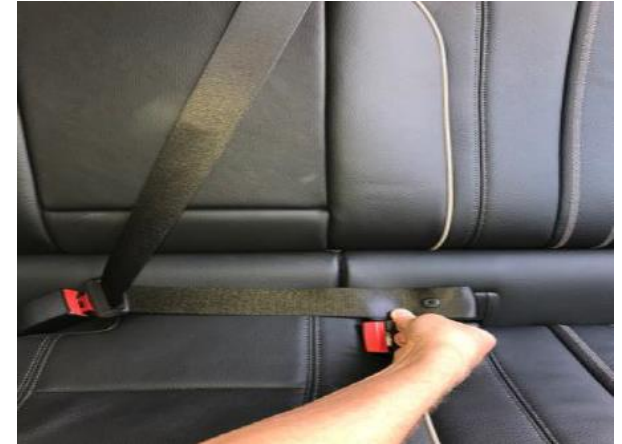
Picture 1

1. Fasten seatbelt over empty vehicle seat, latch seatbelt into buckle.
 - For rear center only; extract 200 - 250 mm lower belt (fabric), fold and fix with your hand (Picture 1).

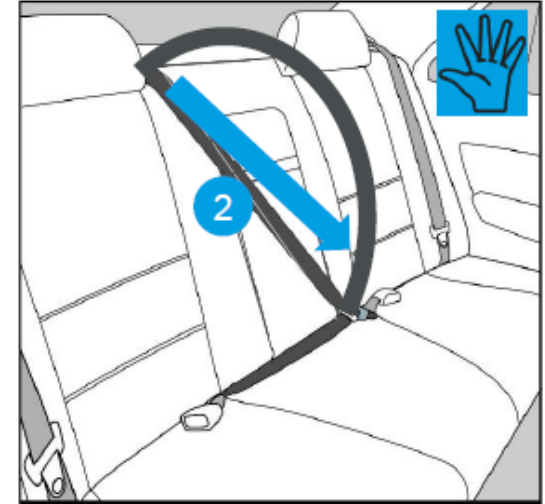
2. Pull seatbelt (fabric) all the way out of the seatbelt retractor to activate ALR.

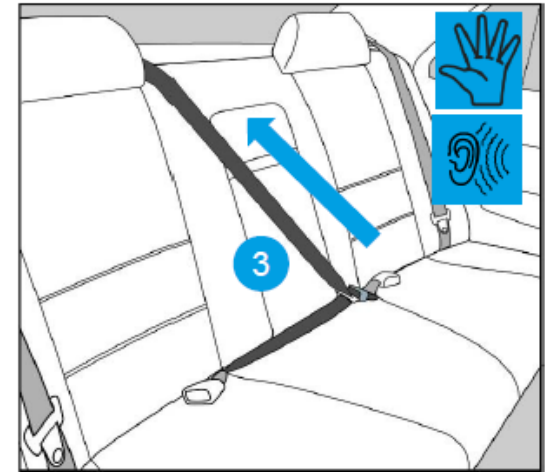
3. Slowly retract the seatbelt (fabric) fully back into the seatbelt retractor while the seatbelt remains buckled over empty seat (you will hear a ratcheting sound).

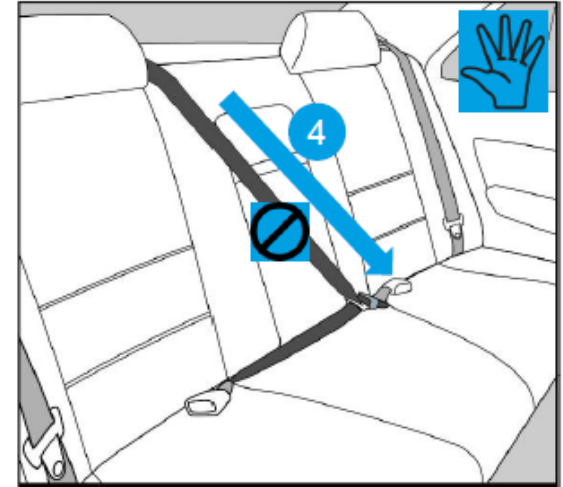
4. Pull on the belt steady and uniformly and verify that it is locked and cannot be pulled out of the seatbelt retractor.
5. EVALUATION
Is the seatbelt locked so webbing cannot be pulled out of seatbelt retractor ?
 - Yes: ALR function works properly – go to step 6
 - No: ALR is not working properly. The affected three-point belt must be replaced as soon as the required parts are available.
6. Unfasten seatbelt and run Step 1 to 5 for 5 consecutive times.
 - If seatbelt retractor locks without releasing, 5 times in succession, no further action is required. The vehicle can be handed over to the customer.

The vehicle **may only be handed over to the customer** after the test outlined in the initial inspection instructions has been completed if all three-point belts to be tested **are functioning as prescribed**. If the function of the three-point seat belt does not comply with specification, **the vehicle must remain blocked and must not be handed over to the customer**.
