# Test instructions

AMB6 Recall Campaign –

Check three-point belt and replace if necessary

*Panamera(971) - MY: 2021*

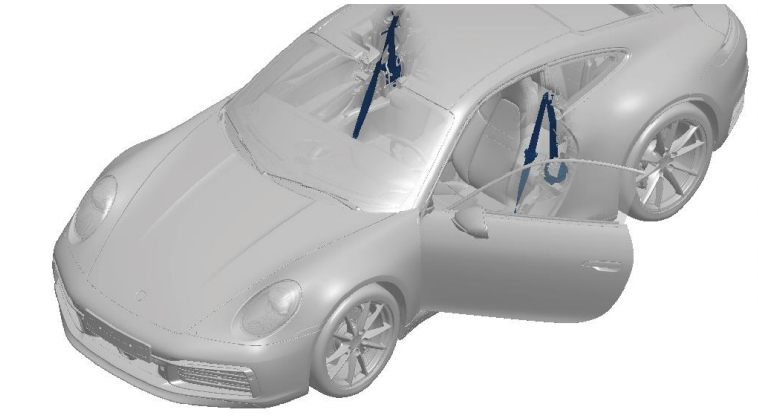
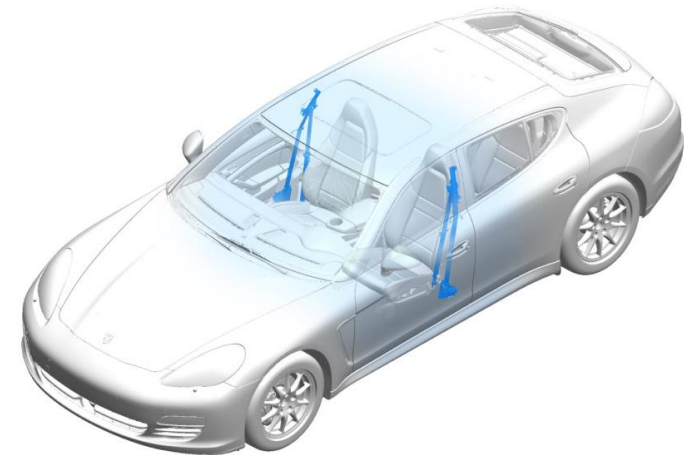
(1) Three-point belt on the **passenger front side (check)**

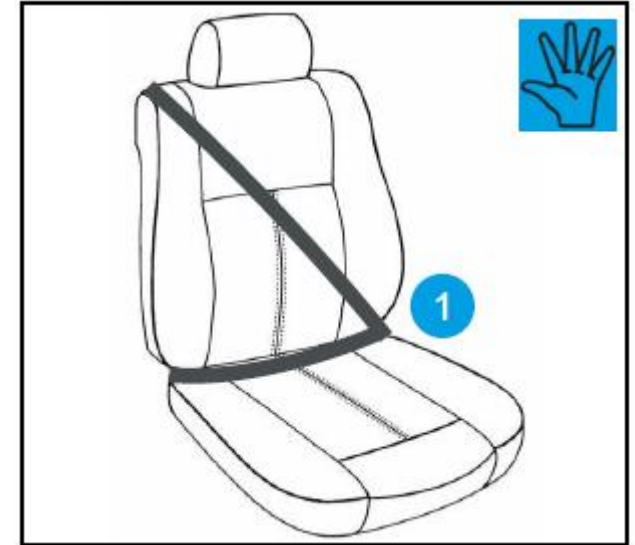
1. Fasten seatbelt over empty vehicle seat, latch seatbelt into buckle.

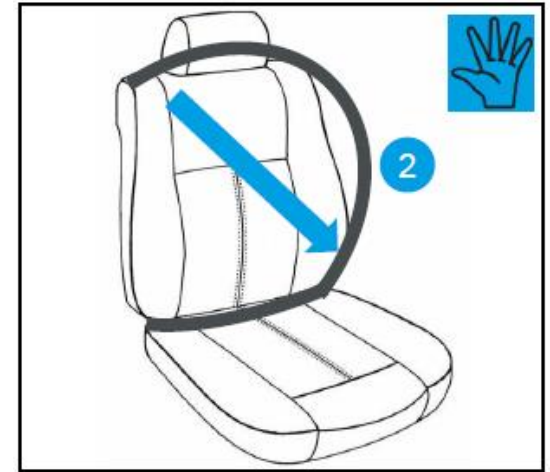
2. Pull the seatbelt (fabric) all the way out of the seatbelt retractor to activate ALR.

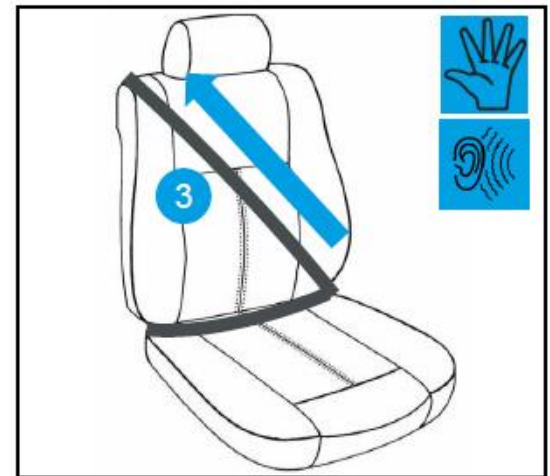
3. Slowly retract the seatbelt (fabric) fully back into the seatbelt retractor while the seatbelt remains buckled over empty seat (you will hear a ratcheting sound).

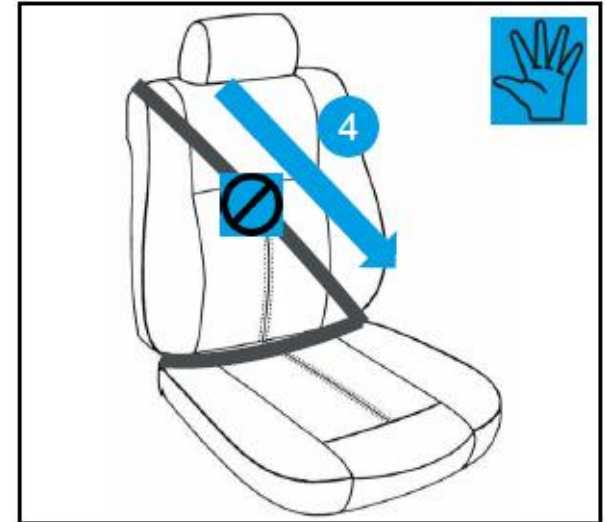
4. Pull on the belt steady and uniformly and verify that it is locked and cannot be pulled out of the seatbelt retractor.
5. EVALUATION
  - Is the seatbelt locked so the seatbelt (fabric) cannot be pulled out of seatbelt retractor ?
  - Yes: ALR function works properly – go to step 6
  - No: ALR is not working properly. The affected three-point belt must be replaced as soon as the required parts are available.
6. Unfasten seatbelt and run Step 1 to 5 for 5 consecutive times.
  - If seatbelt retractor locks without releasing, 5 times in succession, no further action is required. The vehicle can be handed over to the customer.

The vehicle **may only be handed over to the customer** after the test outlined in the initial inspection instructions has been completed if all three-point belts to be tested **are functioning as prescribed**. If the function of the three-point seat belt does not comply with specification, **the vehicle must remain blocked and must not be handed over to the customer**.
