AMB6 - Checking Three-Point Belt and Replacing it if Necessary (Stop Delivery/Recall Campaign)

Model Line: **Panamera (971)**

Concerns: **Child locking function on front three-point belt (passenger's side)**

Action required: **Check front three-point belt (passenger's side) and replace if necessary.**

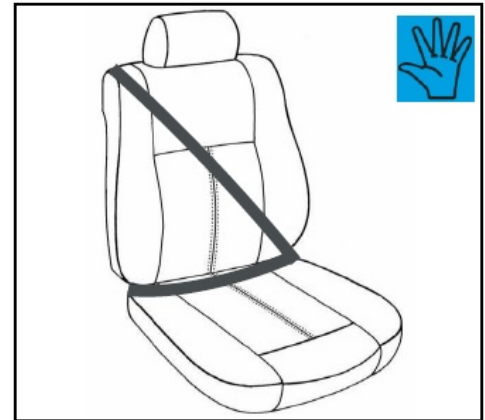
*Closing three-point belt*

- 1 Insert three-point belt with the seat-belt fastener into the seat-belt buckle and lock it ⇒ *Closing three-point belt*.

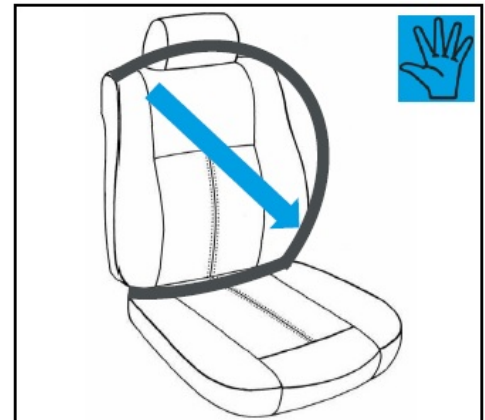
- 2 Pull the belt strap out completely ⇒ *Pulling out belt strap* in order to activate the child locking function (ALR automatic locking retractor).

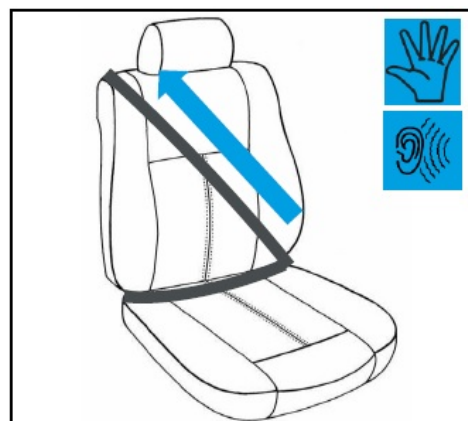
Retracting belt strap

- 3 Allow the belt strap to retract slowly, checking whether an audible click can be heard while it retracts ⇒ *Retracting belt strap.*

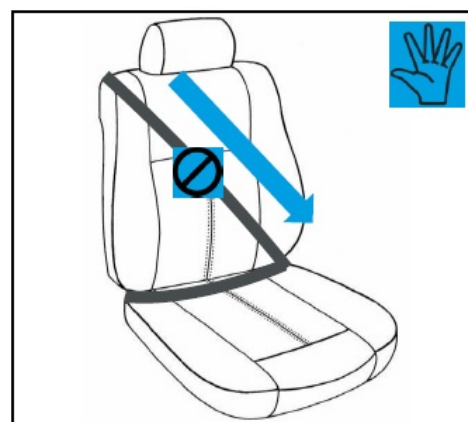
Pulling out belt strap and checking belt locking system

- 4 As soon as the belt strap has retracted, check whether it can be pulled out completely again or is blocked ⇒ *Pulling out belt strap and checking belt locking system.*

When checking the three-point belt, if you discover that the **belt strap does not block**, the three-point belt must be replaced. To do this, continue with:

If the belt strap blocks and an audible click can be heard when the three-point belt retracts:

- **Repeat steps 1 to 4 four times**

If five tests confirm that the child locking function of the three-point belt works according to specifications, the three-point belt does **not** have to be replaced.

- ⇒ *Technical Information 'Replacing front three-point belt (passenger's side)'*
