Safety Recall Y63 / NHTSA 21V-632 Side Air Bag Inflatable Curtain Inflator

2015-2020 (DS) Ram 1500 Pickup
2015-2016 (DJ) Ram 2500 Pickup
2015-2016 (D2) Ram 3500 Pickup
2016 (DF) Ram 3500 10K LB Cab Chassis

The Side Air Bag Inflatable Curtain (SABIC) inflator on about 33,000 of the above vehicles may rupture. A SABIC inflator rupture may result in compressed gas rapidly escaping from the inflator and material potentially being propelled into the vehicle. Material being propelled into the vehicle may cause injury to vehicle occupants.

Inspect and if necessary, replace one or both SABICs as needed.

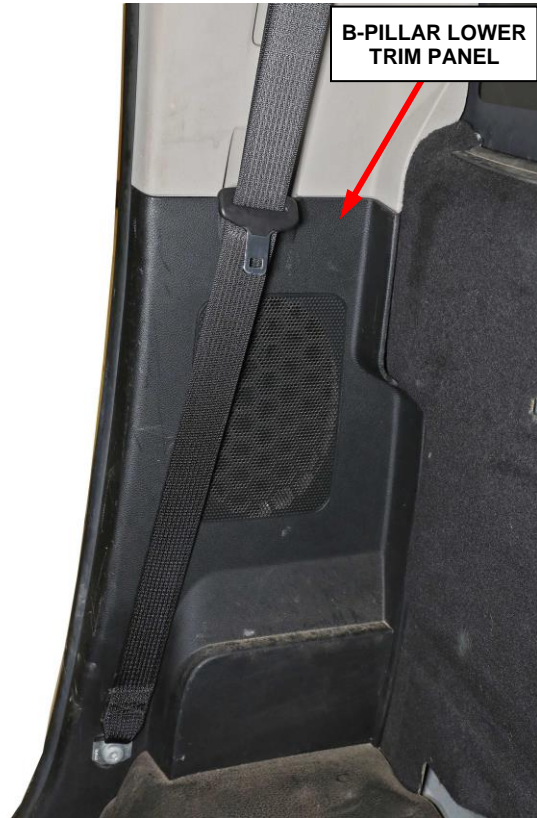
Figure 3 – B-Pillar Lower Trim Panel

5. Release the upper retaining clips of the B-pillar lower trim panel to allow for removal of the B-pillar upper trim panel (Figure 3).

51. Install and tighten the screw that secures the B-pillar upper trim panel then install the airbag applique cover (Figure 5).
52. Remove and **DISCARD** the bolt retainer and the bolt from the seat belt turning loop, save the spacer washer for reuse (Figure 18).
53. Using a **NEW** bolt and reusing the spacer washer, install the turning loop then tighten the bolt to 40 N·m (30 ft. lbs.) (Figure 4).
54. Install the turning loop cover (Figure 4).
55. Position the B-pillar lower trim panel and engage the retaining clips fully (Figure 3).
