Revision (3) September 2022

Dealer Service Instructions for:

Safety Recall Y55 / NHTSA 21V-632 Side Air Bag Inflatable Curtain Inflator

The Side Air Bag Inflatable Curtain (SABIC) inflator on about 184,950 of the above vehicles may rupture. A SABIC inflator rupture may result in compressed gas rapidly escaping from the inflator and material potentially being propelled into the vehicle. Material being propelled into the vehicle may cause injury to vehicle occupants.

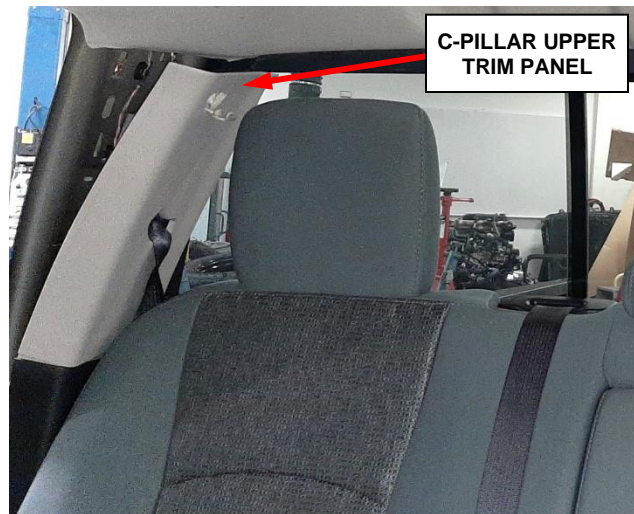
Figure 44 – C-Pillar Trim Panels

14. Release the retaining clips and tilt the top of the C-pillar upper trim panel inward (Figure 44).
