## **Safety Recall Y55 / NHTSA 21V-632 Side Air Bag Inflatable Curtain Inflator**

The Side Air Bag Inflatable Curtain (SABIC) inflator on about 184,950 of the above vehicles may rupture. A SABIC inflator rupture may result in compressed gas rapidly escaping from the inflator and material potentially being propelled into the vehicle. Material being propelled into the vehicle may cause injury to vehicle occupants.

Replace both SABICs. The SABICs for each vehicle are VIN specific and can be determined by using GRS or VIP as described in the Parts Information section below.

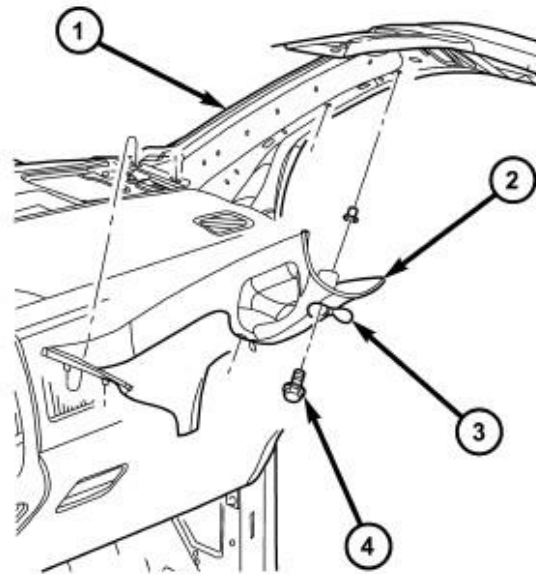
**Figure 1 – A-Pillar**

2. Remove the two bolts (4) that secure the A-pillar trim panel to the A-pillar (1) and remove the trim panel (Figure 1).

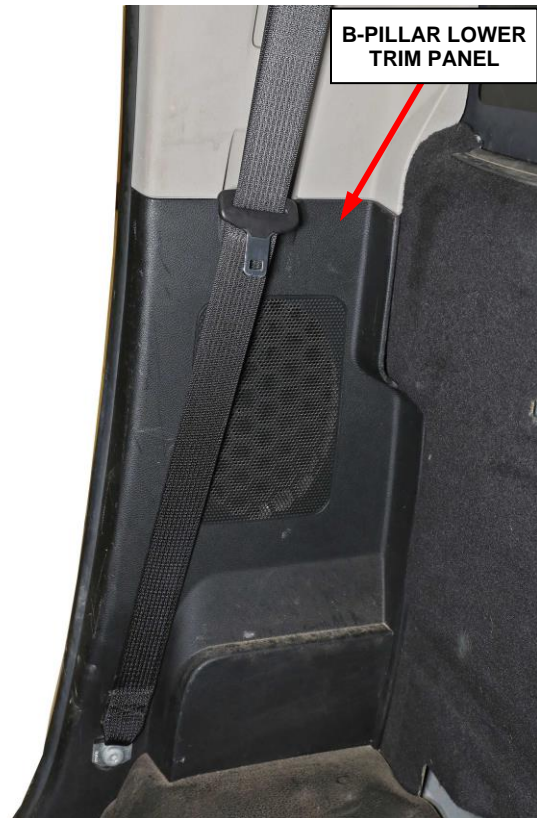
**Figure 3 – B-Pillar Lower Trim Panel**

5. Release the upper retaining clips of the B-pillar lower trim panel to allow for removal of the B-pillar upper trim panel (Figure 3).

47. Install and tighten the screw that secures the B-pillar upper trim panel then install the airbag applique cover (Figure 5).
48. Remove and **DISCARD** the bolt retainer and the bolt from the seat belt turning loop, save the spacer washer for reuse (Figure 14).
49. Using a **NEW** bolt and reusing the spacer washer, install the turning loop then tighten the bolt to 40 N·m (30 ft. lbs.) (Figure 4).
50. Install the turning loop cover (Figure 4).
51. Position the B-pillar lower trim panel and engage the retaining clips fully (Figure 3).

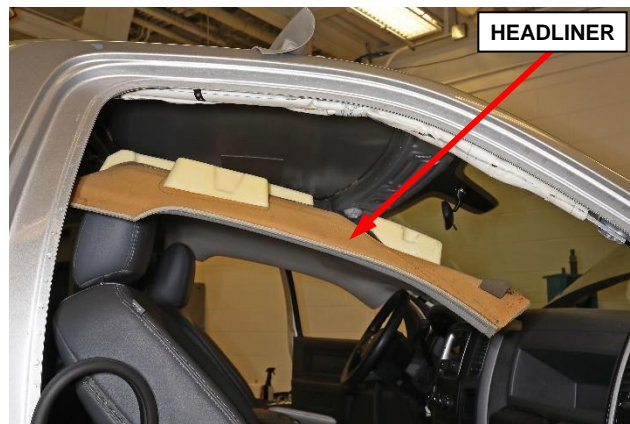
**Figure 11 – Headliner**

17. Carefully lower the headliner allowing it to rest on the seat backs and instrument panel (Figure 11).

**CAUTION:** Disconnect any wiring harness electrical connectors as necessary to allow enough wiring harness slack for lowering headliner. It will not be necessary to remove the headliner from the vehicle.

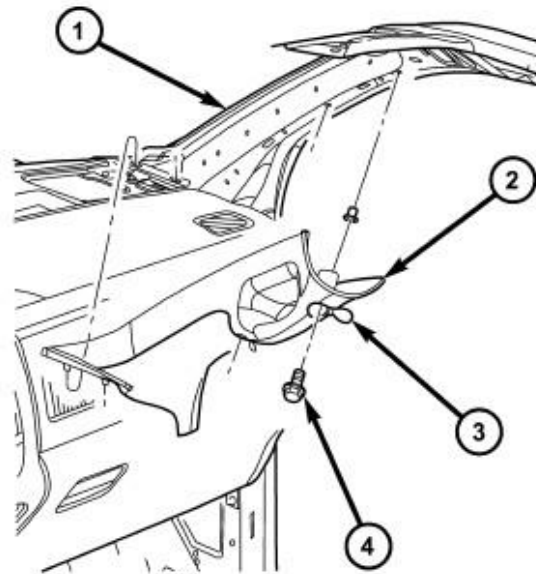
2. Remove the two bolts (4) that secure the A-pillar trim panel to the A-pillar (1) and remove the trim panel (Figure 15).

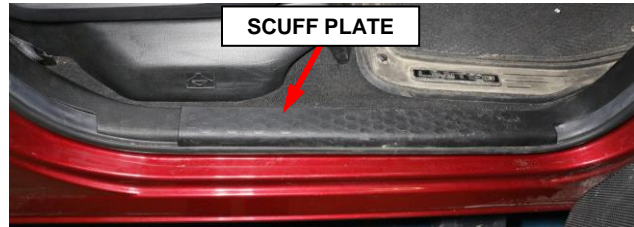
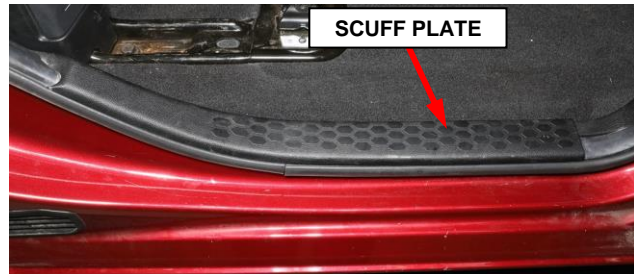
**Figure 17 – Door Sill Scuff Plates**

6. Release the front and rear door sill scuff plates on either side of the B-pillar lower trim panel to allow for removal of the B-pillar lower trim panel (Figure 17).

**Front Door Sill**

**Rear Door Sill**

51. Install the B-pillar upper trim panel (1) and engage the retaining clips fully (Figure 20).
52. Install the grab handle bolts (3) and tighten to 5 N·m (44 in. lbs.). Close the fastener covers (2) (Figure 20).
53. Remove and **DISCARD** the bolt retainer and bolt from the seat belt turning loop, save the spacer washer for reuse (Figure 35).
54. Using a **NEW** bolt and reusing the spacer washer, install the turning loop then tighten the bolt to 40 N·m (30 ft. lbs.) (Figure 19).
55. Install the seat belt turning loop cover (Figure 19).
56. Position the B-pillar lower trim panel and engage the retaining clips fully (Figure 18).
57. Position the front and rear door sill scuff plates and engage the retainers (Figure 17).

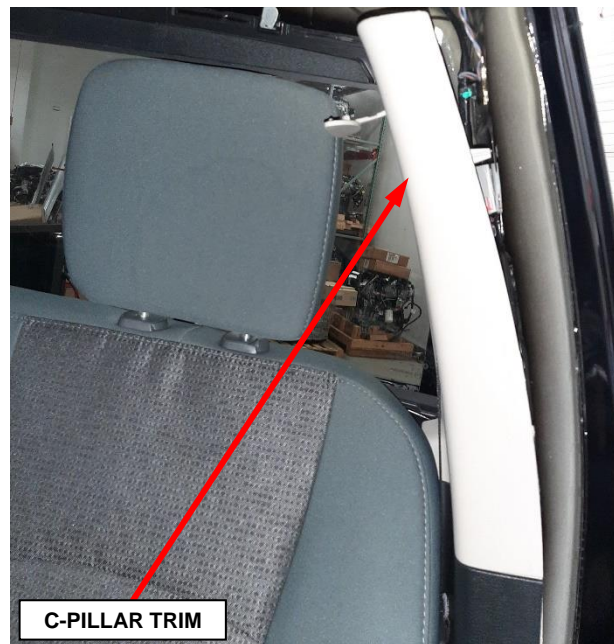
**Figure 24 – C-Pillar Upper Trim Panel**

- Release the retaining clips and tilt the top of the C-pillar upper trim panel inward (Figure 24).

45. Position the upper trim to the C-pillar then engage the retaining clips (Figure 24).
46. Install and tighten the screw that secures the C-pillar upper trim panel. Then install the airbag applique (Figure 23).
47. Remove and **DISCARD** the bolt retainer and bolt from the seat belt turning loop, save the spacer washer for reuse (Figure 34).
48. Using a **NEW** bolt and reusing the spacer, install the turning loop then tighten the bolt to 40 N·m (30 ft. lbs.) (Figure 22).

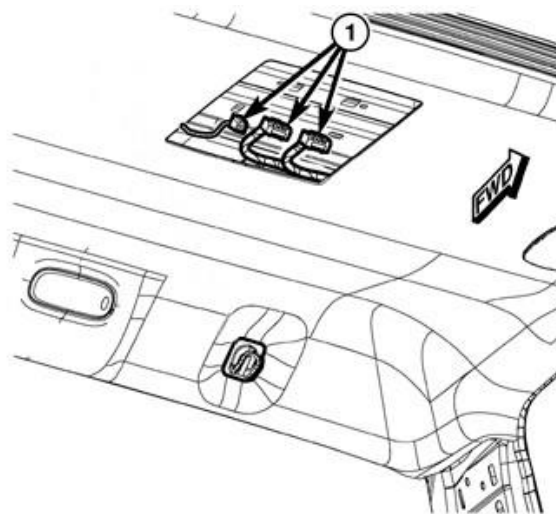
**Figure 26 – DVD Monitor Electrical Connectors**

17. If equipped with DVD monitor, disconnect the electrical connectors (1) (Figure 26).

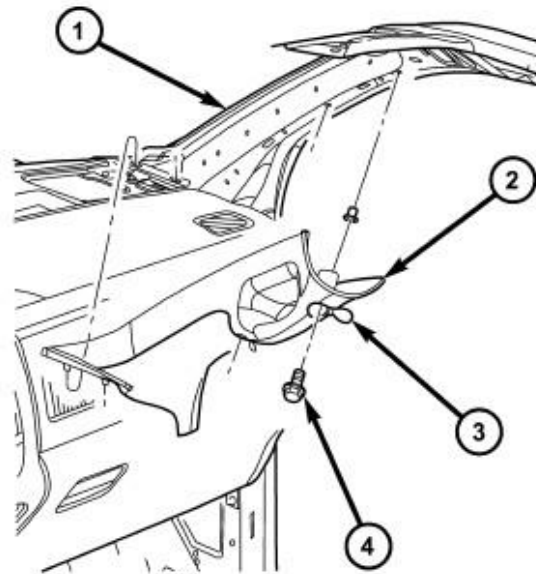
2. Remove the two bolts (4) that secure the A-pillar trim panel to the A-pillar (1) and remove the trim panel (Figure 36).

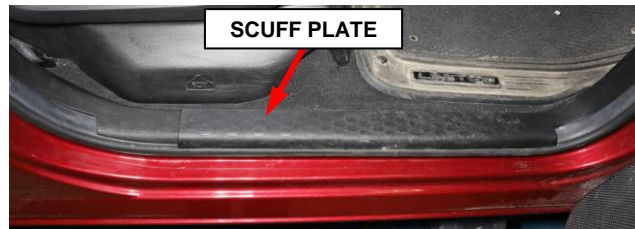
**Figure 38 – Door Sill Scuff Plates**

6. Release the front and rear door sill scuff plates on either side of the B-pillar lower trim panel to allow for removal of the B-pillar lower trim panel (Figure 38).

**Front Door Sill**

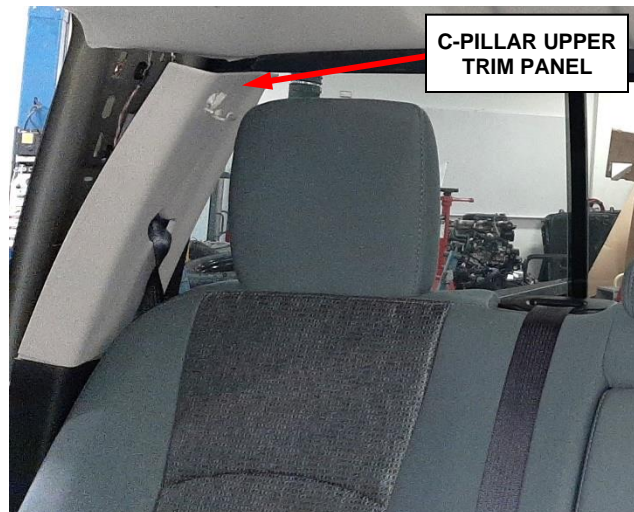
**Figure 44 – C-Pillar Trim Panels**

- Release the retaining clips and tilt the top of the C-pillar upper trim panel inward (Figure 44).

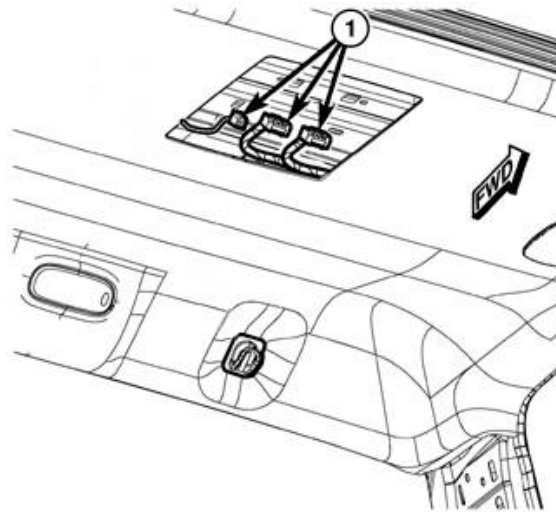
**Figure 46 – DVD Monitor Electrical Connectors**

16. If equipped with DVD monitor, disconnect the electrical connectors (1) (Figure 46).

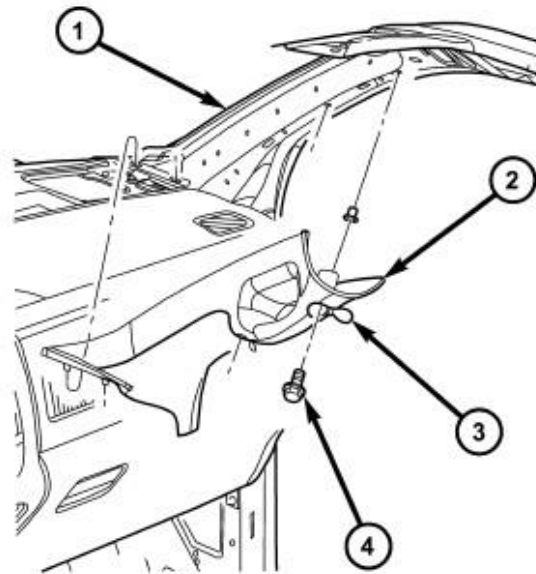
2. Remove the two bolts (4) that secure the A-pillar trim panel to the A-pillar (1) and remove the trim panel (Figure 55).

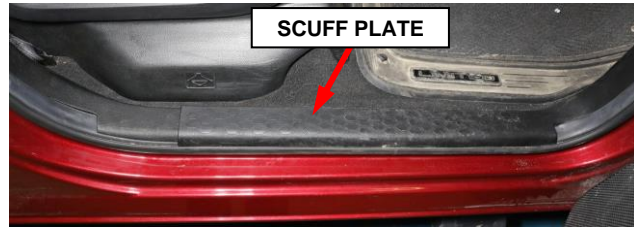
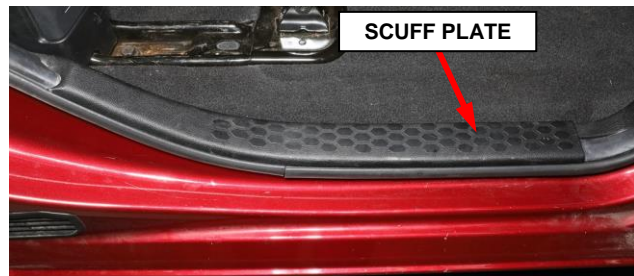
**Figure 57 – Door Sill Scuff Plates**

5. Release the front and rear door sill scuff plates on either side of the B-pillar lower trim panel to allow for removal of the B-pillar lower trim panel (Figure 57).

**Front Door Sill**

**Rear Door Sill**

66. Install the seat belt turning loop cover (Figure 59).
67. Position the B-pillar lower trim panel and engage the retaining clips fully (Figure 58).
68. Position the front and rear door sill scuff plates and engage the retainers (Figure 57).

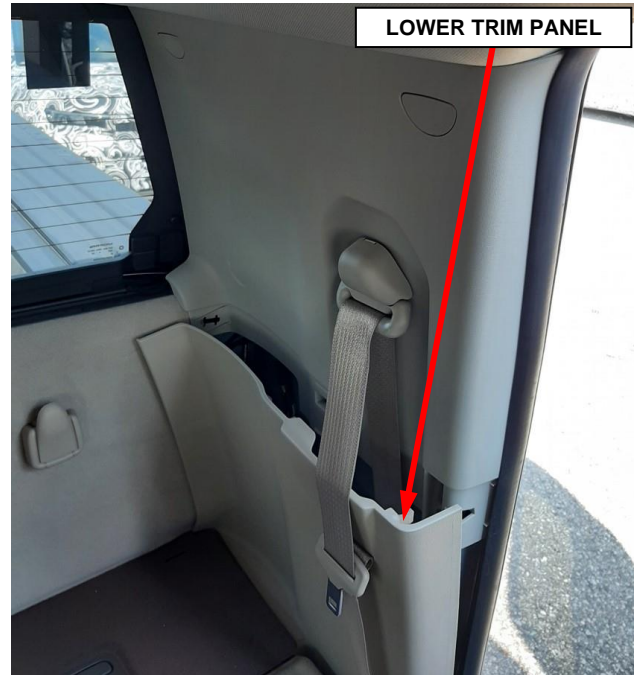
**Figure 61 – C-Pillar Lower Trim Panel**

11. Fold the rear seat backs down.
12. Release the upper retaining clips of the lower C-pillar trim panel to allow for removal of the upper C-pillar trim panel (Figure 61).

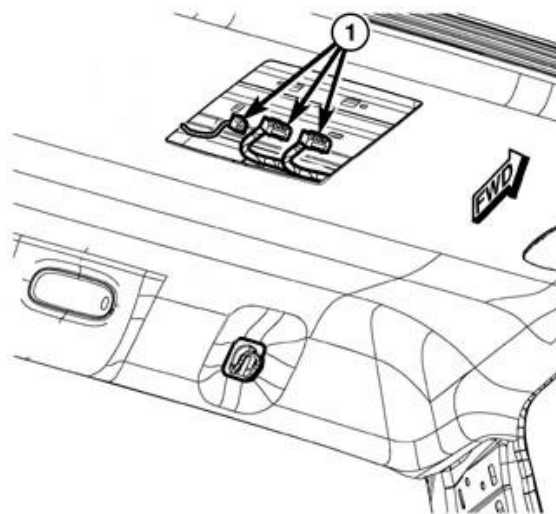
**Figure 66 – DVD Monitor Electrical Connectors**

19. If equipped with DVD monitor, disconnect the electrical connectors (1) (Figure 66).

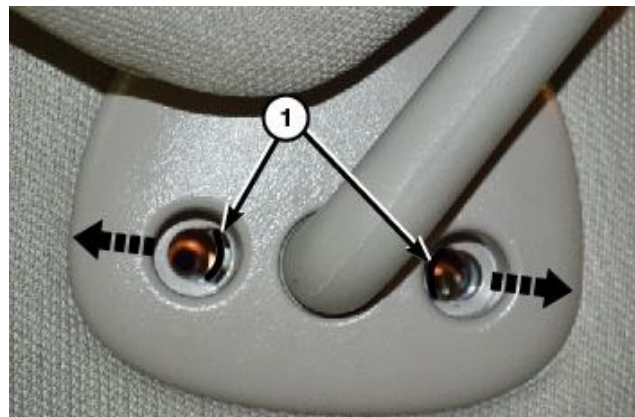
**Figure 68 – Visors**

Using a small flat bladed tool or equivalent, release the retaining tabs (1) and separate the visor from the headliner (Figure 68).
