Campaign No. 2021080016, August 2021

SUBJECT: **Model C204 and C/A207**
Model Years 2011-2016
Variant of Front Passenger Airbag

Mercedes-Benz AG (“MBAG”), the manufacturer of Mercedes-Benz vehicles, has determined that on certain Model Year (“MY”) 2011 - 2016 C-Class (204 platform) and E-Class Coupe/Convertible (207 platform) vehicles a passenger airbag may have been installed that is not approved for the model during a prior repair.

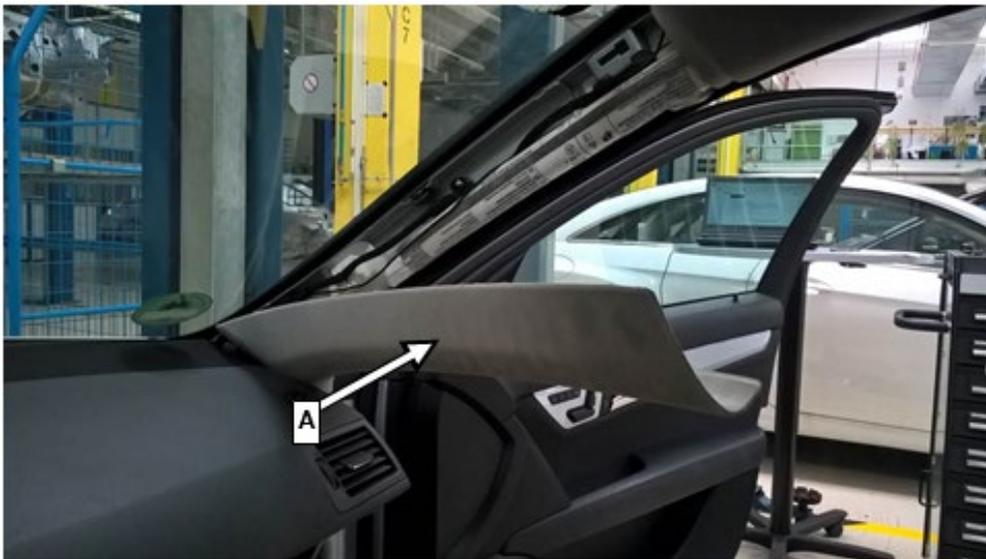
Figure 2

1. Disconnect ground line from the on-board electrical system battery.
2. Remove right A-pillar trim (**A, figure 2**).

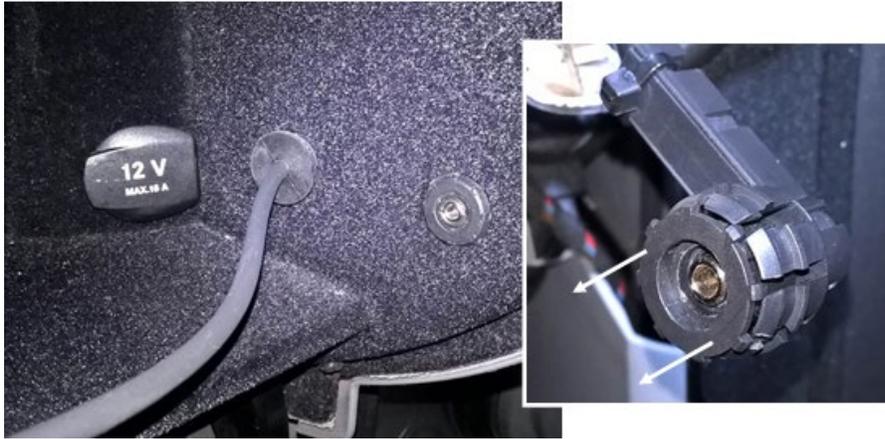
Figure 3

i Release inner retaining ring (**figure 3**) at the AUX connection towards the inside. The connection can then be removed from the glove box housing.

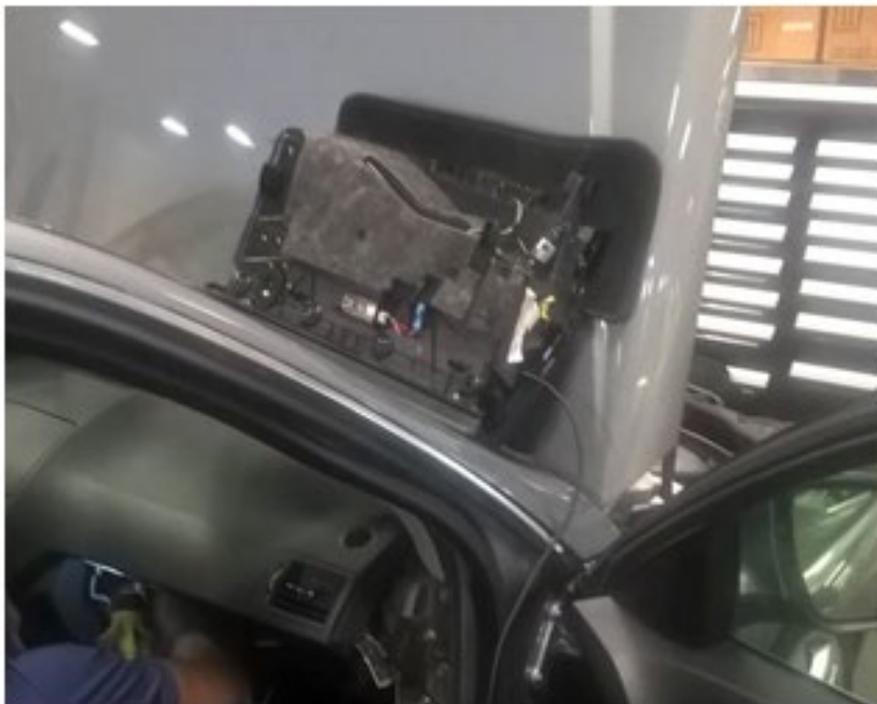
Figure 4

i Pull out the iPod cable as far as possible and set down glove box housing on the windshield **with** exterior iPod cable connected (**figure 4**).

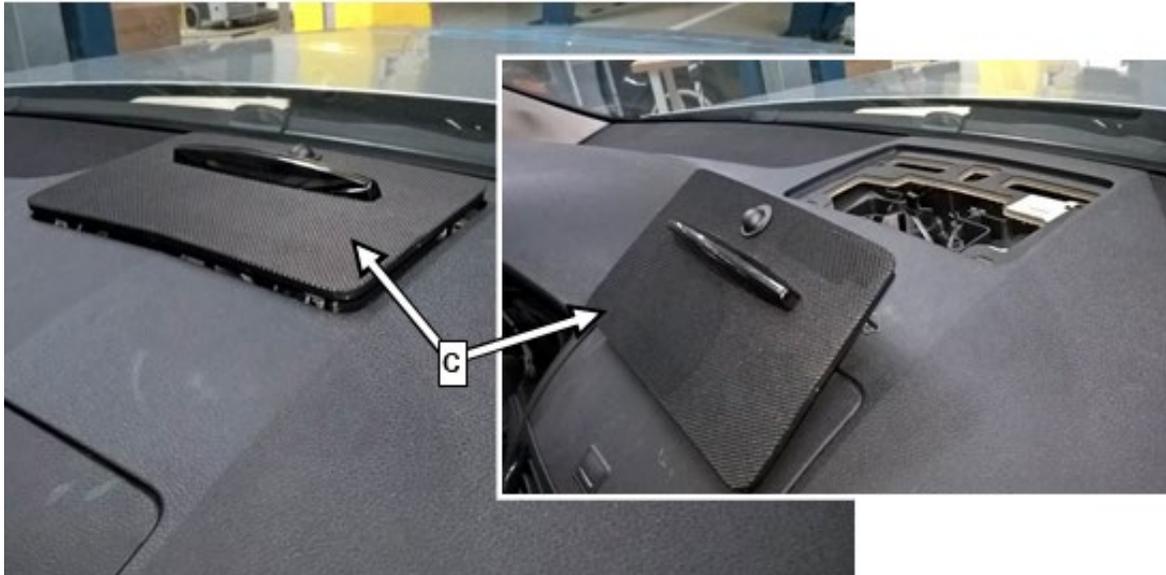
Figure 6

5. Unclip and remove cover (**C, figure 6**) at the instrument panel on top.

i With a sound system, also remove speaker under the cover.

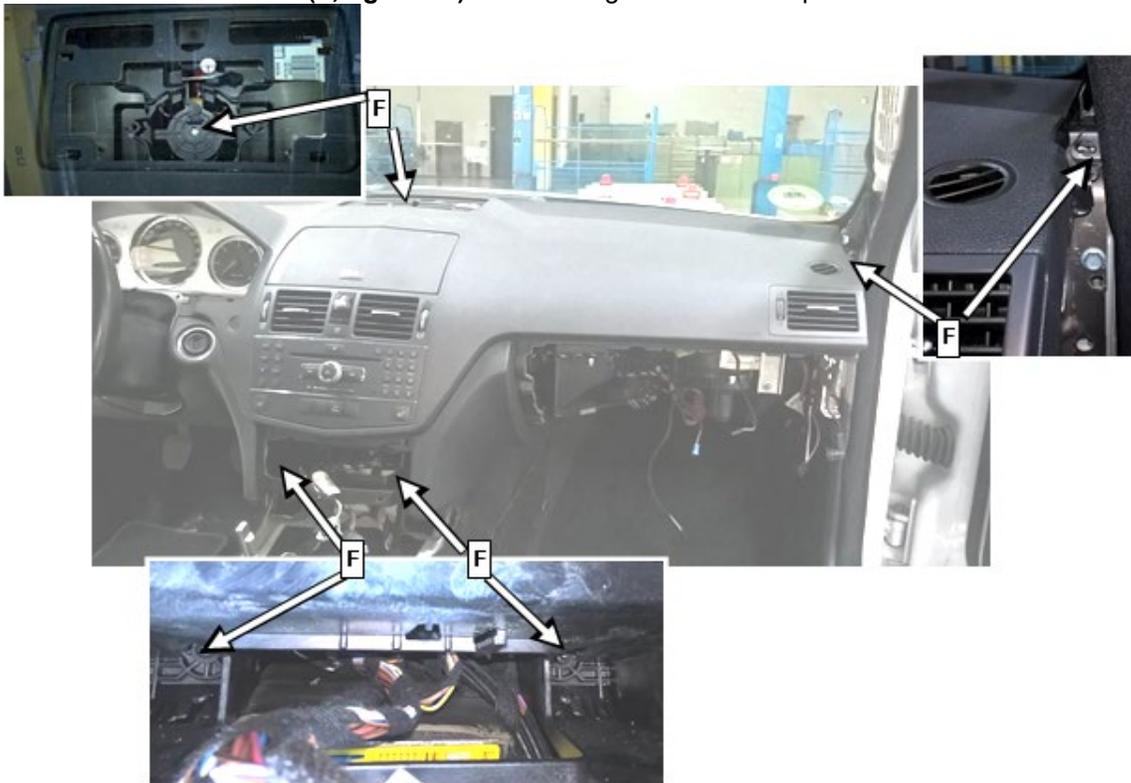
Figure 10

10. Remove four screws (F, figure 10) for fastening the instrument panel

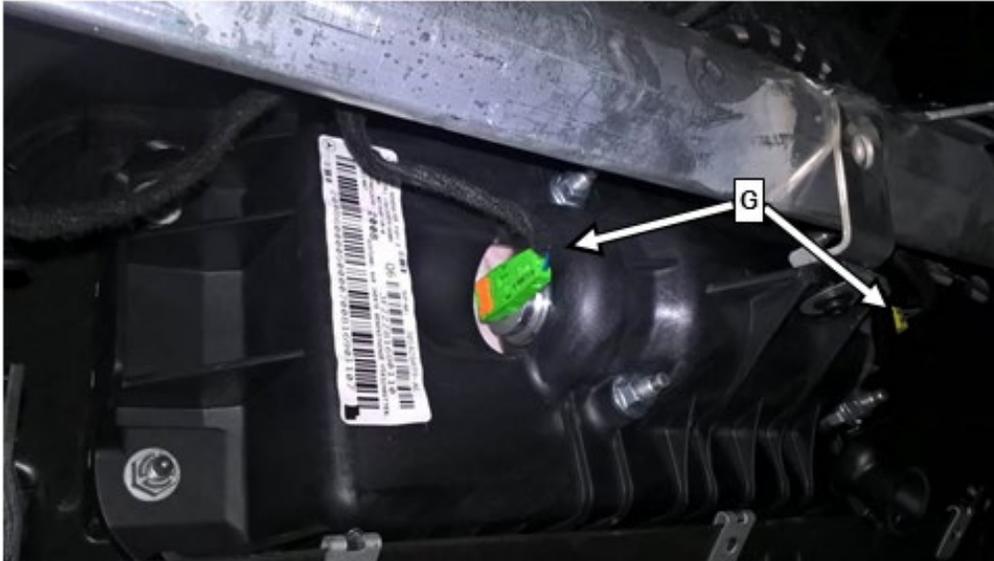
Figure 11

11. Disconnect electrical contacts (**G**, **figure 11**) at the front passenger airbag.

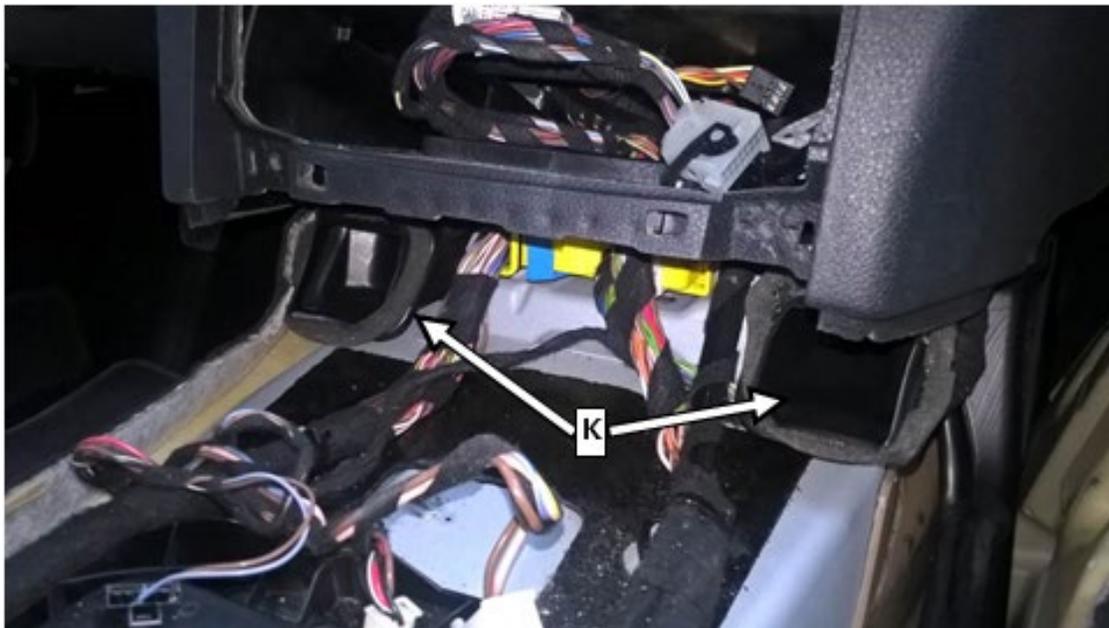
Figure 17

20. Place instrument panel back into position and install the air ducts (**K**, figure 17) correctly.

i The air ducts are pulled out when the instrument panel is raised.
