INSTRUCTIONS FOR INSPECTING AND REPLACING WINDOW VENTS, IF NEEDED. PLUS, INSTRUCTIONS FOR SUBMITTING CLAIMS TO LIPPERT FOR REIMBURSEMENT OF INSPECTION AND REPAIR TIME, IF APPLICABLE.

NHTSA Safety Recall: 21V672

LIPPERT HEHR 6400 SERIES WINDOW VENT RECALL

MID-HINGE VENT REPLACEMENT FOR HEHR WINDOWS

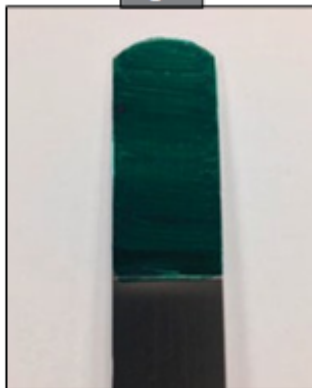
Fig. 5

The provided gauge has a colored segment at one end (Fig. 5). Use the gauge as outlined in the instructions below to determine any possible break in the seal.

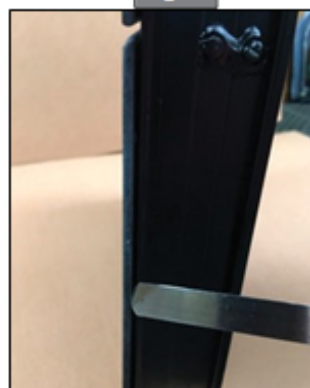
Fig. 6

1. Be sure window is in closed position.
2. Lightly insert the gauge into the gap between the glass and the frame (Fig. 6) starting near the hinge on the exterior side of the window.
3. The gauge should stop within the colored segment (Fig. 7).
4. Continue reinserting the gauge at different points, working around the glass.

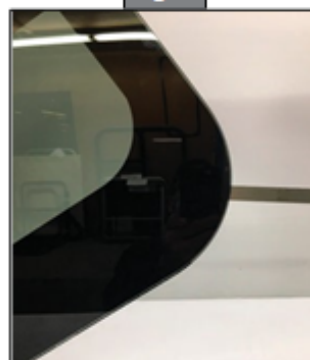
Fig. 8

NOTE: If the gauge inserts beyond the colored segment (Fig. 8) this indicates a possible break in the seal and the vent of the window will need replacing.

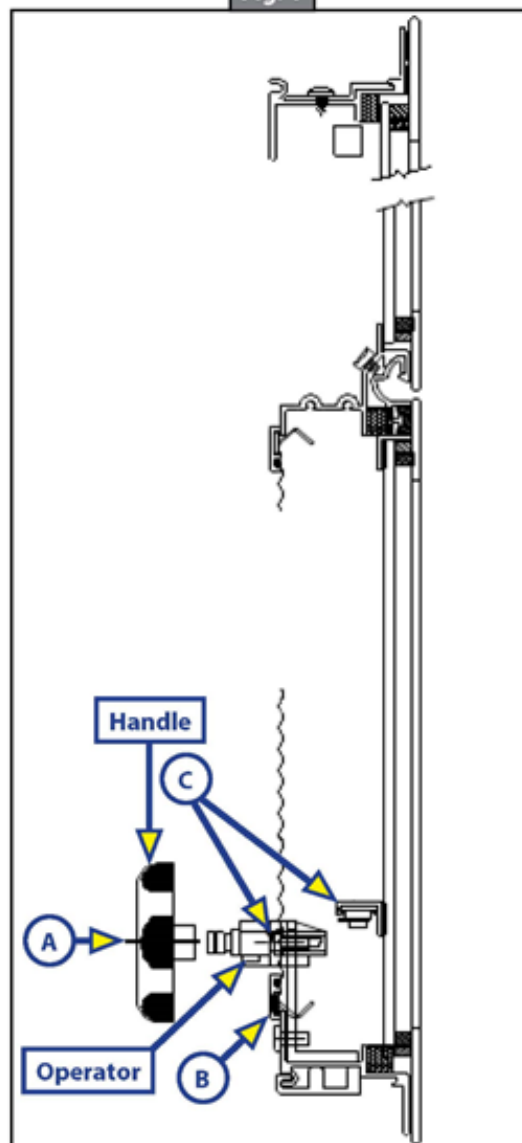
Fig. 1

1. Remove the screw securing the handle, then remove handle from operator (Fig. 1A). Retain screw and handle for re-installation.
2. Remove the screen by slightly lifting and pulling on the bottom of the screen frame. Once the bottom screen springs are free, continue to slightly pull until the screen is free from the window. Gently remove the screen over operator body (Fig. 1B). Retain for re-installation.

3. Remove operator using 3/16" drill bit. Drill out rivets, then lift and push operator from bracket and slide arms from the rail (Fig. 1C). Retain operator for re-installation.
4. Remove vent section by opening the vent section slightly past 90 degrees. Apply forward pressure at 90 degrees and the vent section will disengage and come out (Fig. 2A).
5. Replace the vent section. With the vent section at 90 degrees to the window, install the vent hinge portion into the mullion area (Fig 2B). As it contacts the back of the mullion, lift slightly and pull out on the vent section until it locks into place.
