INSTRUCTIONS FOR INSPECTING AND REPLACING WINDOW VENTS, IF NEEDED. PLUS, INSTRUCTIONS FOR SUBMITTING CLAIMS TO LIPPERT FOR REIMBURSEMENT OF INSPECTION AND REPAIR TIME, IF APPLICABLE.

NHTSA Safety Recall: 21V672

LIPPERT HEHR 6400 SERIES WINDOW VENT RECALL

MID-HINGE VENT REPLACEMENT FOR HEHR WINDOWS

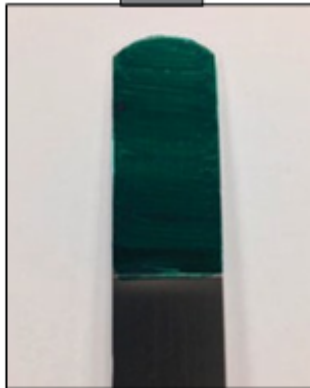
Fig. 5

The provided gauge has a colored segment at one end (Fig. 5). Use the gauge as outlined in the instructions below to determine any possible break in the seal.

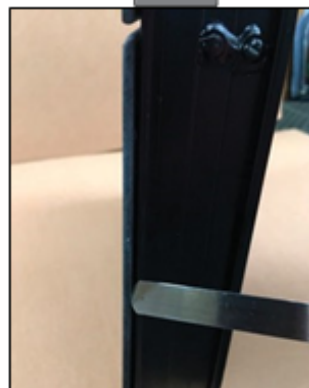
Fig. 6

1. Be sure window is in closed position.
2. Lightly insert the gauge into the gap between the glass and the frame (Fig. 6) starting near the hinge on the exterior side of the window.
3. The gauge should stop within the colored segment (Fig. 7).
4. Continue reinserting the gauge at different points, working around the glass.
