Revision 2 May 2022

# Safety Recall Y61 / NHTSA 21V-699

## Seat Belt Locking Retractor

2021 (VM) Ram ProMaster City  
2021 (VF) Ram ProMaster

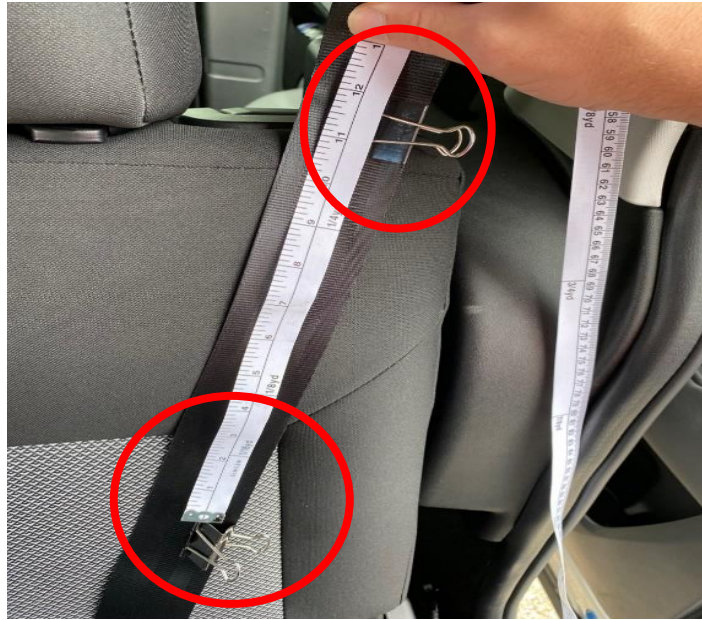
**Figure 3 – Measure Distance**

3. Pull out a small amount of webbing, and place a second binder clip **8 inches (203mm) away for 1st Row or 12 inches (305mm) away in the 2nd Row** to establish your control point for determining if the ALR deactivation is in specification or not (Figure 3).
4. Slowly extract all of the seat belt webbing from retractor until no more webbing will pull out. At this point the ALR mode for securing a child seat will be activated and you will hear an audible ratcheting or clicking noise as the seat belt begins to retract.
5. Slowly allow the seat belt to retract, and after every 1-2 inches of webbing is retracted, gently pull on the webbing to verify the retract is still locked (ALR mode still engaged).

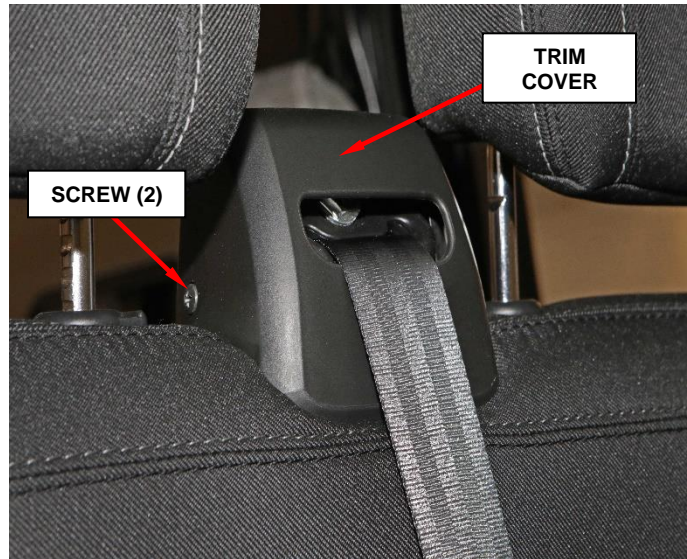
**Figure 6 – Center Seat Trim Cover**

8. Working from the front of the passenger bench seat, pull the seat belt lower anchor up from between the seat back and the seat cushion.
9. Remove the two screws that secure the trim cover to the center seating position seat belt turning loop bracket at the top of the seat back frame (Figure 6).
10. Disengage the seat belt webbing, latch plate and lower anchor from the trim cover.

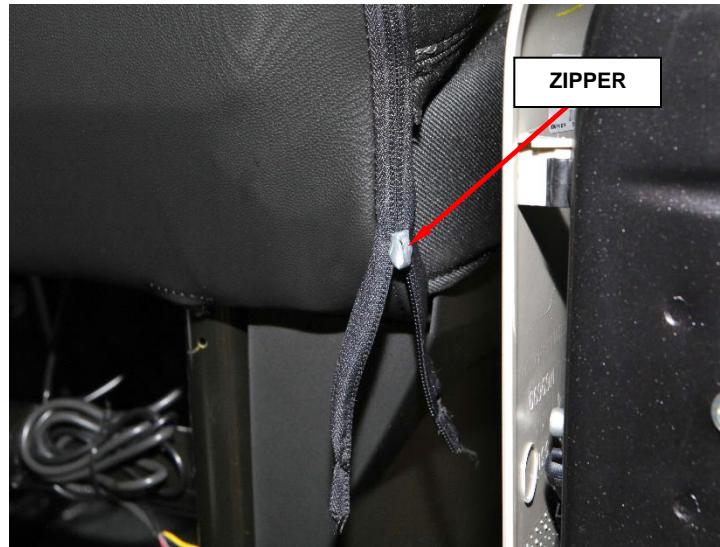
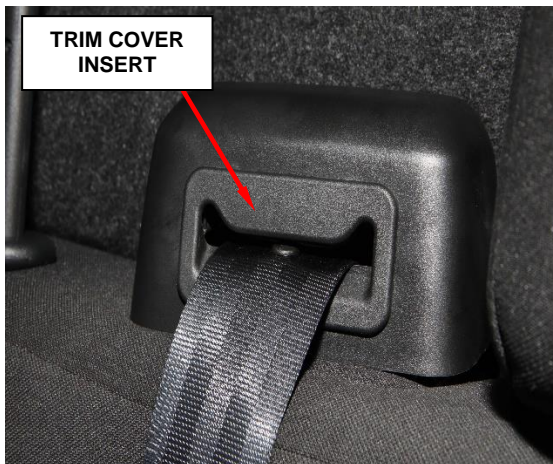
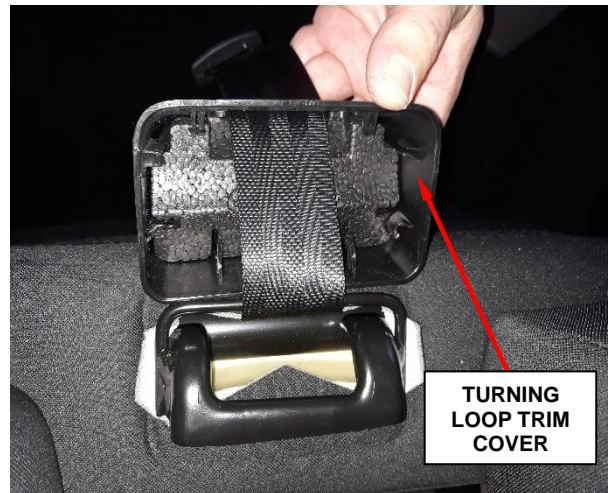
12. Unzip the right center seat cover (Figure 8).
13. Using a trim stick remove the turning loop trim cover and insert (Figure 9).
14. Route the seat belt through the turning loop bracket and down the back of the seat (Figure 10).

Figure 8 – Center Seat Back Cover

Figure 9 – Trim Insert

Figure 10 - Cover

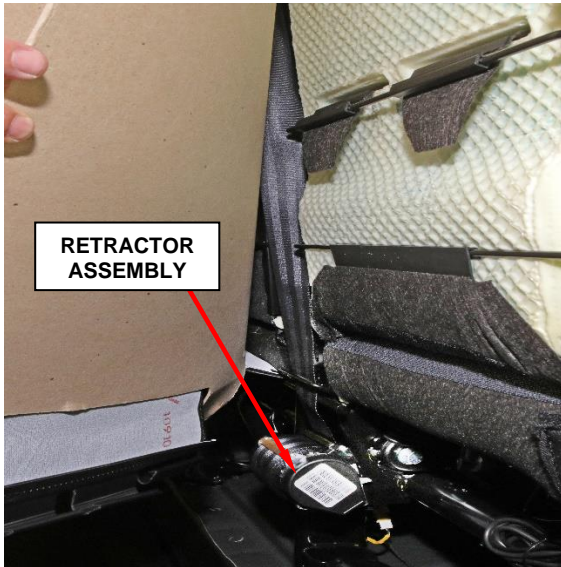
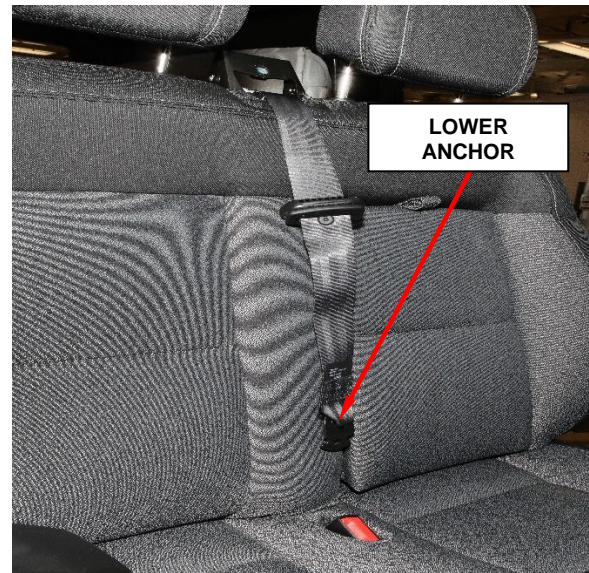
17. Route the seat belt up the rear seat guide and through the turning loop bracket (Figure 11).

**Figure 11 – Back of Seat**

**Figure 12 – Front of Seat**

18. Be certain the seat belt webbing is not twisted between the retractor and the top of the seat back.
19. Install and tighten the bolt that secures the turning loop to the bracket. Tighten the screw to 40 N·m (30 ft. lbs.).
20. Thread the lower anchor, latch plate and webbing through the opening of the trim cover.
21. Position the trim cover over the turning loop bracket at the top of the seat back frame.
22. Install and tighten the two screws that secure the trim cover to the bracket. Tighten the screws securely.
23. Push the lower anchor down between the seat back and the seat cushion. Be certain the seat belt webbing is not twisted between the turning loop and the lower anchor.
24. Working from behind the passenger bench seat, position the retractor to the seat riser frame bracket.

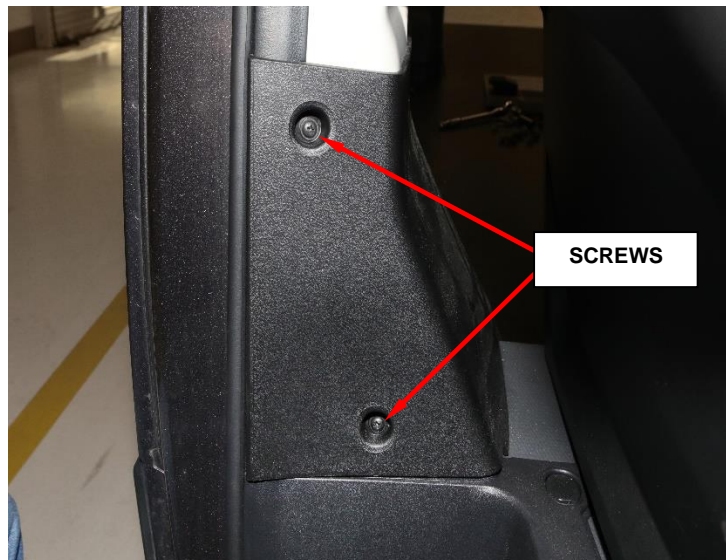
**Figure 13 – Lower “B” Pillar Trim**

1. Move the seat to its most forward position for easiest access to the outboard seat belt retractor.
2. Remove the screws from the lower B-pillar trim (Figure 13).

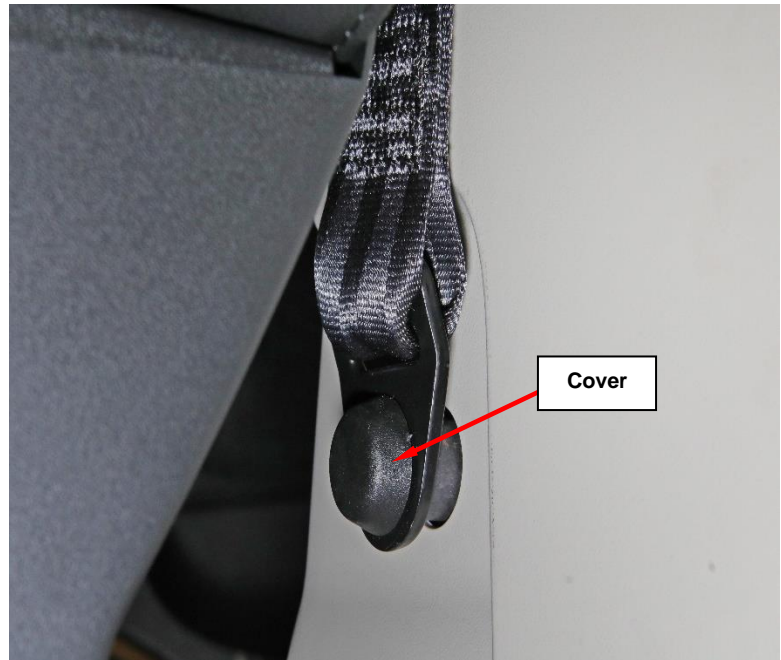
3. Remove the protective cover from the screw for the outboard seat belt lower anchor (Figure 14).
4. Remove the screw that secures the outboard seat belt lower anchor to the B-pillar.
5. Release and remove the knob from the seat belt height adjuster on the upper B-pillar (Figure 15).
6. Remove the trim cover from the nut for the outboard seat belt turning loop (Figure 15).
7. Remove the nut that secures the seat belt turning loop to the height adjuster on the upper B-pillar (Figure 15).
8. Remove the seat belt turning loop from the height adjuster.

**Figure 14 – Front Seat Lower Anchor**

**Figure 15 – Front Seat Belt Turning Loop**

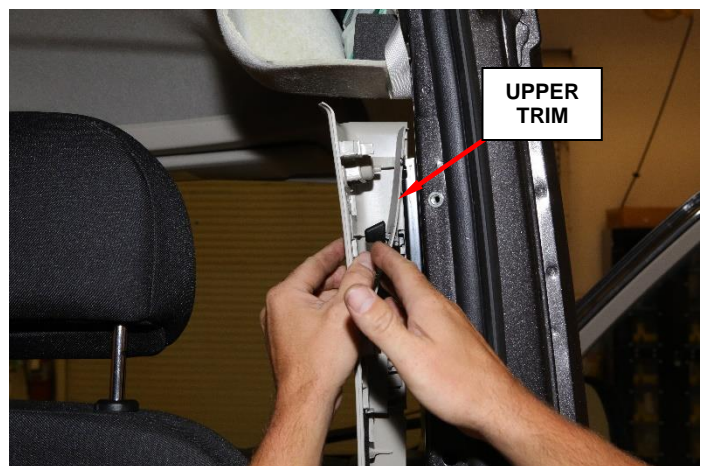
**Figure 17 – Upper Trim**

16. Install the upper trim onto the inside of the B-pillar (Figure 17).

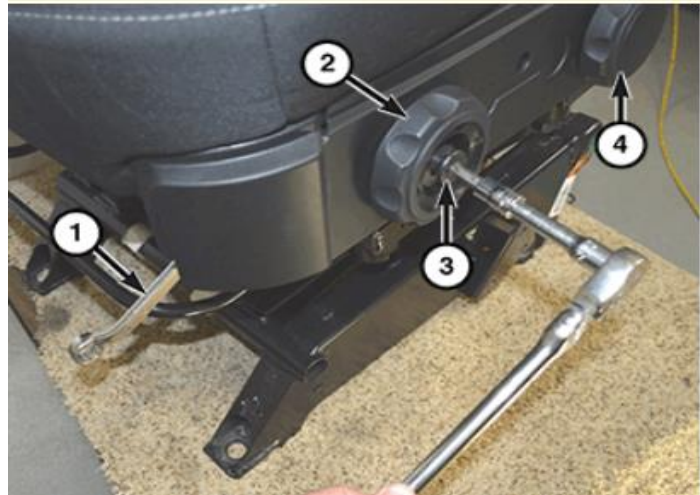
**Figure 20 – Bolt Removal**

4. Use the proper sized wrench (1) to hold nut under the seat, then remove the bolt (3) (Figure 20).

5. Pull off the front adjuster handle (2). Remove the rear adjuster handle (4) the same way (Figure 20).

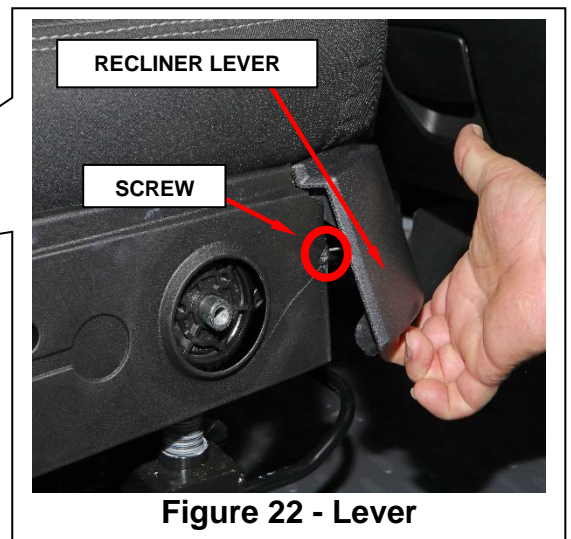
**Figure 22 - Lever**

**NOTE:** Pull up on the recliner lever to gain access to screw (Figure 22).

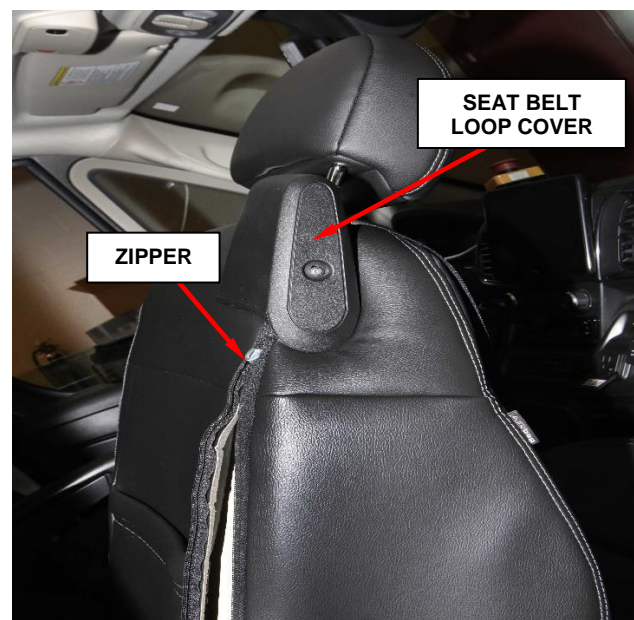
**Figure 24 – Seat Cover Zipper**

8. Place the seat back into the full forward position and release the side zippers (Figure 24).
9. Release the lower J-clip retainers then remove the cardboard backer panel.
10. Remove the screw and seat belt loop cover (Figure 24).

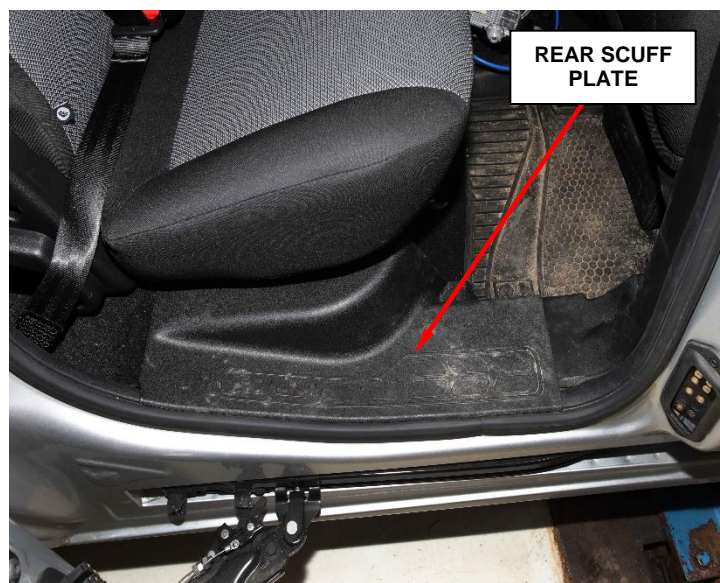
**Figure 27 – Rear Scuff Plate**

4. Remove the rear scuff plate (Figure 27).

24. Install the lower trim onto the inside of the B-pillar.
25. Install the screws securing the B-pillar.
26. Install the front and rear scuff plates (Figures 29 and 30).

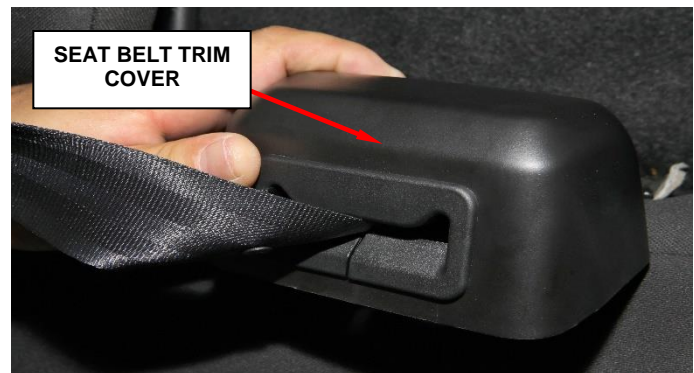
1. Tip the left rear seat forward.
2. Remove the screw that secures the center rear seat belt lower anchor plate to the outboard side of the bracket on the seat cushion frame (Figure 33).
3. Restore the left rear seat back to an upright position.
4. Remove the trim cover from the top of the left rear seat back and from the center seat belt webbing (Figure 34).
5. Unzip the right side and left side trim cover and release it from the back frame to access the rear center seat belt retractor (Figure 35).

**Figure 33 – Rear Seat**

**Figure 34 – Seat Belt Trim Cover**

**Figure 35 – Rear Seat Trim Cover**

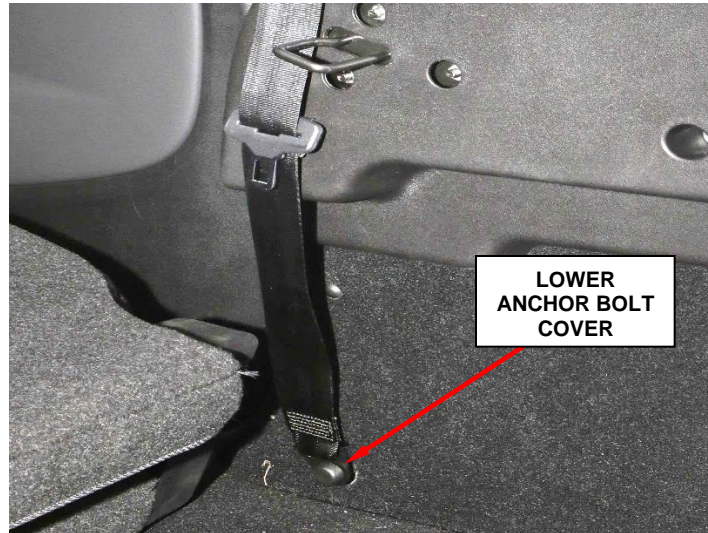
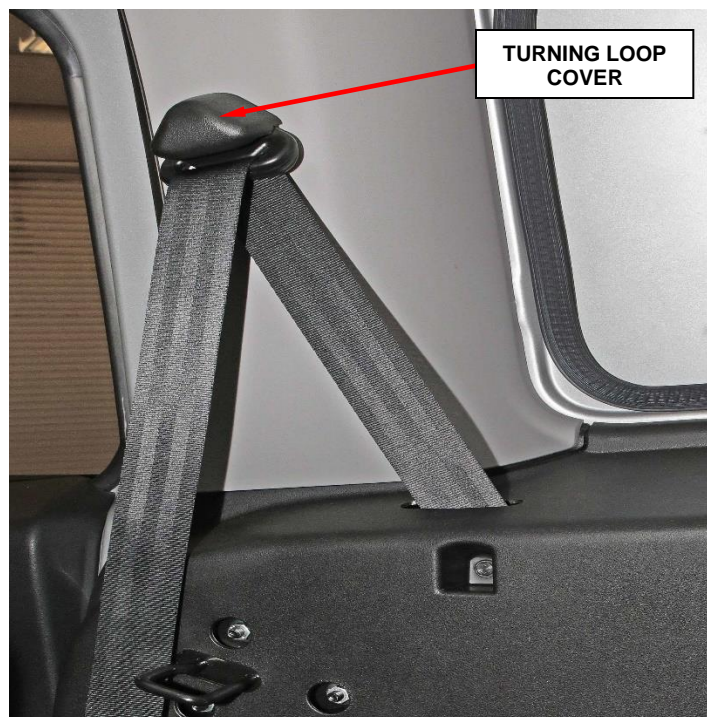
1. Remove the trim cap from the screw that secures the left or right rear seat belt lower anchor plate near the base of the C-pillar (Figure 37).
2. Remove the screw that secures the rear outboard seat belt lower anchor near the base of the C-pillar.
3. Remove the protective cover from over the screw for the seat belt turning loop (Figure 38).
4. Remove the screw that secures the seat belt turning loop to the upper C-pillar.
5. Remove the seat belt turning loop from the upper C-pillar.
6. Remove the trim from the inside of the lower C-pillar.
7. Pull the seat belt webbing, turning loop and lower anchor through the seat belt opening in the lower C-pillar trim.

**Figure 37 – Anchor Screw**

**Figure 38 – Turning Loop**
