Dealer Service Instructions for:

## Safety Recall Y61 / NHTSA 21V-699 Seat Belt Locking Retractor

2021 (VM) Ram ProMaster City  
**2021 (VF) Ram ProMaster**

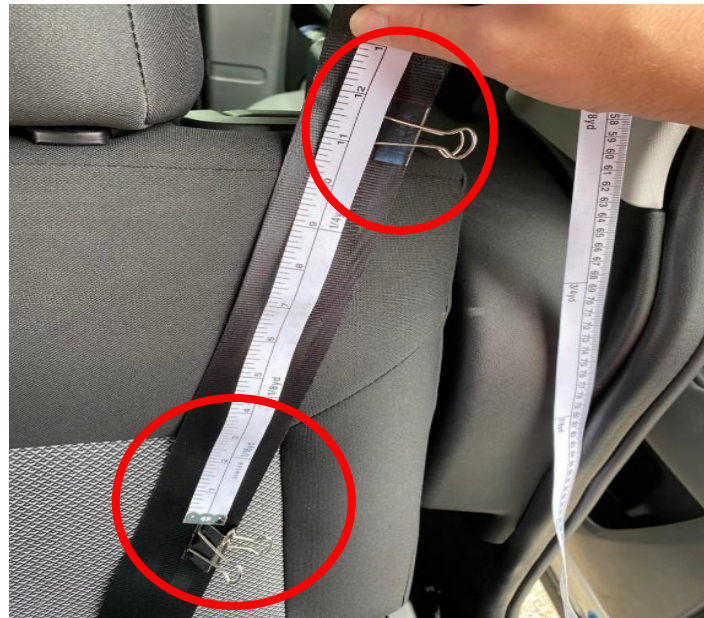
**Figure 3 – Measure Distance**

3. Pull out a small amount of webbing, and place a second binder clip **8 inches (203mm) away for 1st Row or 12 inches (305mm) away in the 2nd Row** to establish your control point for determining if the ALR deactivation is in specification or not (Figure 3).

4. Slowly extract all of the seat belt webbing from retractor until no more webbing will pull out. At this point the ALR mode for securing a child seat will be activated and you will hear an audible ratcheting or clicking noise as the seat belt begins to retract.

5. Slowly allow the seat belt to retract, and after every 1-2 inches of webbing is retracted, gently pull on the webbing to verify the retract is still locked (ALR mode still engaged).

- If the retractor remains in ALR mode (locked - webbing can't be freely extracted) upon reaching the nearest binder clip that was placed on the webbing, then the retractor is OK and is capable of securing a child seat.
  - If the retractor switches out of ALR mode (unlocked - can freely extract webbing) before reaching the nearest binder clip, then retractor is NOK, and must be replaced. Proceed to seat belt replacement procedure section below.
- 
- ✓ Front (Passenger) ALR – Reference Section E, page 21.
  - ✓ Rear Center ALR – Reference Section F, page 28.
  - ✓ Rear Outboard ALR – Reference Section G, page 30.

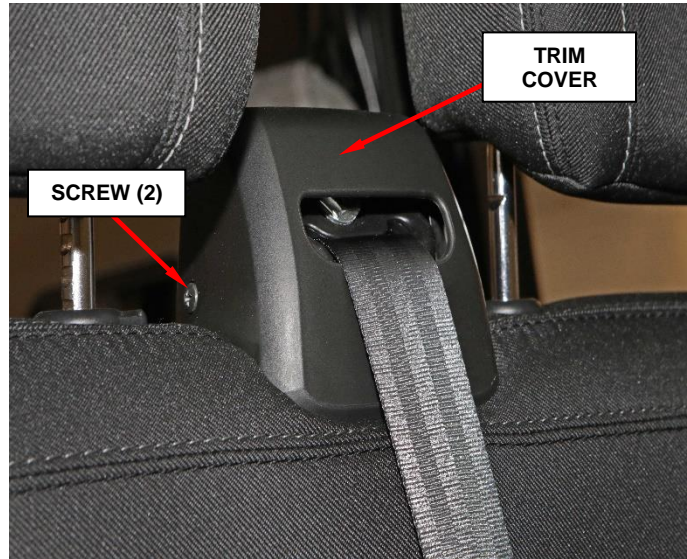
**Figure 6 – Center Seat Trim Cover**

8. Working from the front of the passenger bench seat, pull the seat belt lower anchor up from between the seat back and the seat cushion.
9. Remove the two screws that secure the trim cover to the center seating position seat belt turning loop bracket at the top of the seat back frame (Figure 6).
10. Disengage the seat belt webbing, latch plate and lower anchor from the trim cover.

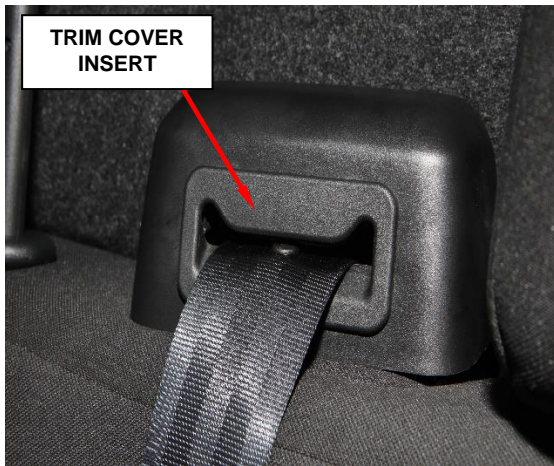
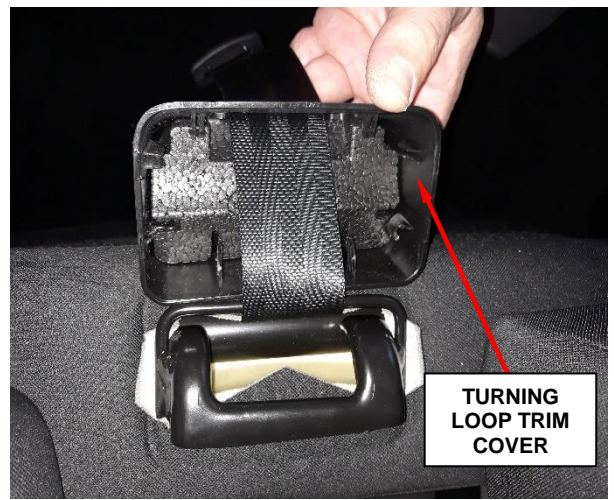
12. Unzip the right center seat cover (Figure 8).
13. Using a trim stick remove the turning loop trim cover and insert (Figure 9).
14. Route the seat belt through the turning loop bracket and down the back of the seat (Figure 10).

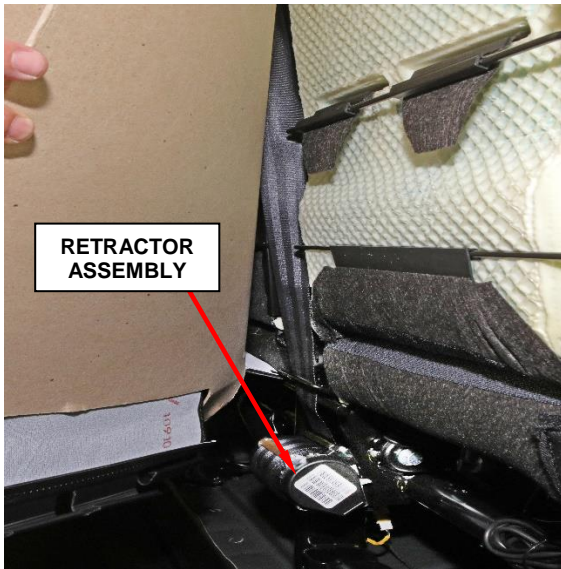
**Figure 11 – Back of Seat**

17. Route the seat belt up the rear seat guide and through the turning loop bracket (Figure 11).

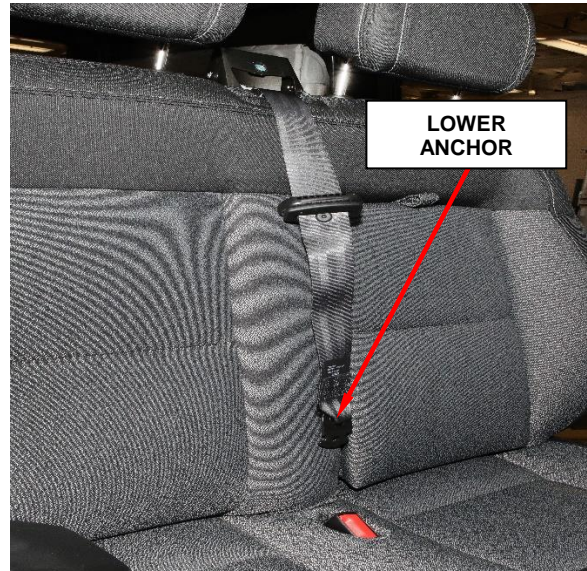
**Figure 12 – Front of Seat**

18. Be certain the seat belt webbing is not twisted between the retractor and the top of the seat back.
19. Install and tighten the bolt that secures the turning loop to the bracket. Tighten the screw to 40 N·m (30 ft. lbs.).
20. Thread the lower anchor, latch plate and webbing through the opening of the trim cover.
21. Position the trim cover over the turning loop bracket at the top of the seat back frame.
22. Install and tighten the two screws that secure the trim cover to the bracket. Tighten the screws securely.
23. Push the lower anchor down between the seat back and the seat cushion. Be certain the seat belt webbing is not twisted between the turning loop and the lower anchor.
24. Working from behind the passenger bench seat, position the retractor to the seat riser frame bracket.

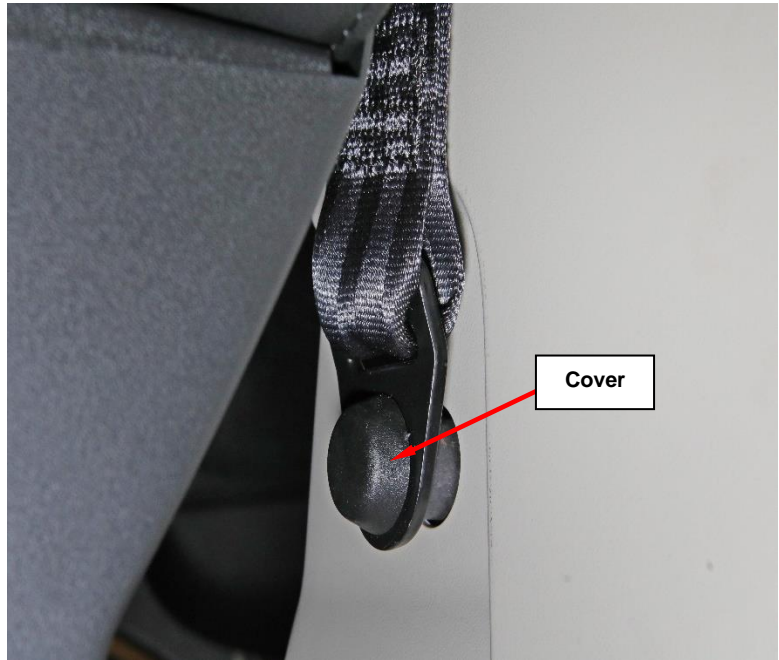
**Figure 14 – Front Seat Lower Anchor**

3. Remove the protective cover from the screw for the outboard seat belt lower anchor (Figure 14).
4. Remove the screw that secures the outboard seat belt lower anchor to the B-pillar.
5. Release and remove the knob from the seat belt height adjuster on the upper B-pillar (Figure 15).
6. Remove the trim cover from the nut for the outboard seat belt turning loop (Figure 15).
7. Remove the nut that secures the seat belt turning loop to the height adjuster on the upper B-pillar (Figure 15).
8. Remove the seat belt turning loop from the height adjuster.

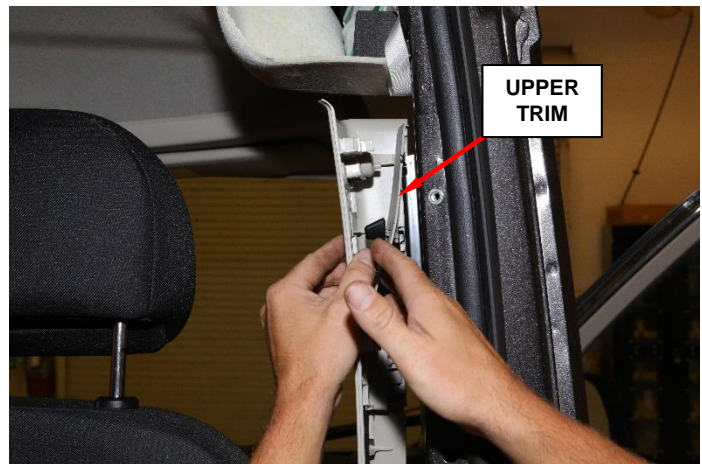
**Figure 17 – Upper Trim**

16. Install the upper trim onto the inside of the B-pillar (Figure 17).

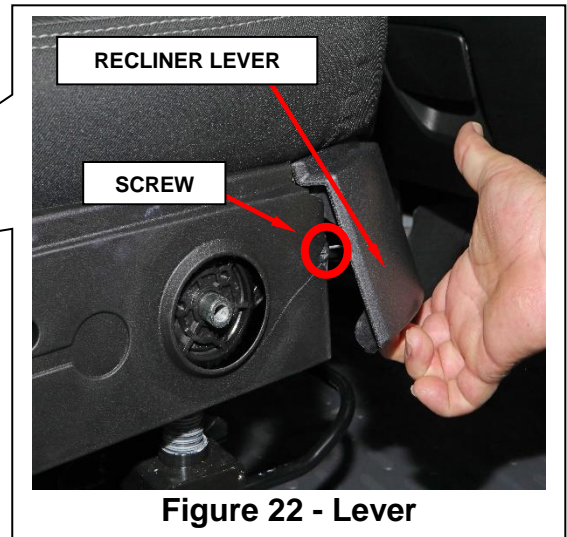
**Figure 22 - Lever**

**NOTE:** Pull up on the recliner lever to gain access to screw (Figure 22).

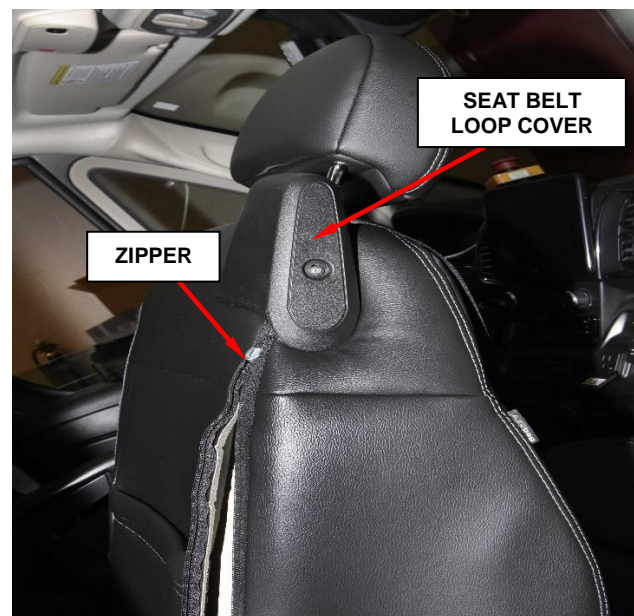
Figure 24 – Seat Cover Zipper

8. Place the seat back into the full forward position and release the side zippers (Figure 24).
9. Release the lower J-clip retainers then remove the cardboard backer panel.
10. Remove the screw and seat belt loop cover (Figure 24).

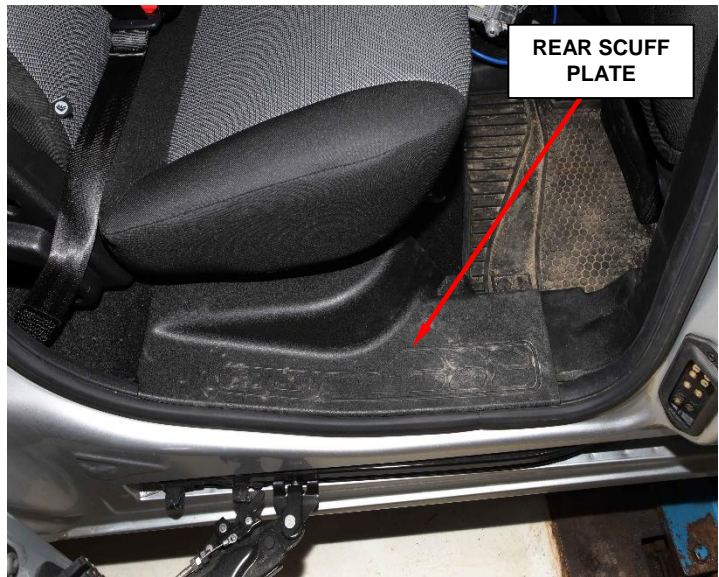
**Figure 27 – Rear Scuff Plate**

4. Remove the rear scuff plate (Figure 27).

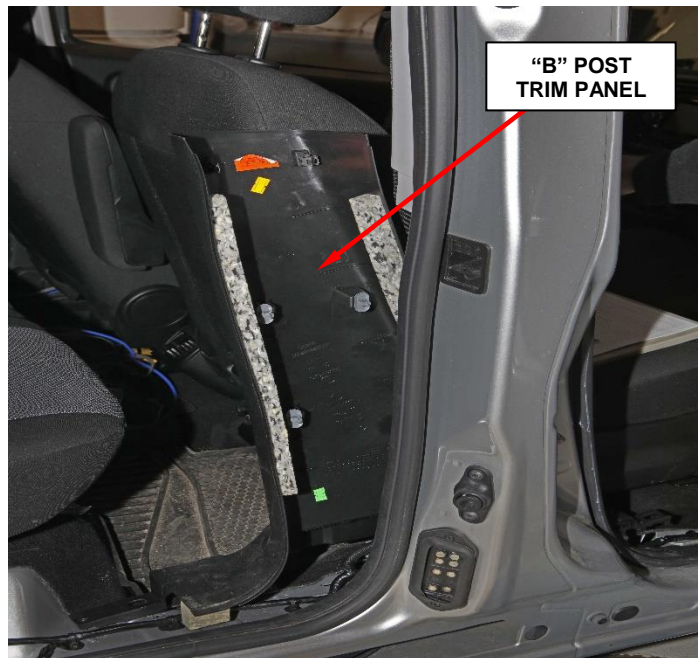
**Figure 30 – “B” Post Trim Panel**

7. Remove the screw securing the front “B” post panel.
8. Remove the trim from the inside of the lower B-pillar (Figure 30).
9. Remove the protective cover from over the nut for the seat belt turning loop.
10. Remove the nut that secures the seat belt turning loop to the height adjuster.
11. Remove the nut that secures the seat belt turning loop to the height adjuster.

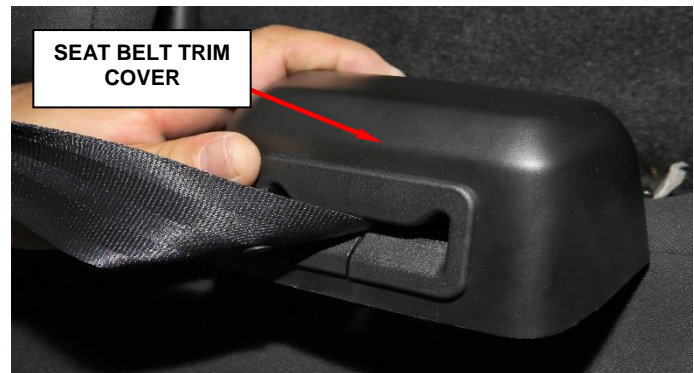
**Figure 34 – Seat Belt Trim Cover**

1. Tip the left rear seat forward.
2. Remove the screw that secures the center rear seat belt lower anchor plate to the outboard side of the bracket on the seat cushion frame (Figure 33).
3. Restore the left rear seat back to an upright position.
4. Remove the trim cover from the top of the left rear seat back and from the center seat belt webbing (Figure 34).
5. Unzip the right side and left side trim cover and release it from the back frame to access the rear center seat belt retractor (Figure 35).
