Safety Recall Code: 47R7

Brake Booster

September 24, 2021

Section B - Repair Procedure

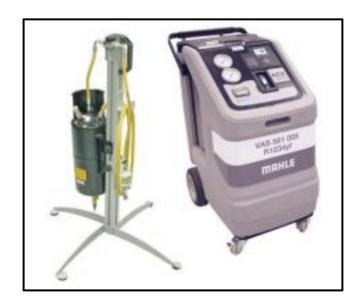
Evacuate A/C system:

- Perform the procedure as described in the A/C Service Station Owner's Manual.
- The quantity of refrigerant oil in the A/C Service Station is checked and if necessary corrected.
- The refrigerant quantity in the A/C Service Station is checked and if necessary corrected.
- For more information, refer to the Repair Manual:
 - ELSA Repair Manual: Repair manual
 Heating, Ventilation & Air
 Conditioning > Refrigerant R1234yf
 Servicing

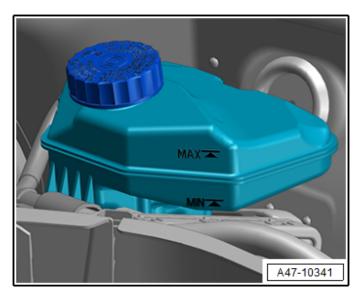
Fill the brake fluid:

Fill the brake fluid reservoir up to the "MAX" mark.
