RECALL 21V724. 2021-578 REMEDY INSTRUCTIONS

Make(s): Alta Travel Trailer
Model(s): Many, See Below
Model Year(s): 2022

Concern:
The LP Gas quick disconnect fitting installed onto the exterior grill by Forest River is not tight, allowing for LP Gas to leak.

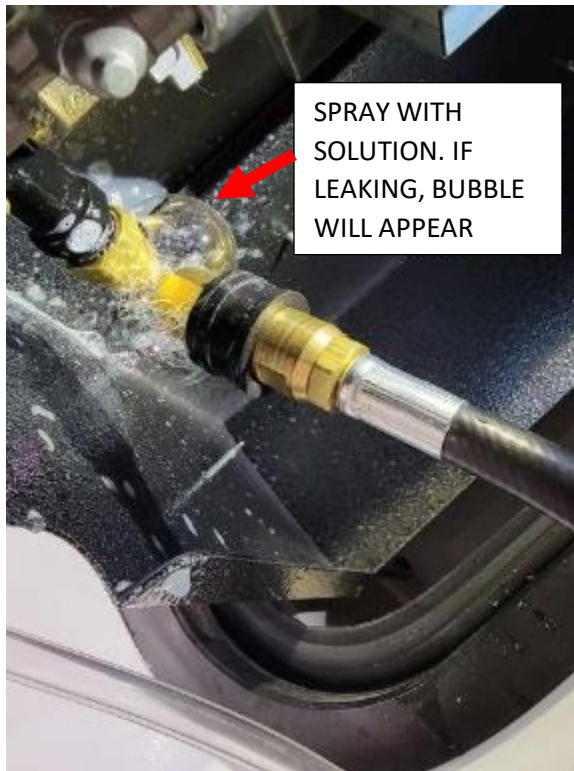
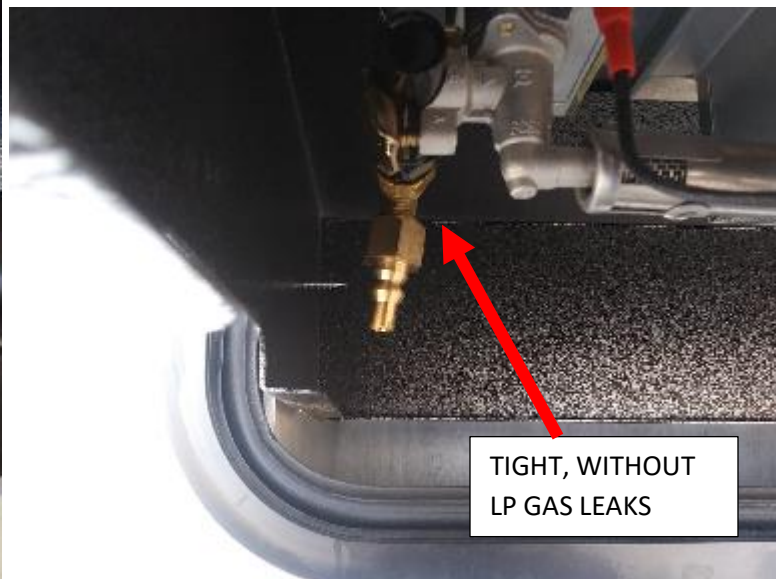
STEP 2: DETERMINE IF THE LP GAS QUICK DISCONNECT IS LOOSE;

- CONNECT THE PROVIDED LP GAS HOSE TO THE QUICK DISCONNECT UNDER THE TRAILER
- CONNECT THE OTHER END OF THE PROVIDED LP GAS HOSE TO THE EXTERIOR GRILL
- TURN ON THE LP GAS SUPPLY AND OPEN THE BOTH QUICK DISCONNECT VALVES
- SPRAY WITH SOAPY WATER OR ANOTHER LP GAS LEAK DETECTOR FLUID
- VERIFY THE LP QUICK DISCONNECT ON THE EXTERIOR GRILL IS POINTED VERTICALLY DOWN

STEP 3: IF THERE IS LEAKING LP GAS, REPAIR THE FITTING;

- TIGHTEN THE QUICK DISCONNECT THAT IS ATTACHED TO THE EXTERIOR GRILL
- VERIFY THE LP QUICK DISCONNECT ON THE EXTERIOR GRILL IS POINTED VERTICALLY DOWN
- SPRAY WITH SOAPY WATER OR ANOTHER LP GAS LEAK DETECTOR FLUID UNTIL THERE ARE NO BUBBLES PRESENT THAT INDICATE A LEAK
