# Product Safety Recall

## N212349040 Driver Front Airbag Inflator May Rupture

**Release Date:** February 2025

**Revision:** 03

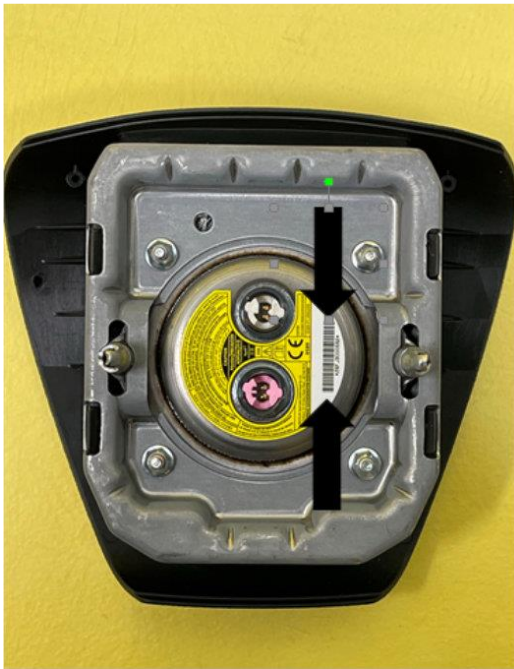
6524631

**Important: (TECHNICIAN and WARRANTY ADMINISTRATOR) SERIAL NUMBER RECORDING REQUIREMENT.** The replacement steering wheel airbag serial number must be captured by the technician and recorded on the job card. The Warranty Administrator **MUST** enter the serial numbers in GWM (Global Warranty Management) or in DMS (Dealer Management System). Enter the serial number of the **replacement airbag** in the 'Labor Operation Dependency Code' field per the screen shown.

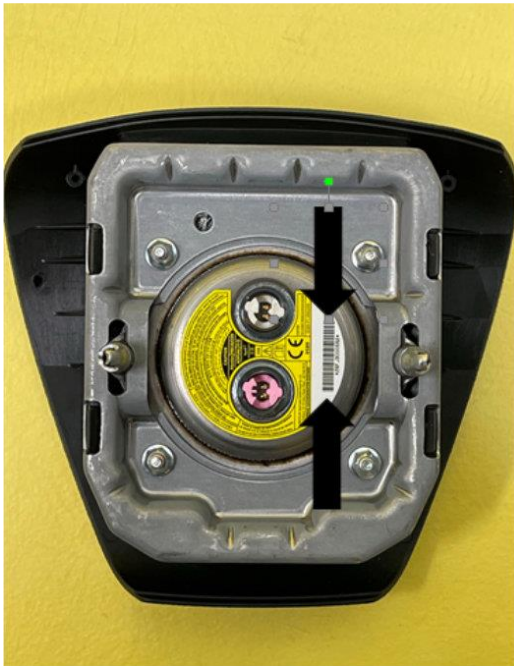
6524631

**Note:** DO NOT SCAN THE QR CODE ON THE SIDE OF THE AIRBAG MODULE. SCAN THE INFLATOR SERIAL NUMBER BARCODE ON THE BACK OF THE AIRBAG MODULE AS PICTURED ABOVE.

**Note:** Scanning the Inflator Serial Number Barcode will not populate all fields within the CSMT app. THE REMAINING FIELDS ARE NOT REQUIRED FOR THIS FIELD ACTION.

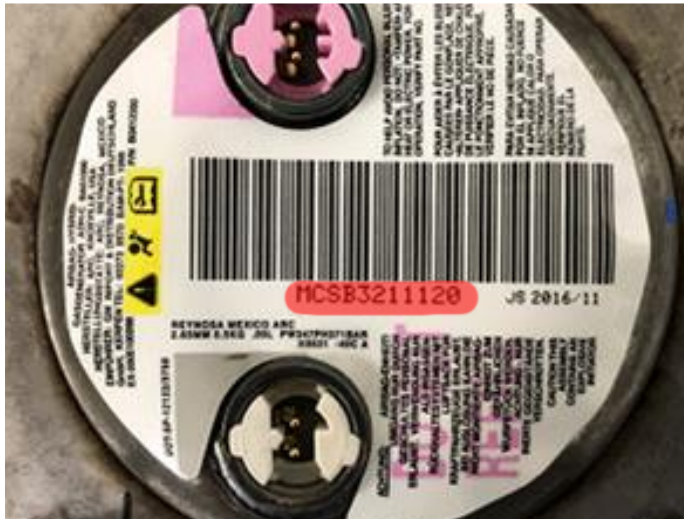
5948574

**Note:** The removed steering wheel airbag module **MUST** be defaced on the airbag cover (customer facing side) with a paint pen or permanent marker to prevent it from being reused.

1. Remove the steering wheel airbag assembly. Refer to *Steering Wheel Airbag Replacement* in SI.
2. Record the serial number of the removed Steering Wheel Airbag.
3. Record the serial number of the New Service Steering Wheel Airbag.
4. Replace the steering wheel airbag assembly. Refer to *Steering Wheel Airbag Replacement* in SI. **Do Not Deploy the AIRBAG.**

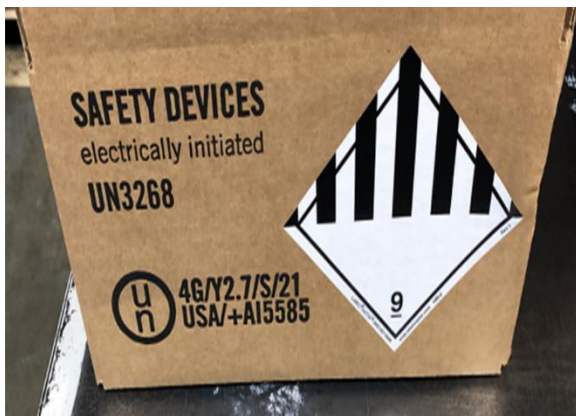
6817433

- Confirm box is in an acceptable condition. Box should have no visible signs of damage and should be capable of withstanding additional transportation.

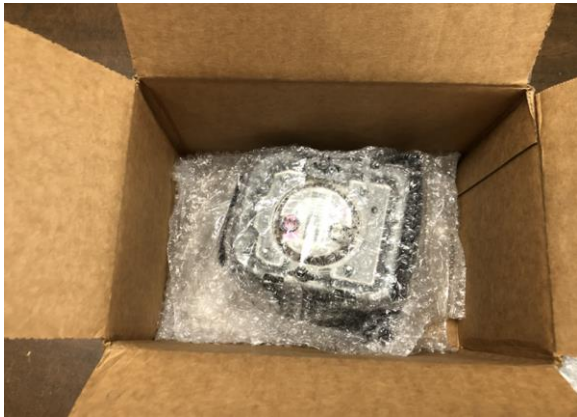
6787552

- Place the undeveloped airbag inflator or module in the “cradle” of the box insert.

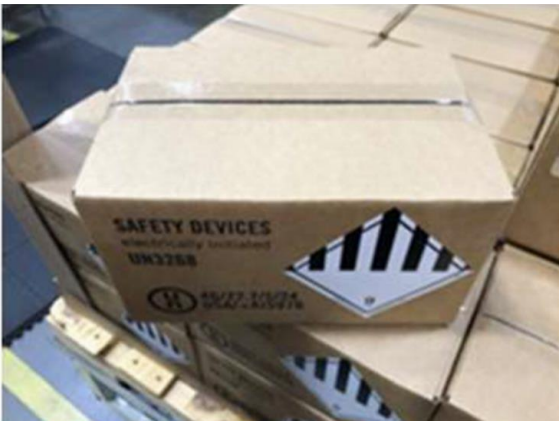
6787553

- Close the top box flaps using a piece of shipping tape to fully and securely close the box.

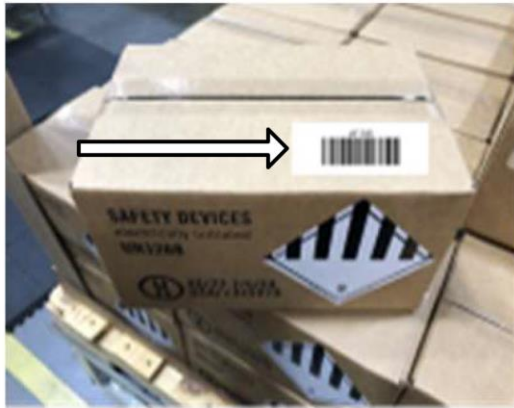
6787556

- Cut and affix the printed “New Leaf Label” to each box as shown in the above graphic. DO NOT COVER THE CLASS 9 MARKING.

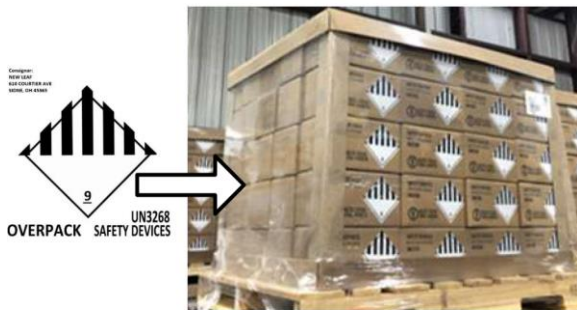
6787558

- Arrange the airbag modules on a pallet in acceptable condition as the above graphic illustrates.
  - 20 boxes per layer – 5 rows / 4 boxes in each row per layer.
  - 5 layers total per pallet (100 Boxes).
- Shrink-wrap the boxes to the pallet.
- Affix the over-pack label and pallet label on the side of the pallet. DO NOT PLACE THESE LABELS ON THE TOP OF THE PALLET.
- If 100 boxes have not been accumulated within a 2-week period, ship a partial pallet, ensuring proper label placement and packaging.
