# RECALL CAMPAIGN BULLETIN

EL21-016

## VOLUNTARY SAFETY RECALL CAMPAIGN 2017-2019 ROGUE HYBRID; ENGINE ROOM HARNESS PROTECTOR

**CAMPAIGN ID #:** R21B6**APPLIED VEHICLES:** 2017-2019 Rogue Hybrid (T32H)

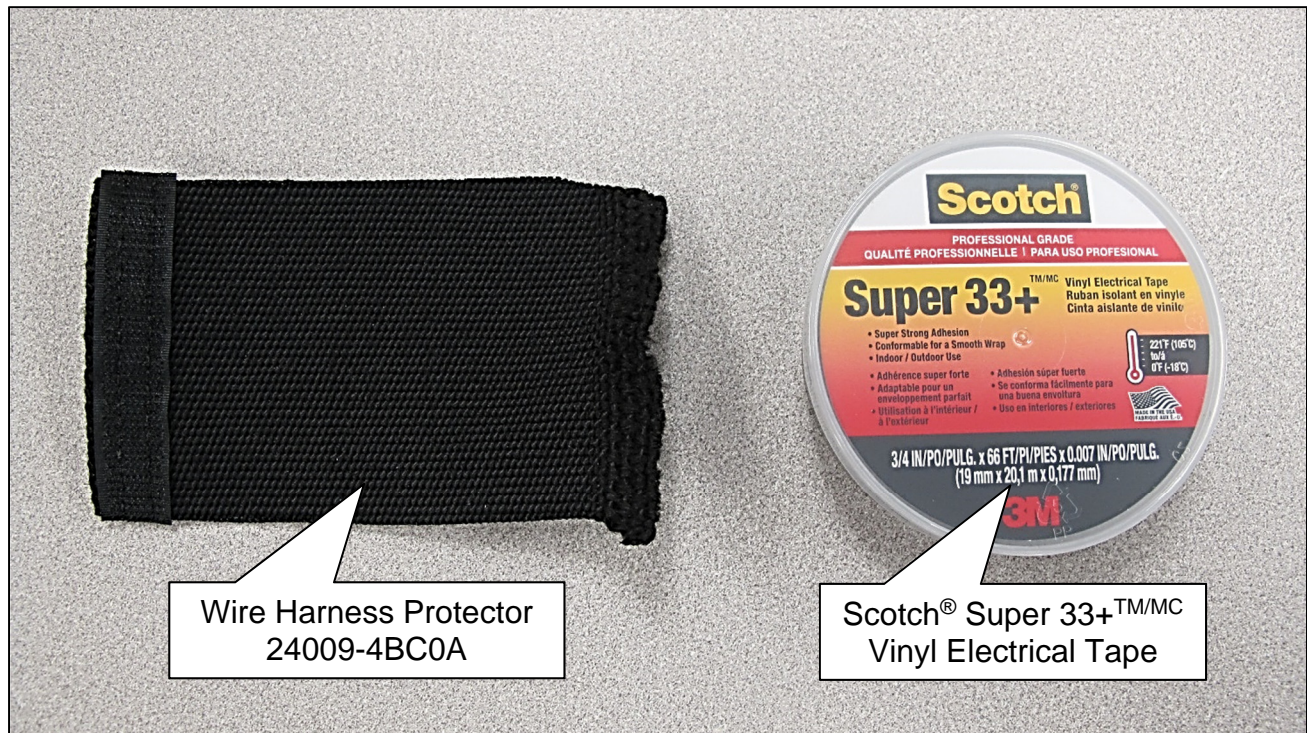
Figure 1

Wire Harness Protector 24009-4BC0A

Scotch® Super 33+<sup>TM/MC</sup> Vinyl Electrical Tape

- This is the only tape approved to perform this repair. Do not substitute this vinyl electrical tape for any other tape.
- This vinyl electrical tape is widely available from most home centers, hardware stores, industrial supply stores, and large box stores.
