Safety Recall

Code: 74E3

Audi

Subject Passenger Occupant Detection System (PODS)

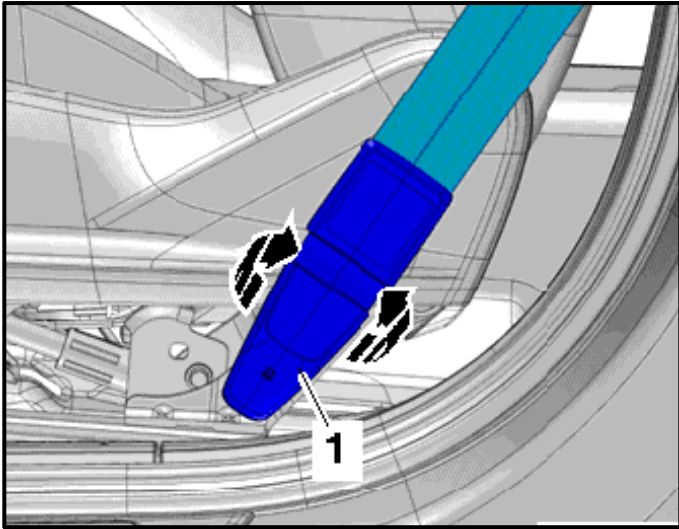
Remove belt end fitting:

- Unclip the cover <1> on the belt relay <arrows> and fold it upward.

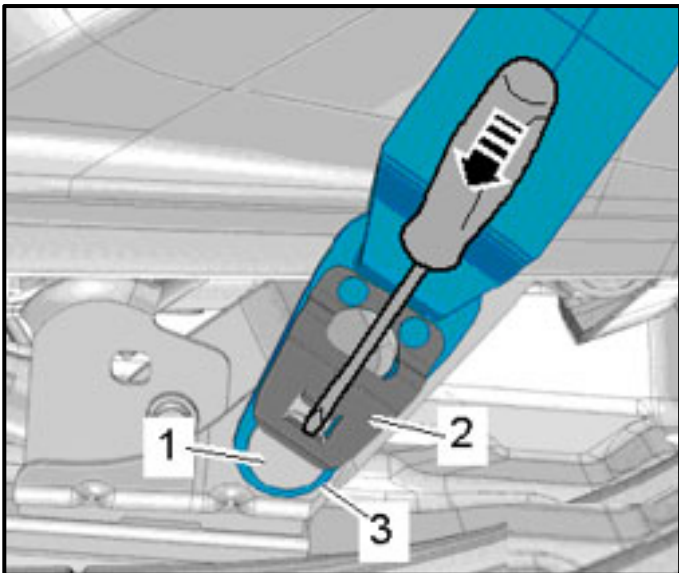
- Release the spring catches <2> by inserting a small screwdriver in the opening in the spring <arrow>.
- Slide the belt end fitting <3> downward and disengage at the pin <1>.

- The spring <2> can bend if removed incorrectly. Replace the three-point seat belt if the spring is bent or distorted. Damage to the seat belt is not covered under this action.
- Only move the spring <2> far enough to unlock the tab on the spring. Do not overextend the spring.

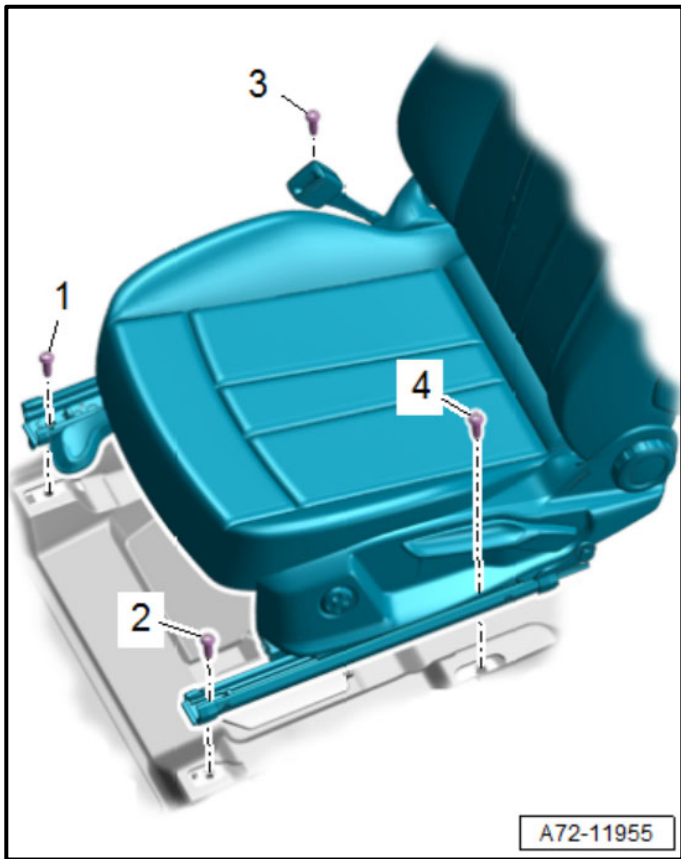
Remove passenger front seat:

- Push the headrest into the lowest position.
- Move the front seat all the way forward and up.
- Remove rear bolts <3 and 4> from the seat rail.
- Move the front seat all the way to the rear in its highest position.
- Remove the front bolts <1 and 2> from the seat rail.

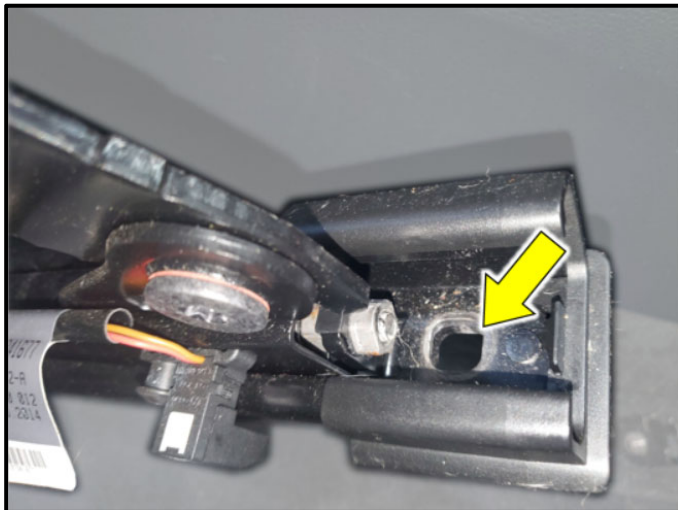
Position seat for removal:

- Move seat to its highest position.
- Move seat toward the rear so the front hole <arrow> for the seat frame bolt can be accessed (as shown).
- Ensure the rear holes for the seat frame bolts can also be accessed.
- Disconnect the connectors from the connector station in the floor. Connect the Airbag Lockout Adapter -VAS6282- to the thorax airbag connector.

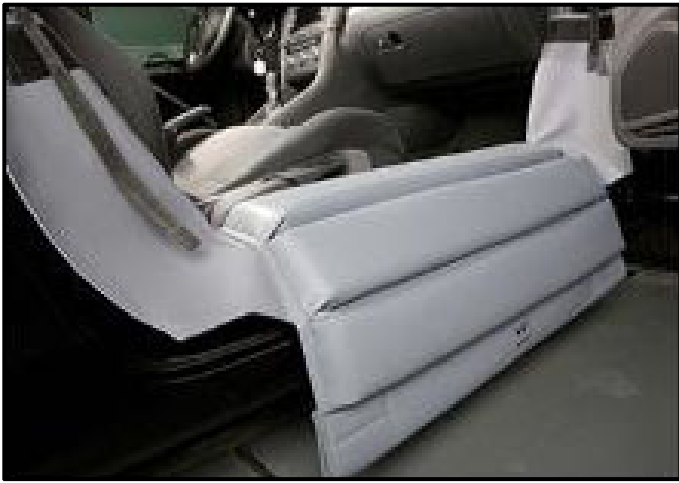
Install -VAS871001-:

- To protect the sill panel before removing the front seat, install the Universal Vehicle Protector -VAS871001- <as shown>.
- Carefully remove the front seat from the vehicle.

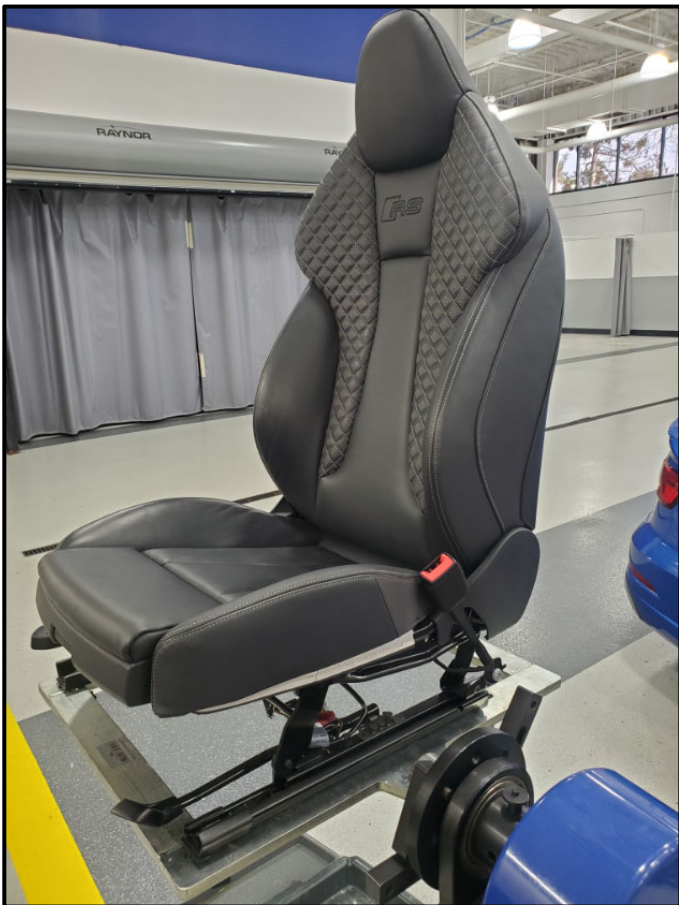
Attach seat to -VAS6136-:

- Attach the Seat Repair Fixture -VAS6136- to the Engine and Transmission Holder -VAS6095-.
- Fasten the front seat onto the Seat Repair Fixture -VAS6136-.

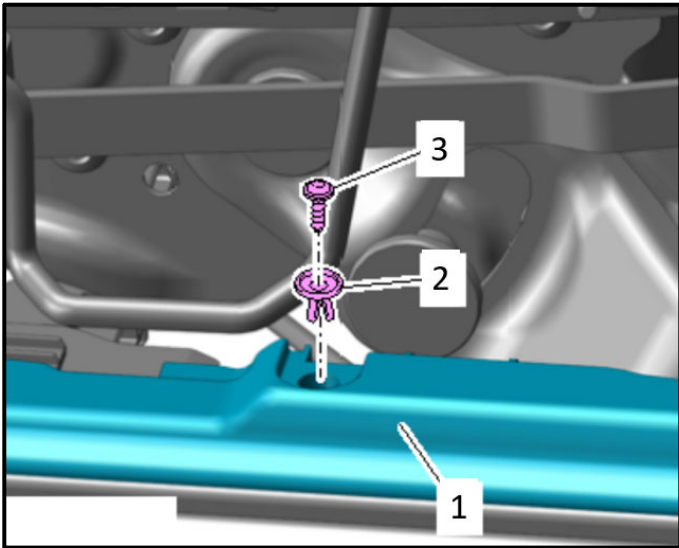
Remove seat rail trim:

- Move the front seat into its highest position.
- Remove the threaded stud <3> and remove the expanding clip <2> from the center seat rail cover <1>.

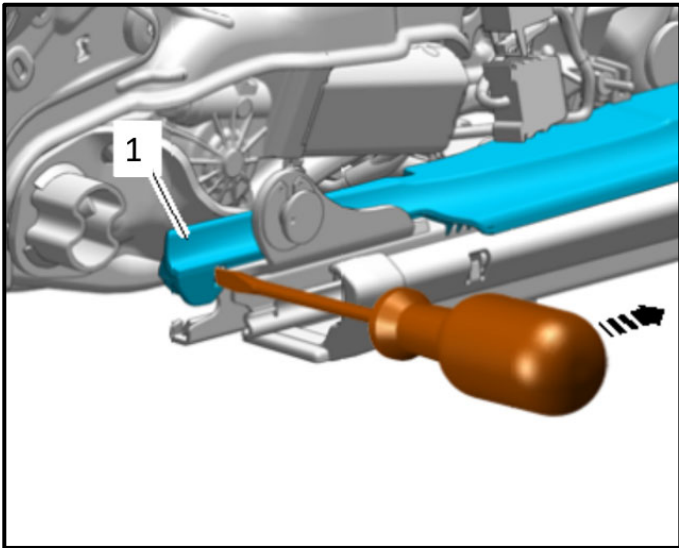
- Carefully release the rear hooks on the seat rail using a screwdriver <arrow>.
- Slide the center seat rail cover <1> in the direction of travel and remove it.

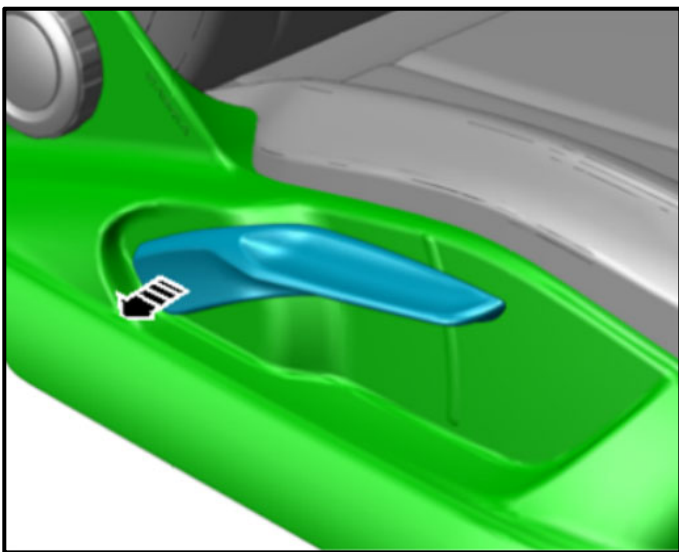
Remove seat height adjuster handle (MANUAL seats):

- Move the front seat all the way forward and up.
- Remove the handle for the seat height adjustment to the side from the seat <arrow> using the -3409-.

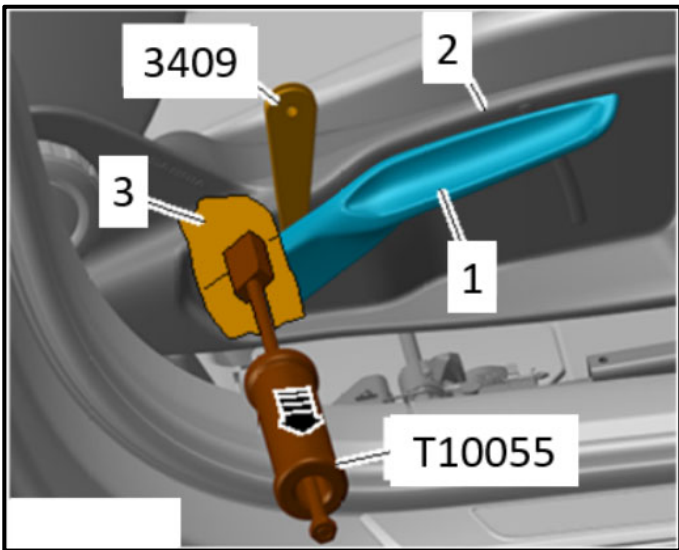
- Slide the <3409> between the handle <1> and the seat side trim <2>.
- To protect the seat side trim, place a cloth <3> between the trim panel and -T10055- before positioning the tool.
- Position the -T10055- as shown on the lever and remove the lever from the seat <arrow>.

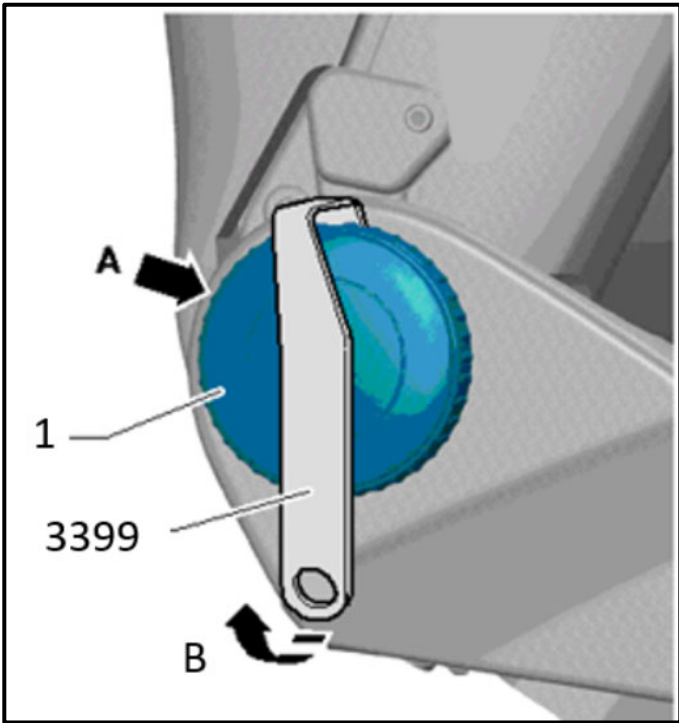
Remove backrest adjustment hand wheel (MANUAL seats):

- Turn the seat back adjustment wheel <1> until one catch is visible from behind <arrow A>. Use a flashlight if necessary.
- Using the Assembly Tool -3399-, carefully pry the adjustment wheel off the seat <direction of arrow B>.
- Turn the seat back adjustment wheel 120° further and repeat the process.
- Remove the seat back adjustment wheel.

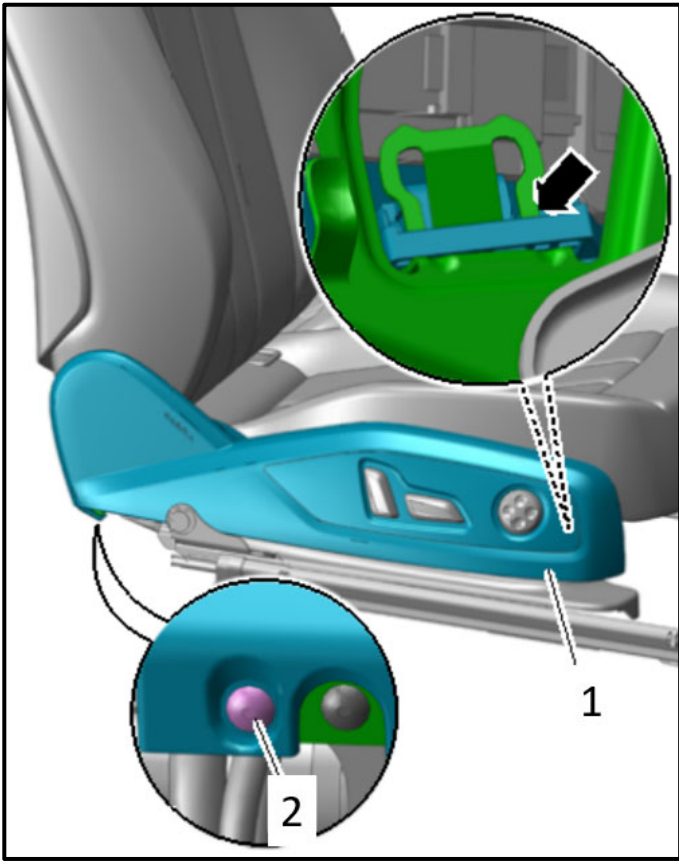
Remove sill side seat trim (standard/sport seat):

- Remove the expanding rivet (or bolt) <2>.
- Disengage the inner front bracket <arrow> on the seat side trim upward.
- Pull out the seat side trim <1> upward.
- Bend tab <arrow> back to its original position.

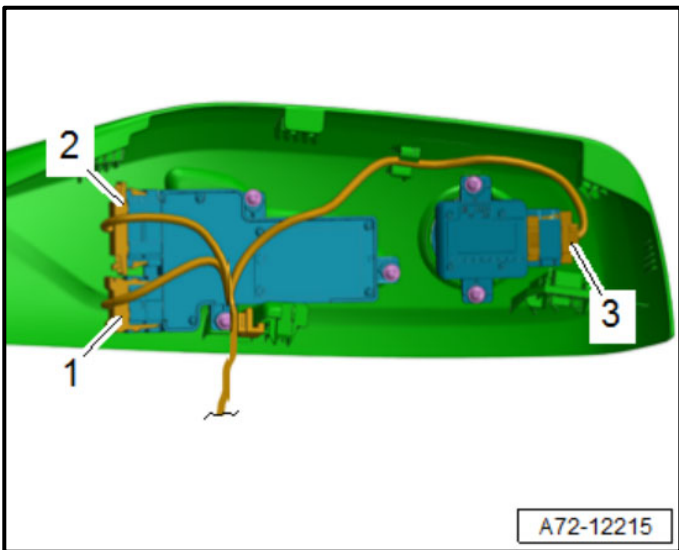
- Equipped on some models: disconnect the connectors:
 <1 and 2>: Front Passenger Seat Adjustment Control Head -E471-
 <3>: Front Passenger Seat Switch Module -E664-
- Free up the wiring harness.
- Remove the seat side trim on side sill side.

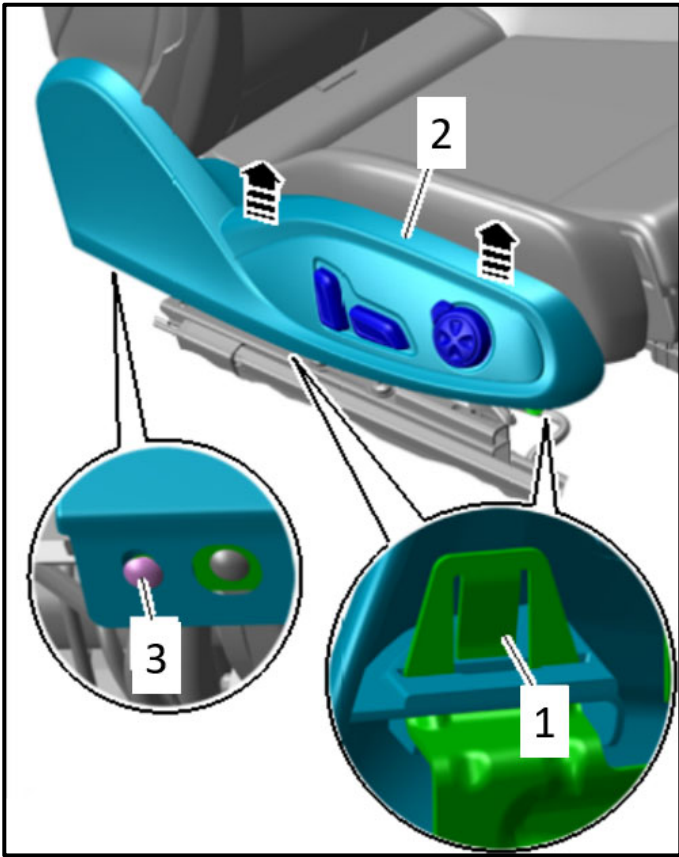
Remove sill side seat trim (standard/sport seat):

- Remove the expanding rivet <3> from the seat side trim on side sill side.
- Release the hook <1> using a screwdriver and remove the seat side trim.
- Remove the seat side trim <2> upward from the brackets <arrows>.
- Disengage the rear seat side trim on side sill side from the backrest hinge and the seat pan.
- Bend tabs <1> back to their original position.

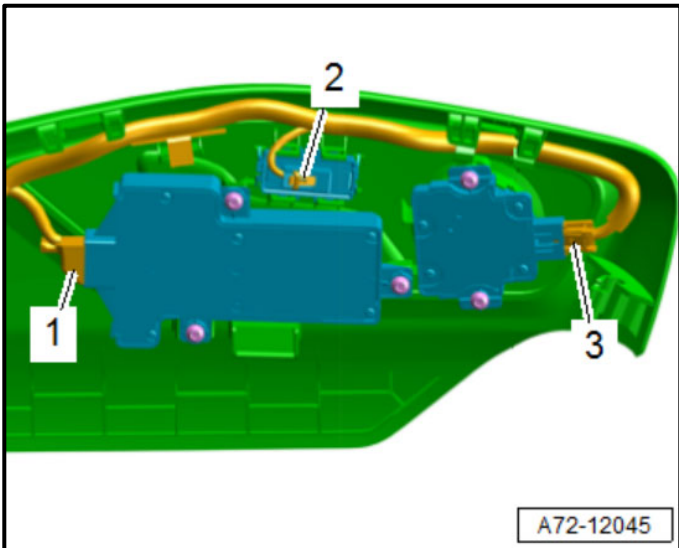
- Disconnect the connectors:
 - <1> Front Passenger Seat Adjustment Control Head -E471-
 - <2> Front Passenger Massage Function Button -E671-
 - <3> Front Passenger Seat Switch Module -E664-
- Free up the wiring harness.
- Remove the seat side trim on side sill side.

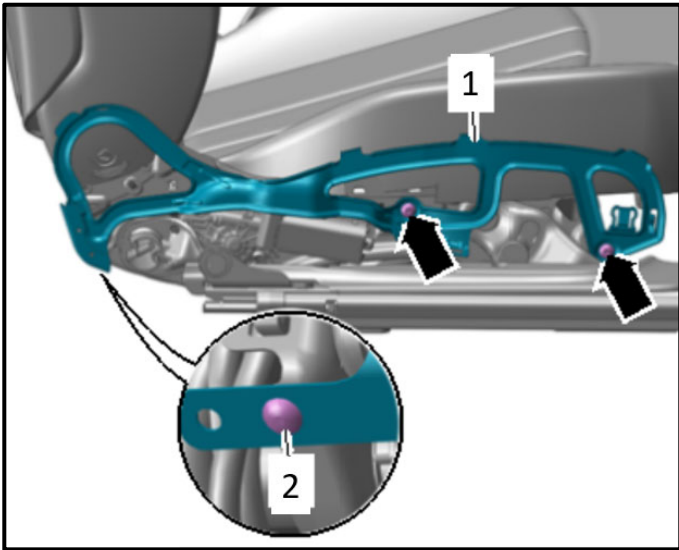
Remove seat trim bracket:

- Remove the expanding rivet (or bolt) <2>.
- Remove the bolts <arrows> and the bracket <1>.

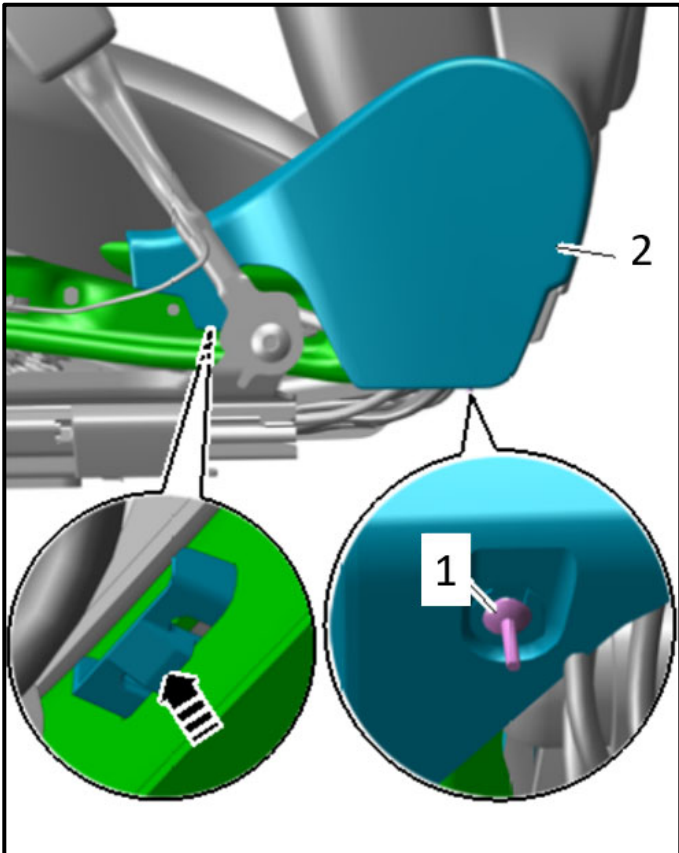
Remove tunnel side seat trim:

- Remove the expanding rivet <1>.
- Press down the tab <arrow> at the inside of the seat rail.
- Remove the seat side trim on the tunnel side <2>.

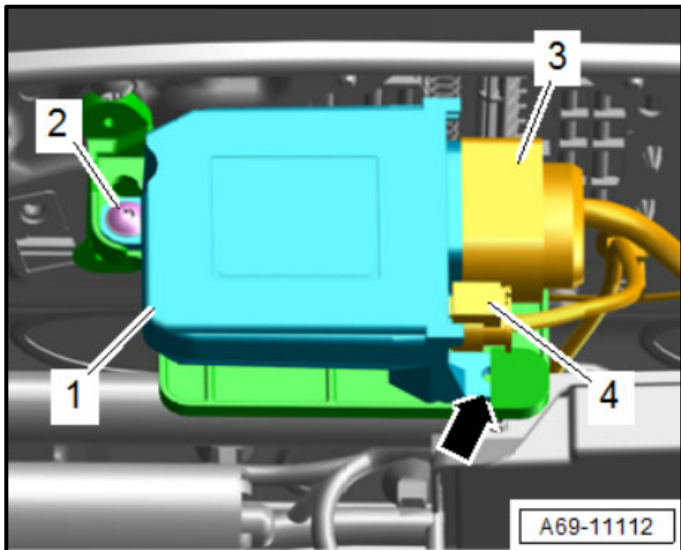
Remove PODS Control Module:

- Remove the bolt <2>.
- Disengage the control module <1> from the bracket <arrow>.
- Disconnect the connectors <3 and 4> from the control module by pressing the release.
- Set the PODS control module aside.

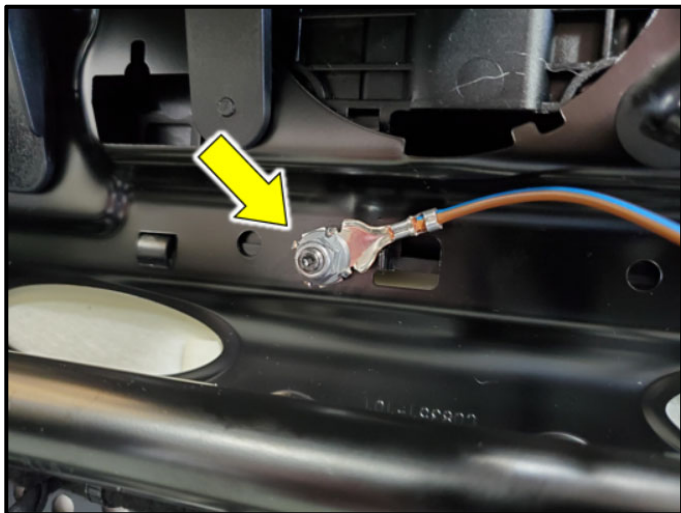
Free up wiring harness:

- Loosen nut <arrow> and free up the wire.

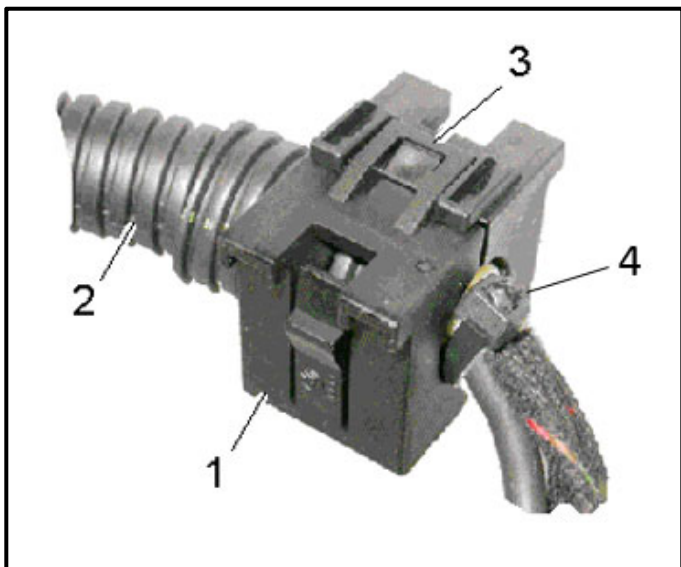
- Unclip lock <3> and open the front cable holder <1>.
- Remove the cable holder from the corrugated tube <2>.
- Cut cable tie <4>.

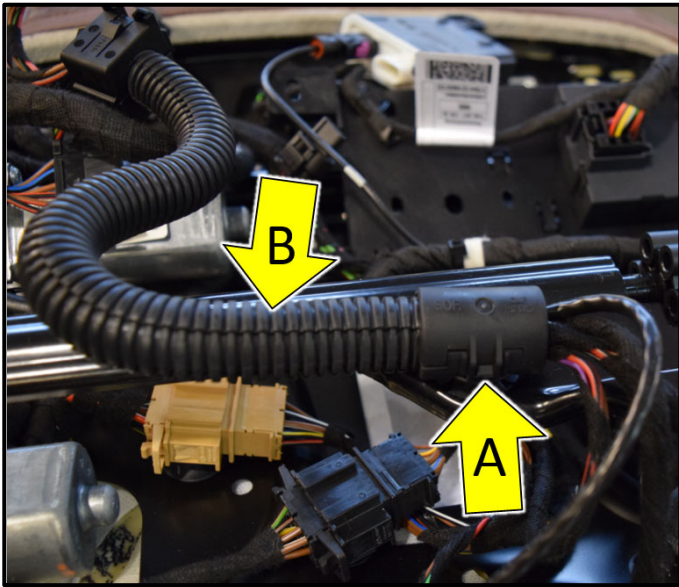
- Using a small, flat-blade screwdriver (or equivalent), open the rear wiring bracket <arrow A>.
- Remove the corrugated tube <arrow B> from the bracket.
- Remove the outer corrugated tubes from the wiring harness.

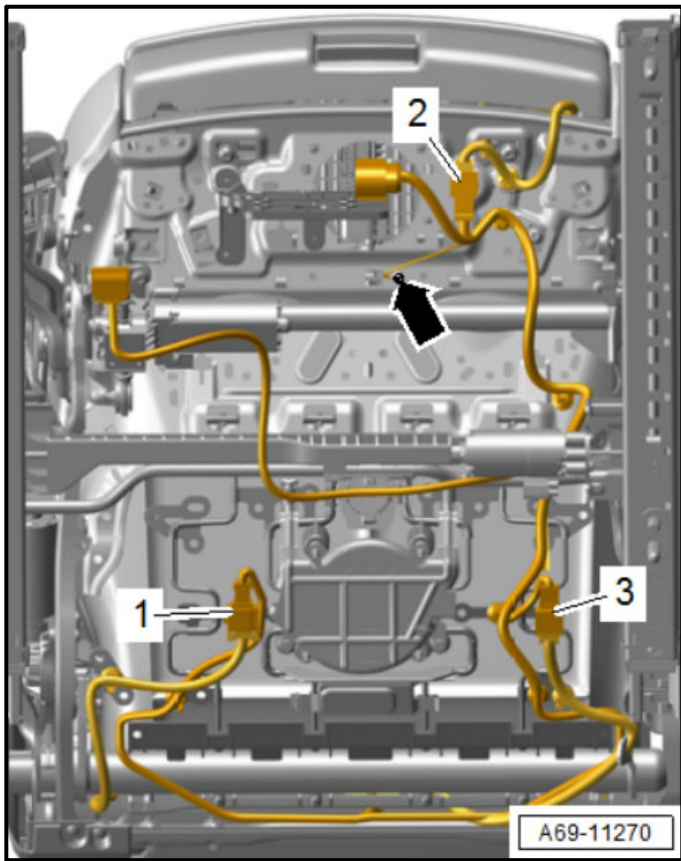
- Disconnect the connectors <1, 2 and 3>.
- Unclip and free up the wiring harness from the seat pan.

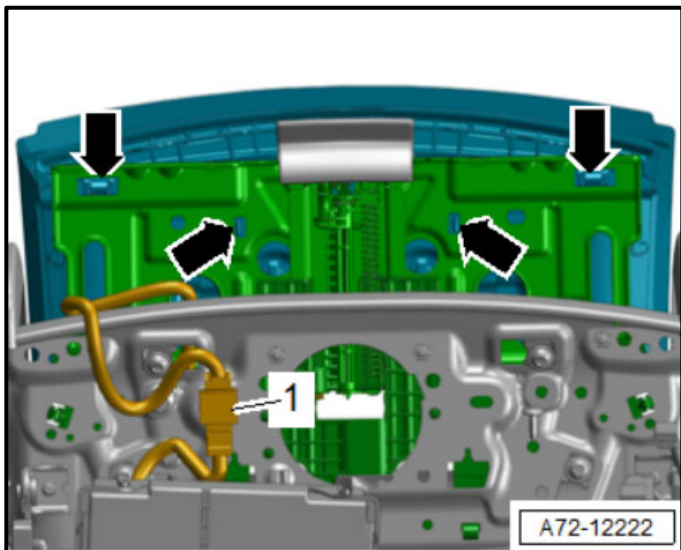
Disengage seat depth adjuster cushion (if equipped):

- Disconnect the connector <1>.
- Release the hooks <arrows>, and fold the retaining plate with cushion and cover toward the rear.
- Pay close attention to the routing of the wiring harness.

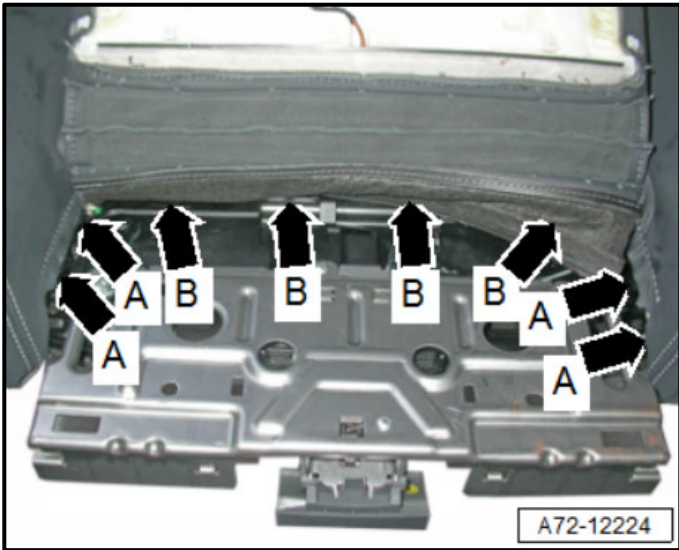
- Disengage the contour wire on the left and right side from the hooks <A arrows>.
- Using the -T40207- or -3370-, disengage the cover clamping strip from the hooks <B arrows>.

- Proceed very carefully when clipping and unclipping.
- Gently pulling the molding out of the tabs parallel with the seat frame in the direction of <arrow>, will prevent damage to the tabs.

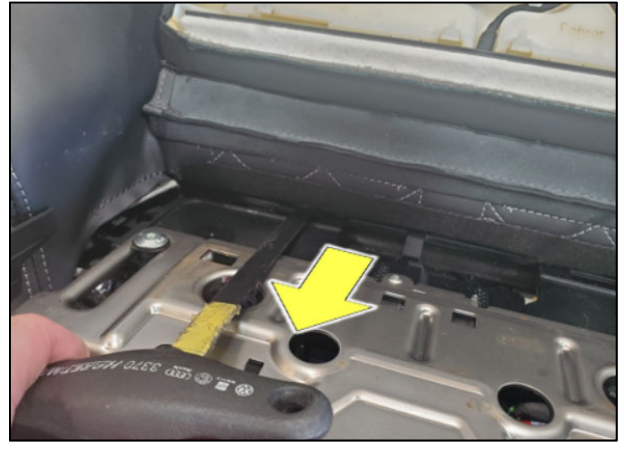
There is a risk of damaging the tabs.

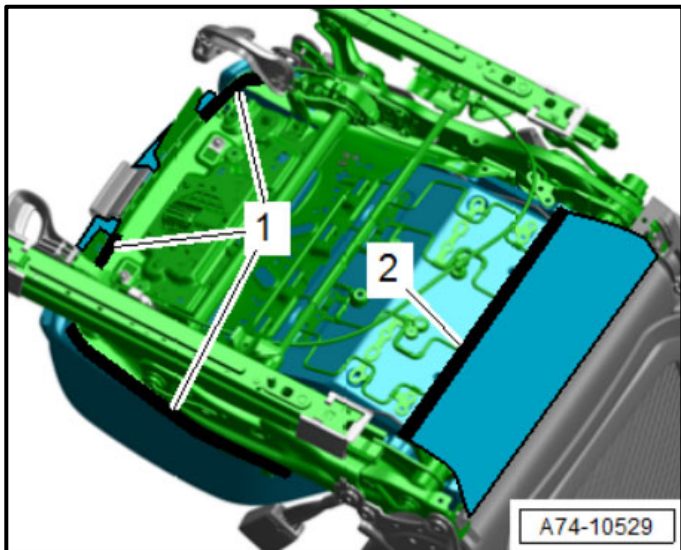
Disengage seat cover from seat frame and remove seat cushion (Super Sport seat):

- Disengage the cover molding <1> in the front and side area using the Backrest Panel Tool -3370-.
- Disengage the molding <2> on the cover at the back using the Backrest Panel Tool -3370-.

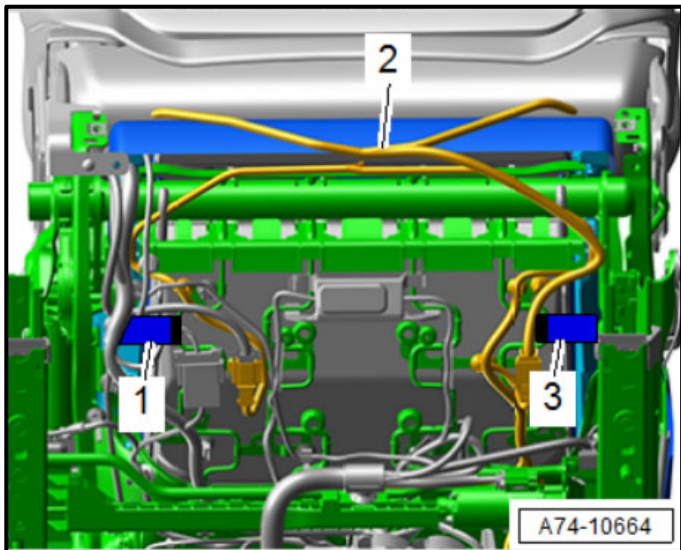
- Disengage the tabs <1 and 3> from the bottom of the seat pan.
- Equipped on some models: disconnect the connector for seat bolster heating and free up the wires <2>.

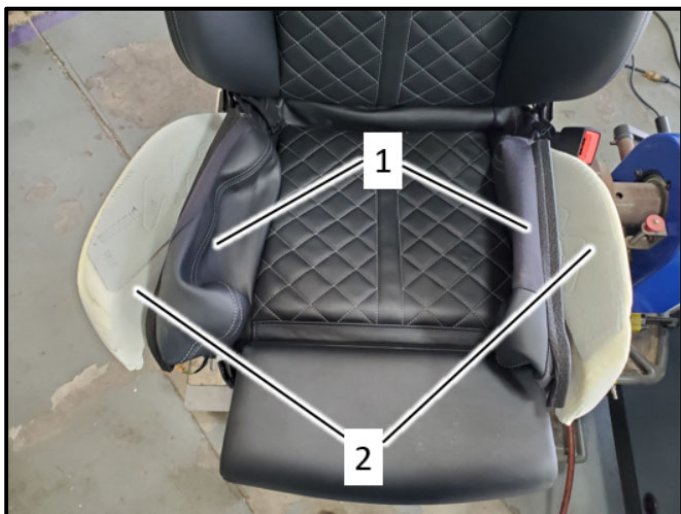
- Remove seat covering <1> from side bolsters <2>.

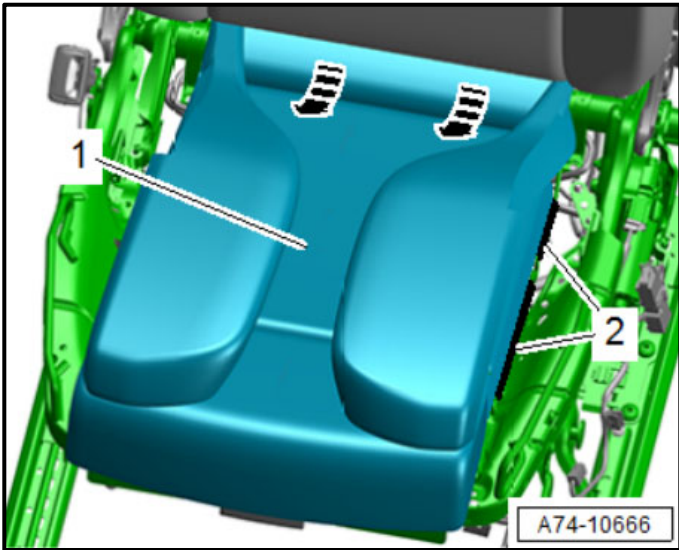
- Disengage the molding <2> at the bottom of the bracket on the seat pan.
- Repeat this procedure on the opposite side.
- Loosen the cushion with the cover <1> from the seat pan and remove carefully under the backrest forward <arrows>.
- Remove the cover and cushion from the seat pan while guiding the seat heating wiring harness out.

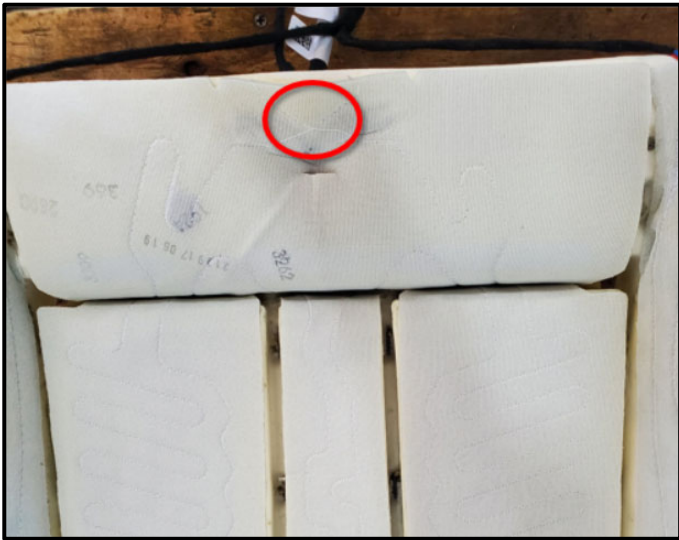
Prepare seat cushion for new seat heating element:

- Do not remove the old seat heating element. The new seat heating element will be installed over the old one.
- The wiring harness of the old seat heating element will be cut in the area of the <circle>.

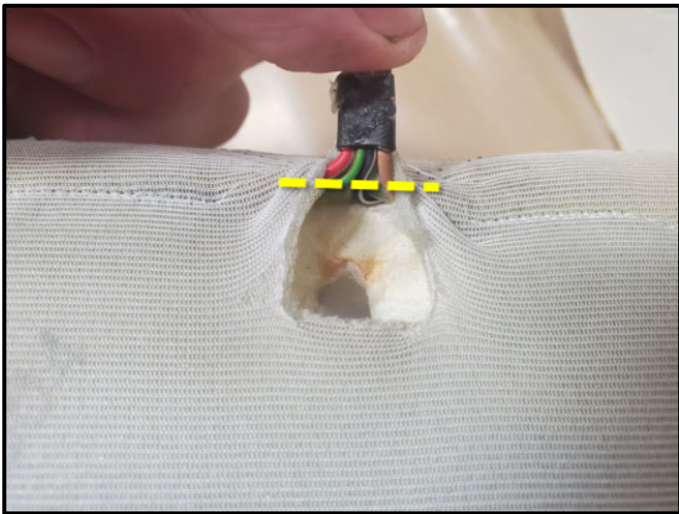
- Cut the wiring harness along the area shown.

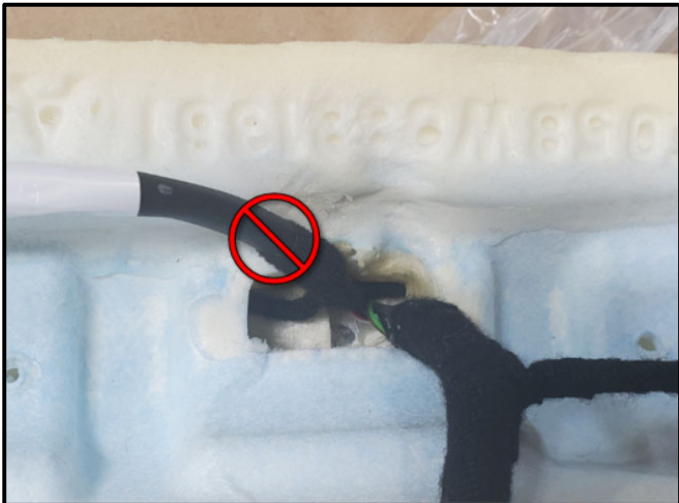
For vehicles with standard seats, only cut the wiring harness for the center seat cushion.
DO NOT cut the harness for the side bolster seat heating elements!!

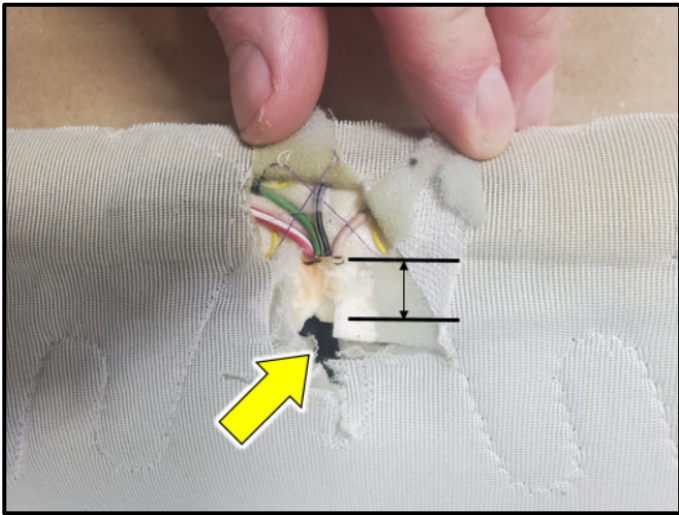
- Ensure the harness is cut so the exposed wires are far enough away from the opening <arrow>. This will prevent damage to the new wiring harness.

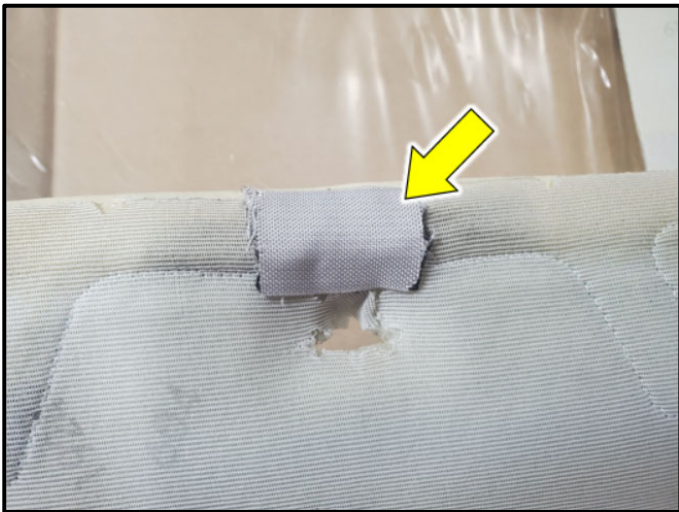
- Place a piece of cloth tape <arrow> over the exposed wires. If necessary, use more than one layer.

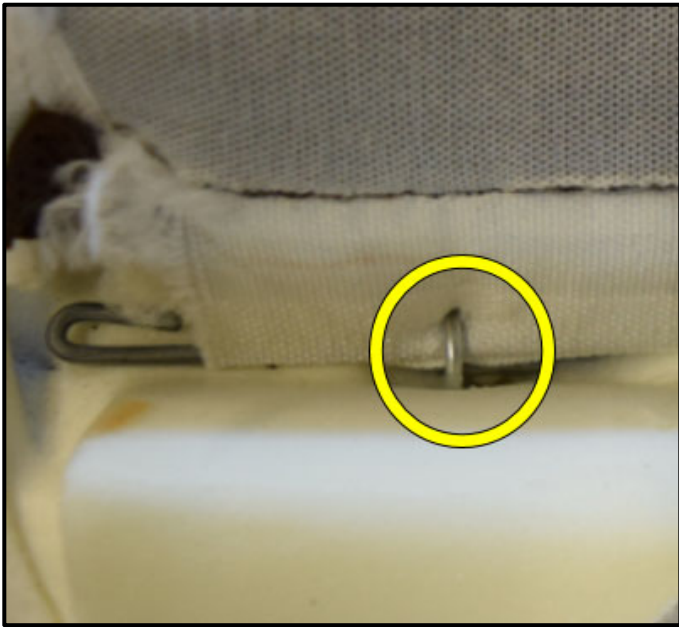
- Prior to fully clamping the upholstery clips closed, be sure each upholstery clip engages BOTH the webbing on the bottom side of the seat cover AND the fastening wire molded into the seat cushion as shown <circle>.

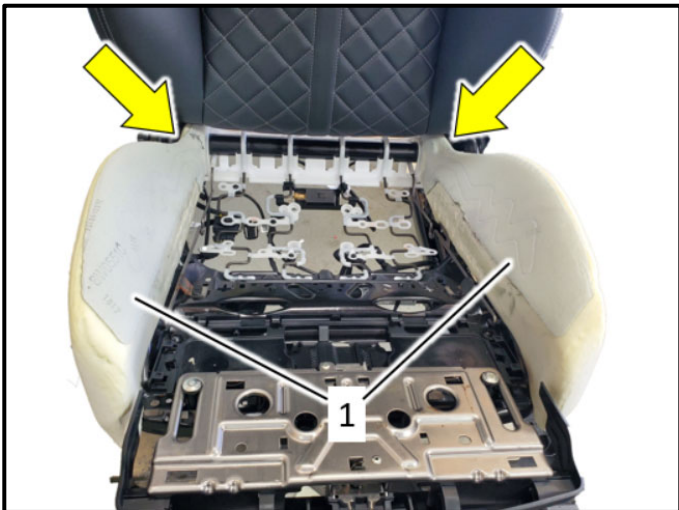
Reinstall seat cushion:

- Installation is the reverse order of removal.
- Versions with Super Sport seats: ensure the side bolsters <1> are fully installed over the seat frame at <arrows>.

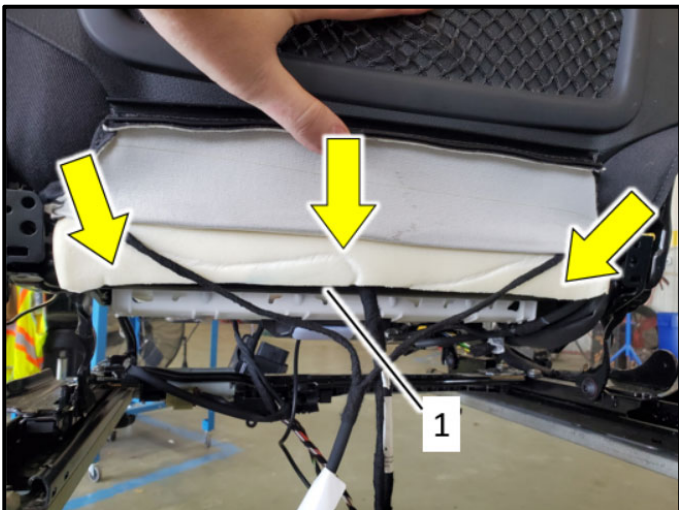
- Ensure seat foam <arrows> is fully engaged over the rear of the seat pan <1>.

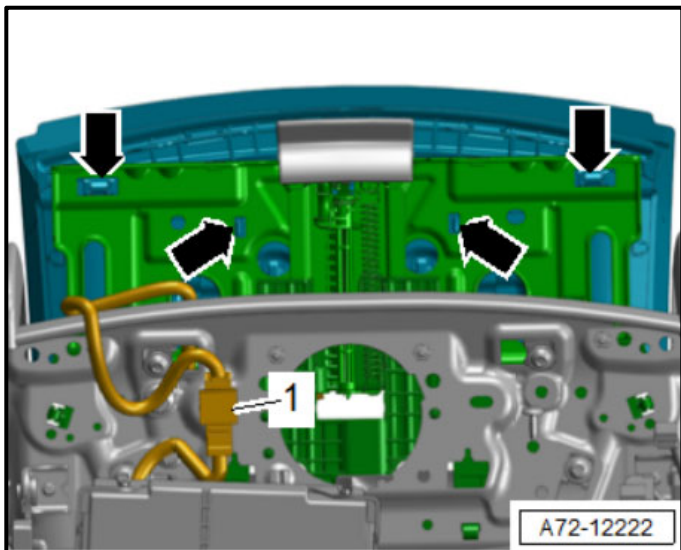
Reinstall seat depth adjuster (if equipped):

- Installation is the reverse order of removal.
- Connect and secure connector <1>.

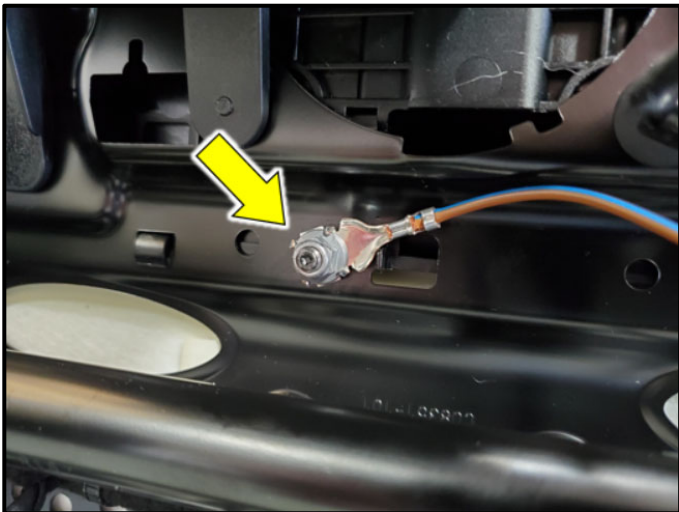
Reinstall ground cable:

- Position ground cable as shown and torque nut <arrow> to 1.5 Nm.
- DO NOT OVERTIGHTEN.

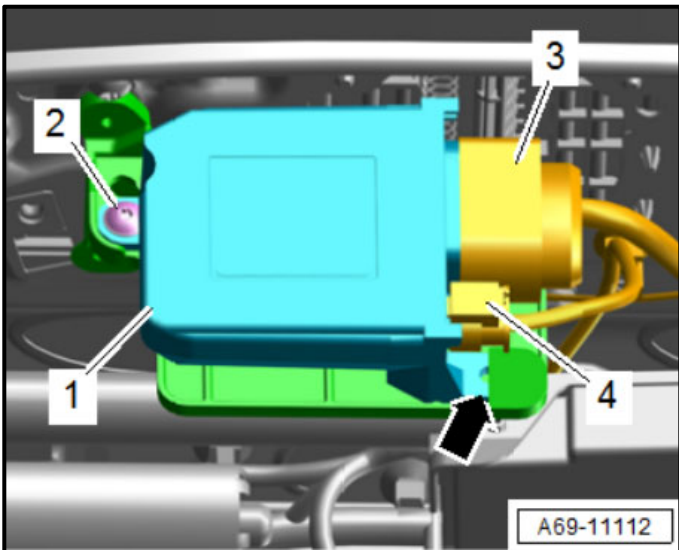
Reinstall PODS Control Module:

- Installation is the reverse order of removal.
- Torque nut <2> to 1.5 Nm.
- Connect connectors <3> and <4>.

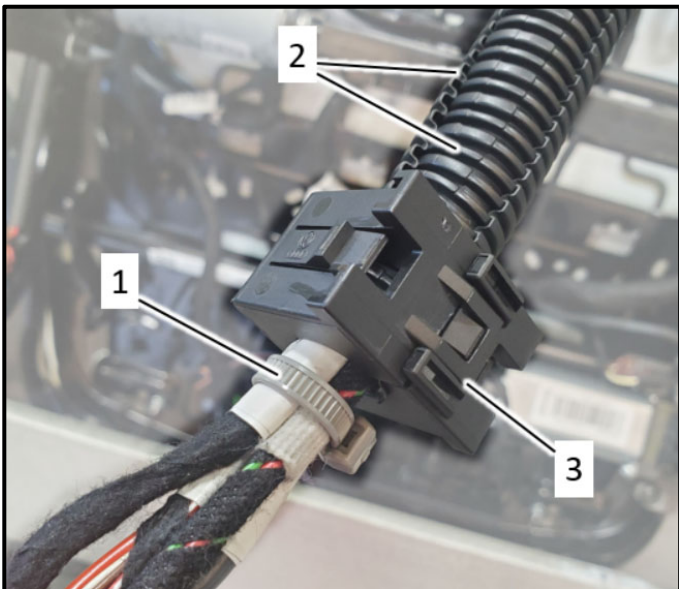
Re-secure seat wiring harness:

- Install new tie wrap <1>.

- Install both corrugated tubes <2>.
- Install cable holder <3>.

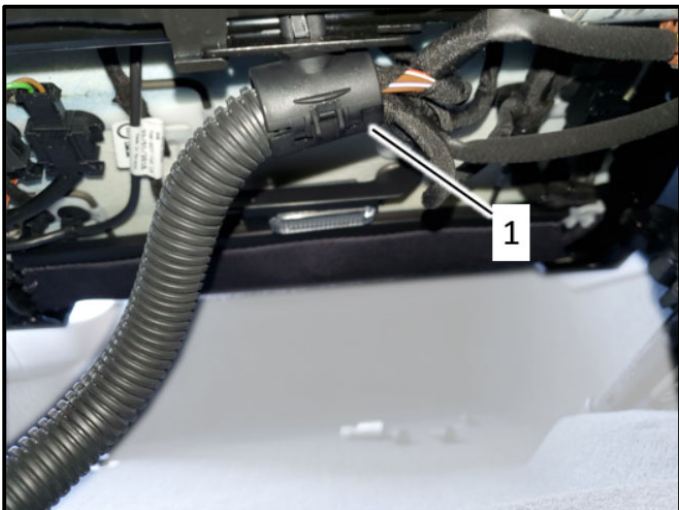
- Install and secure cable holder <1>.

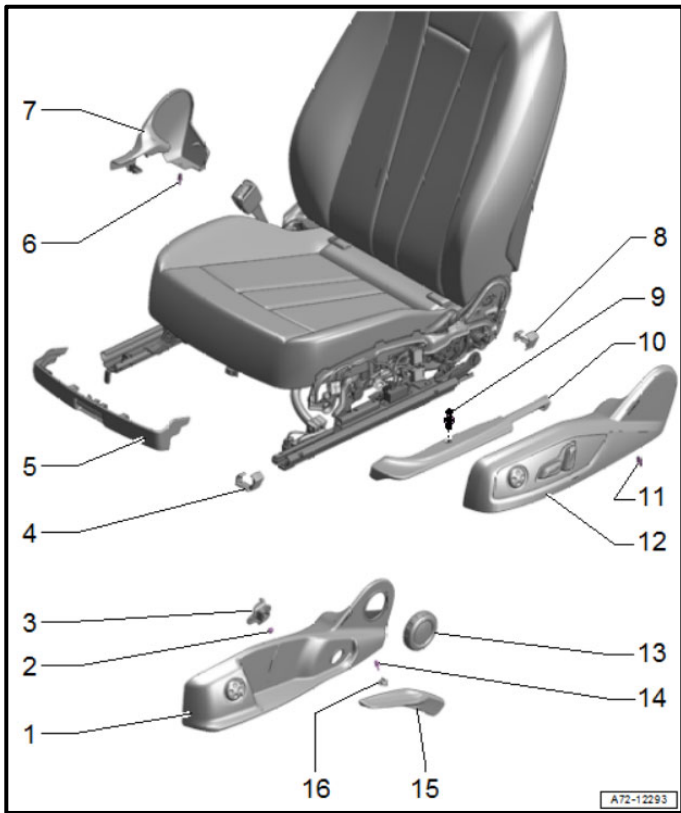
Reinstall seat trim brackets and seat trim:

- Installation is the reverse order of removal.
- Connect and secure seat adjustment electrical connectors.
- Torque fasteners for seat trim bracket to 7.5 Nm.

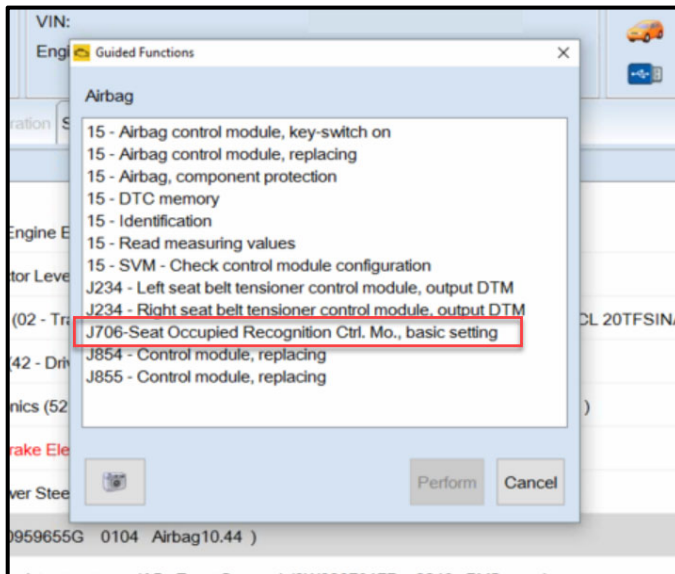
Section C – PODS Basic Settings

- Connect a battery maintainer.
- Switch the ignition ON.
- Connect the VAS tester to the vehicle.
- Using ODIS, perform a complete GFF scan of the vehicle.
- Select the Guided Functions menu for 0015 - Airbag Control Module.
- Perform the test plan "J706 – Seat Occupied Recognition Ctrl. Mo., basic setting".
- Follow the on screen prompts.
- Exit GFF.
