Repair Procedure

Safety Recall 5321K – Multi-Model Fuel Pump May Fail – MX-5 ONLY Supplement

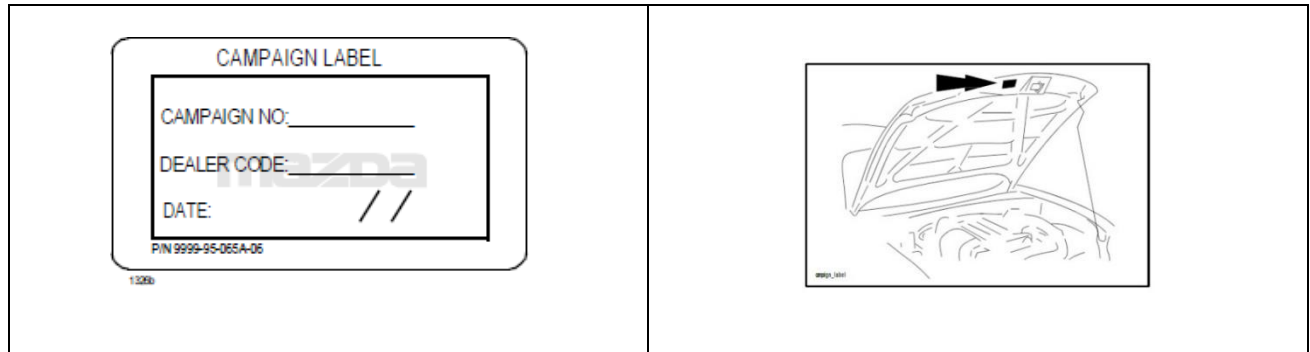
2. Perform a Warranty Vehicle Inquiry using your eMDCS System and inspect vehicle for Campaign Labels **Recall 5321K** attached to the vehicle’s hood. Refer to eMDCS System - Warranty Vehicle Inquiry Results table below.

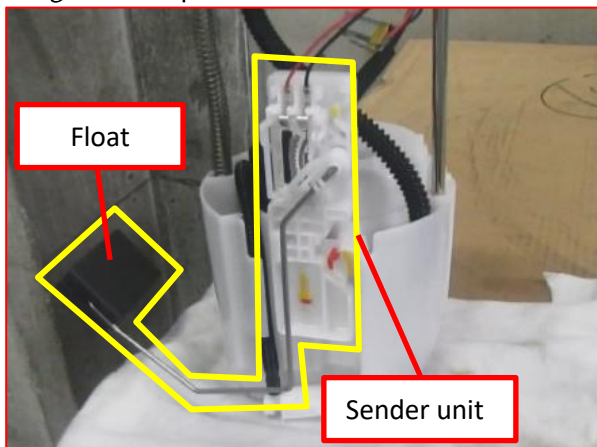
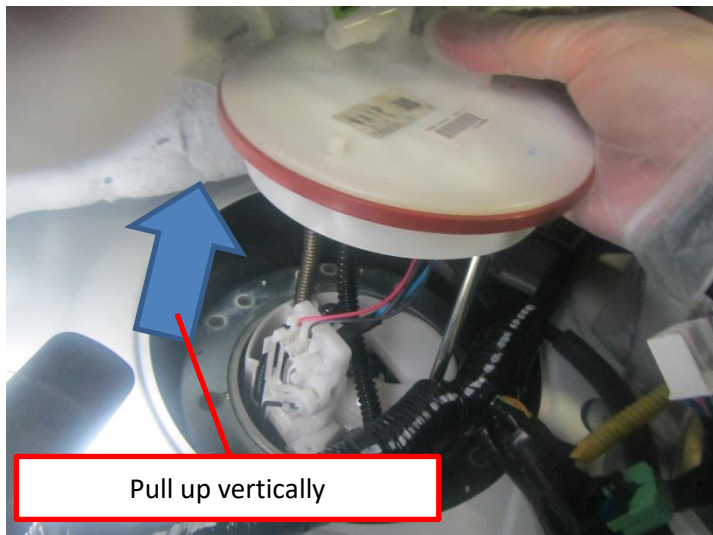
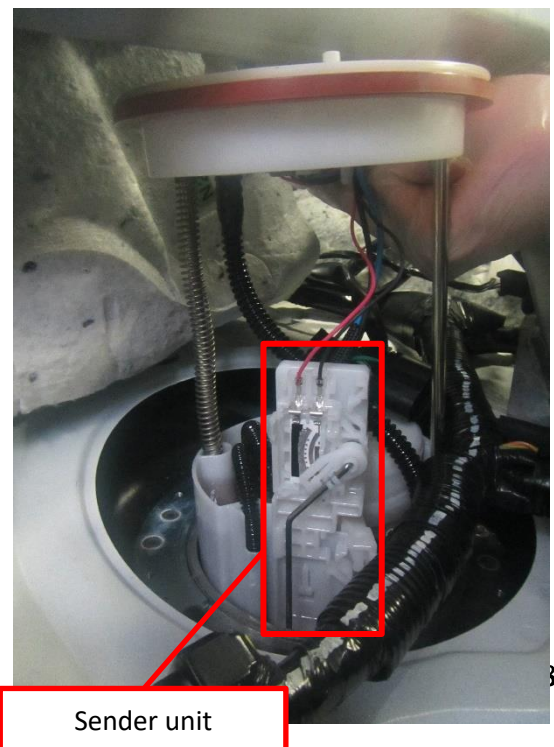
Image for the part 'Sender unit' with float. Be careful the float may damage and bend easily.

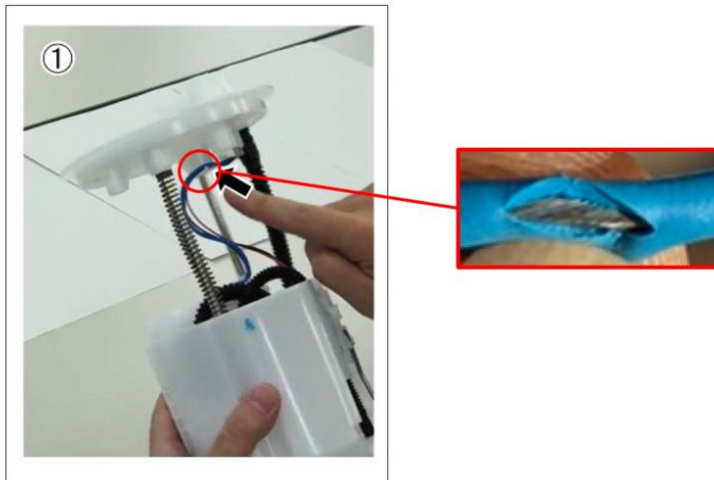
IMPORTANT NOTE: Check for broken, cut, frayed or chafed wire on FDM units as in the photo (1) below.

- If found to be damaged, the harness must be replaced.
- Part ordering: **Do not contact the Dealer Assistance Group.** Depending on the model, there are different harnesses. Please contact Mazda Technical Hotline and a countermeasure part will be shipped to your dealership free of charge.
- While waiting for the countermeasure part to arrive please continue the repair and install the new harness when received.

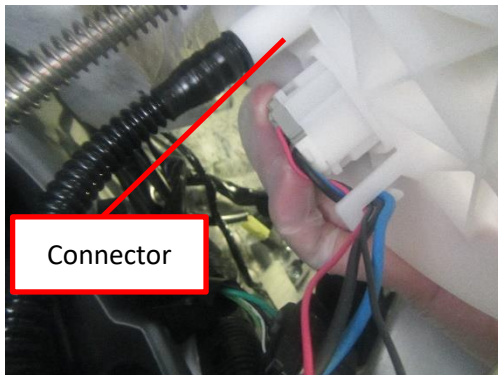
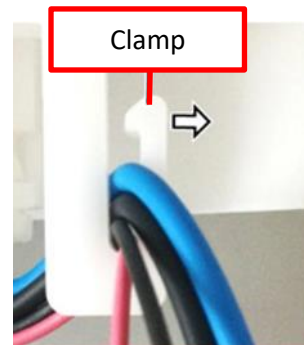
1, Remove the connector and harness from clamp.

※Image for the harness with clamp.

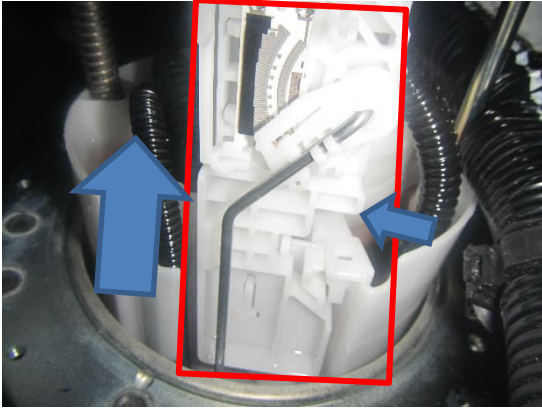
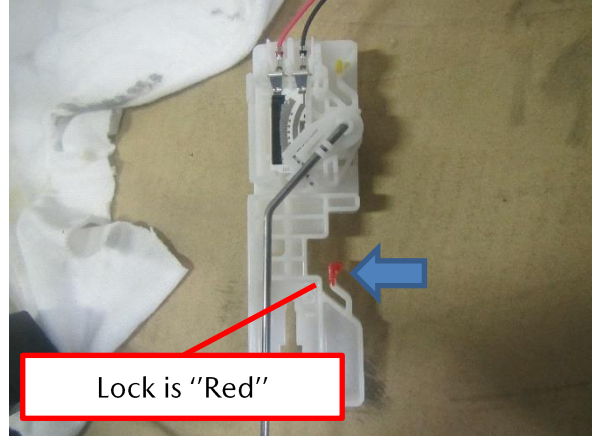
2, Release the 'Lock' then pull up the sender unit vertically.

※Image for the 'Lock' position.

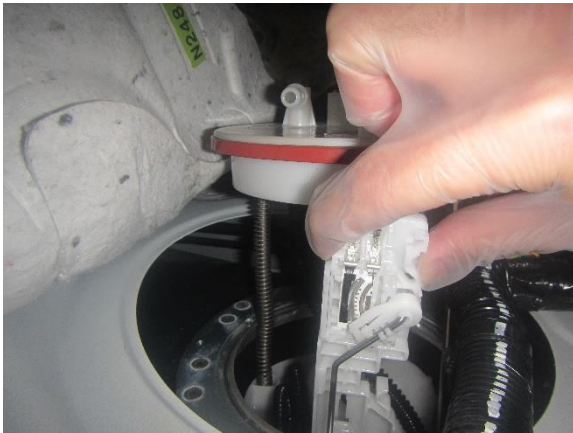
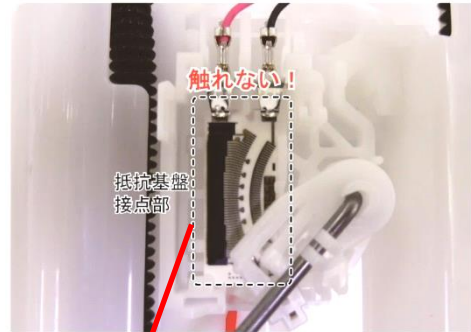
E119486

3, Hold the sender unit with harness up and go down the fuel pump unit vertically.

※Do not touch the sensor.

Do not touch terminals.

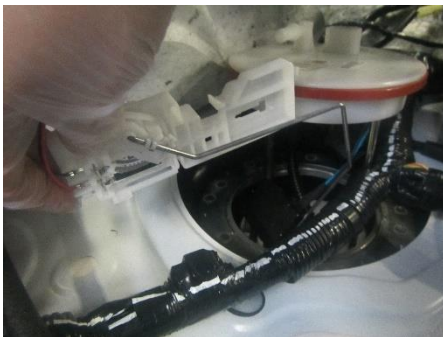
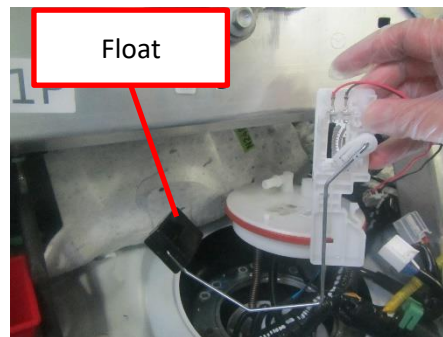
4, Be sure that the float part of the sender unit does not contact the fuel tank.

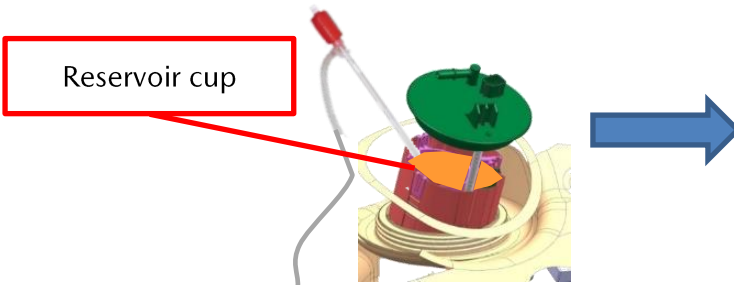
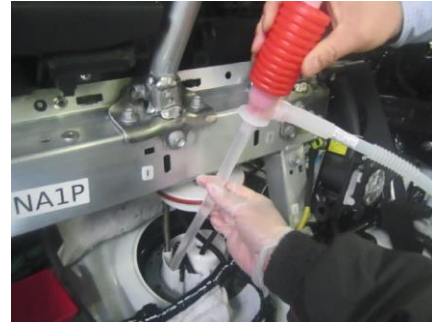
4. Remove the fuel remaining in the unit's reservoir cup with a dropper.

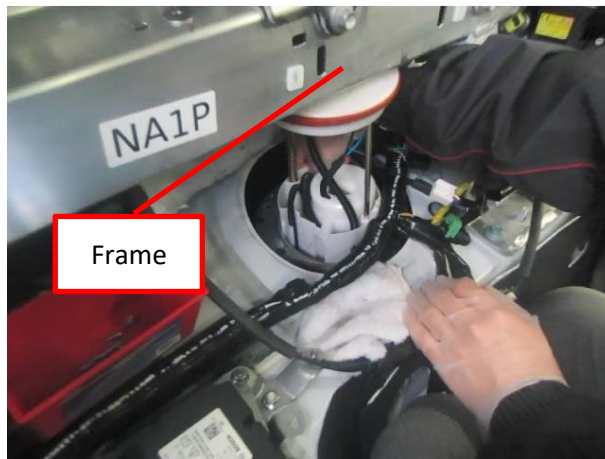
1, Lift the unit to the limit of the frame.

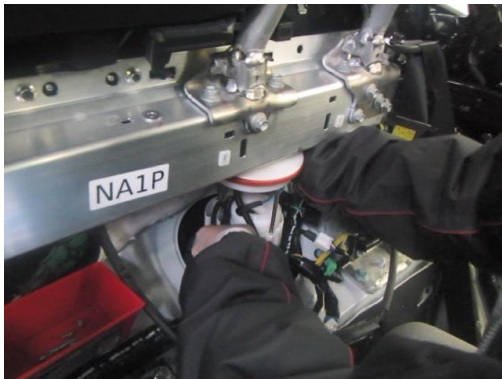
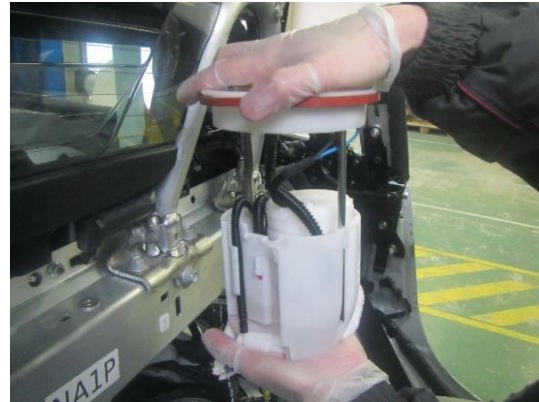
2, Apply the upper part of the unit to the frame and compress.

※Image of compression.

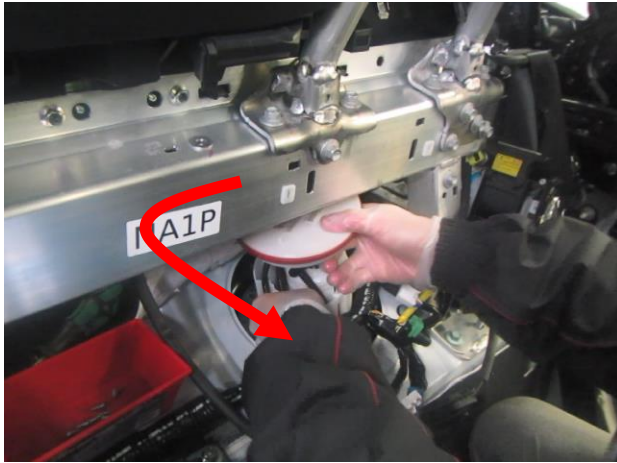
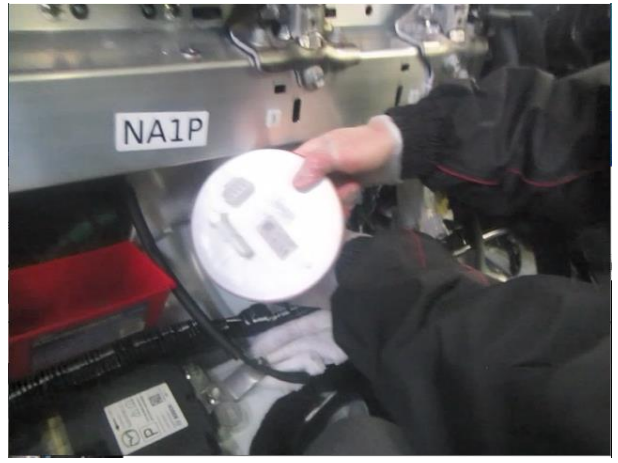
3, Slide the fuel pump unit as shown by the arrow to remove it from the fuel tank.

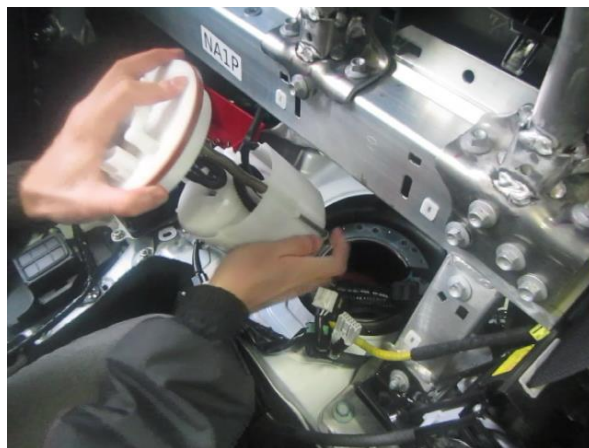
1, Compress the unit.

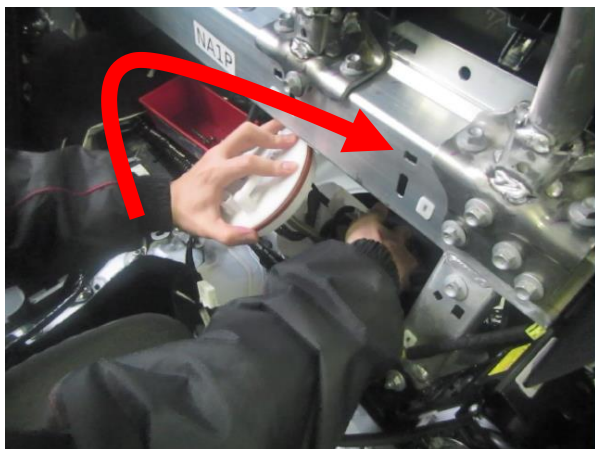
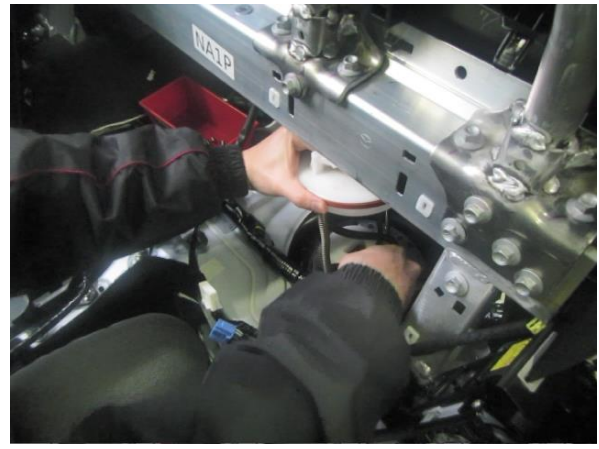
2, While compressed, push under the frame and rotate the fuel pump unit in the direction of the arrow to install the unit into the fuel tank.

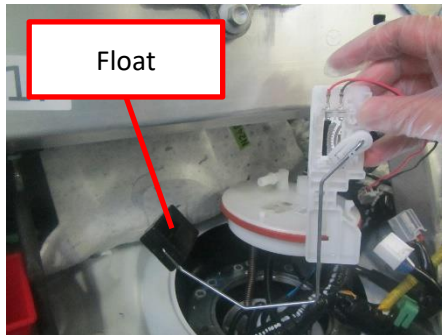
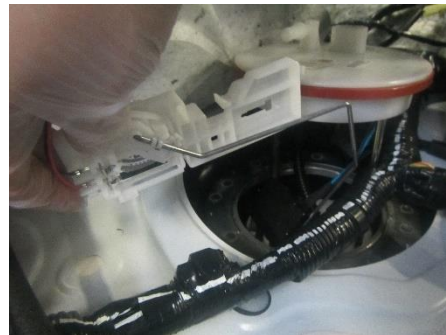
1, Reinstall the sender unit inside. Make sure that the floating part does not contact to the fuel tank.

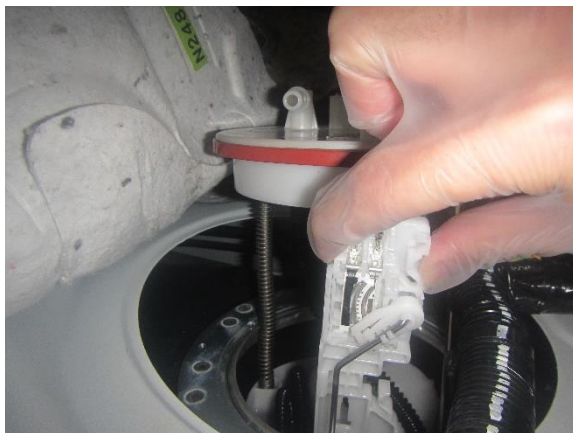
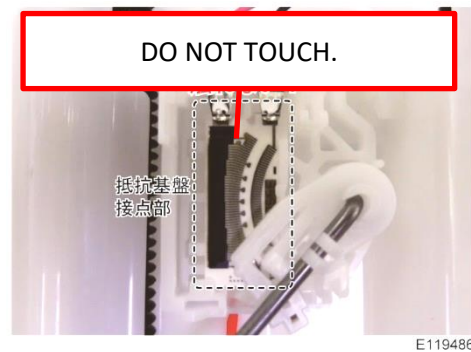
E119486

2, Hold the sender unit in your hand and slowly lower the fuel pump unit.

※Do not touch the sensor.

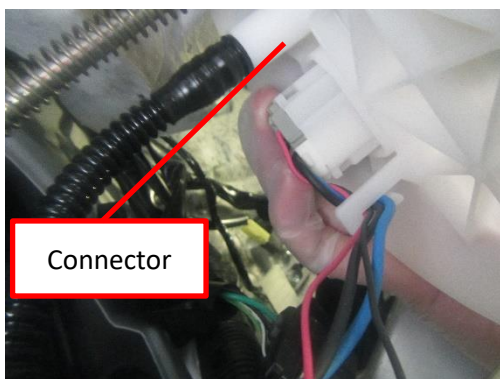
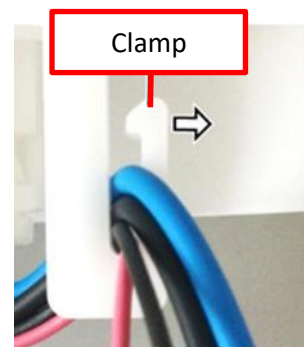
4, Install the connector and harness from clamp.

※Image for the harness with clamp.

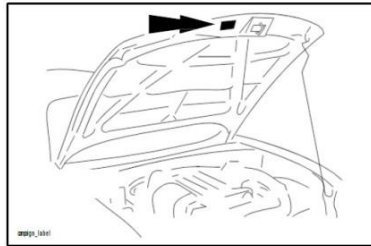
2. Affix it to the hood as shown:
