Technical Service Bulletin: TSB230102	Released Date: 01-Nov-2023
Cummins Field Action Campaign #4776: Repair of PowerPact L 250A-600A Molded Case Circuit Breakers, from Schneider Electric.

Schneider Electric has notified Cummins Inc. that a population of PowerPact L 250-600A Molded Case Circuit Breakers (MCCB) may contain a nonconforming component in the mechanism that may result in the circuit breaker **not** operating as intended under certain conditions. Cummins Inc. is campaigning these generator sets and transfer switches to implement a Product Notice PRB-233066 issued by Schneider Electric.

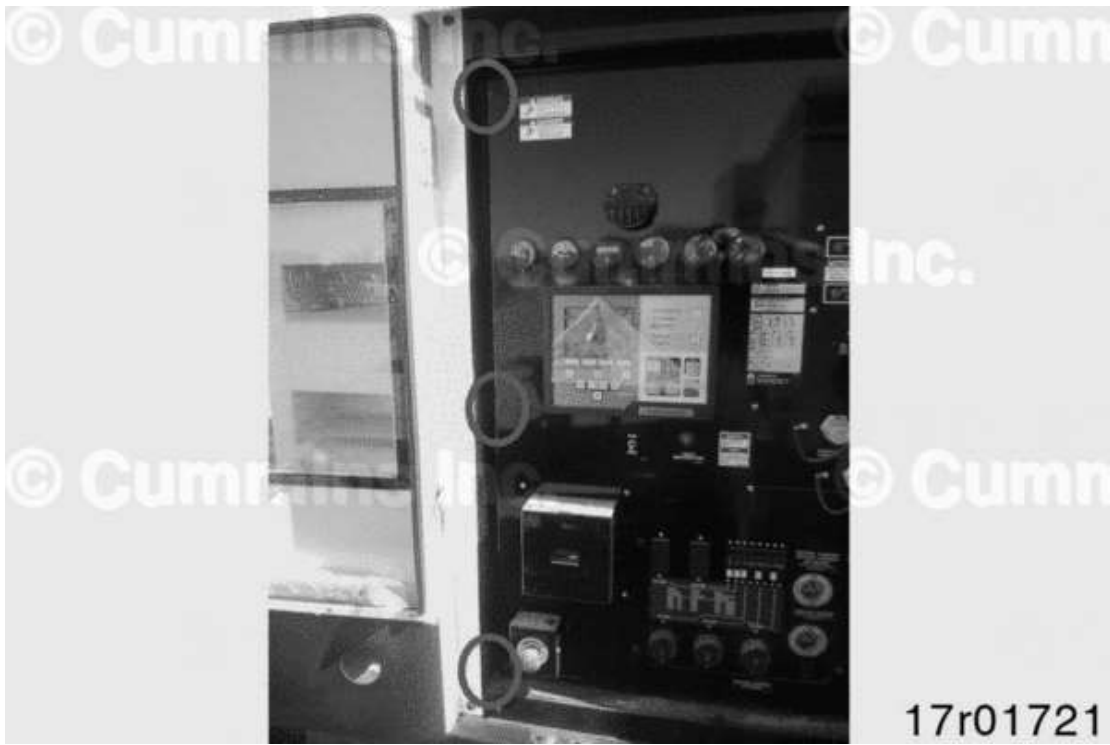
Figure 10, Control Cover Installation

2w. Close the control cover and reinstall the three bolts located in figure 10.
