SAFETY RECALL 21TA08

SECOND-ROW OUTBOARD SEAT BELT COULD TEAR IN A CRASH

CERTAIN 2022 MODEL YEAR SIENNA VEHICLES

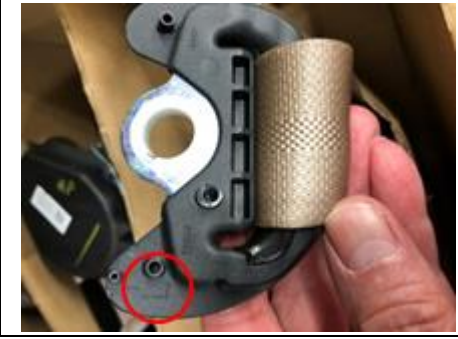
1. CONFIRM THE “L” OR “R” MARK ON **NEW** SEAT BELT

DO NOT install seat belt on incorrect side
