Safety Recall 21TA09

NHTSA Recall No. 21V-890

SUDDEN LOSS OF POWER BRAKING ASSIST MAY OCCUR

CERTAIN 2018-2019 MODEL YEAR CAMRY VEHICLES

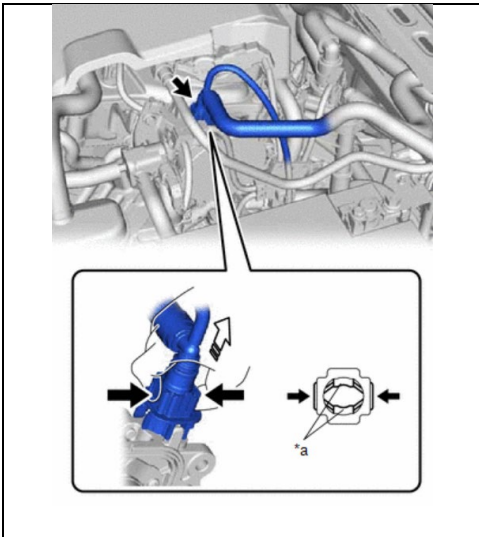
1. Vacuum Pump Assembly Removal - Process

- Disconnect No. 1 vacuum hose connector.
- Pinch the retainer of the No. 1 vacuum hose connector, and then pull the hose connector off the vacuum pump assembly.

Note: Be sure to disconnect the vacuum hose connector by hand to avoid damaging the connector.

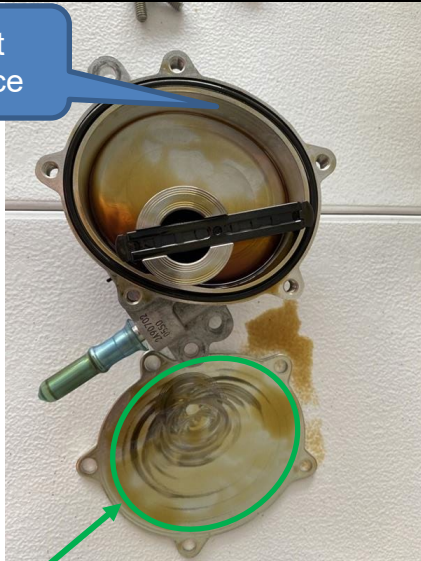
Example of OK Vacuum Pump Internals

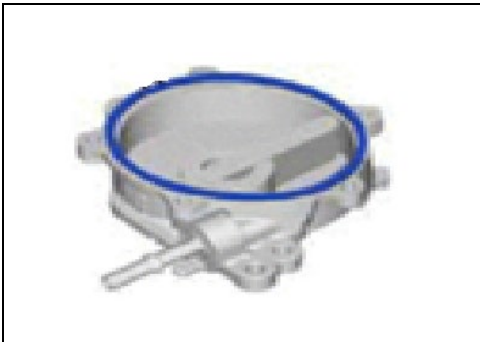
- f. Clean the inside surface of the vacuum pump cover plate using a lint free shop towel.

- g. Replace vacuum pump cover O-ring with PN: 29346-25010

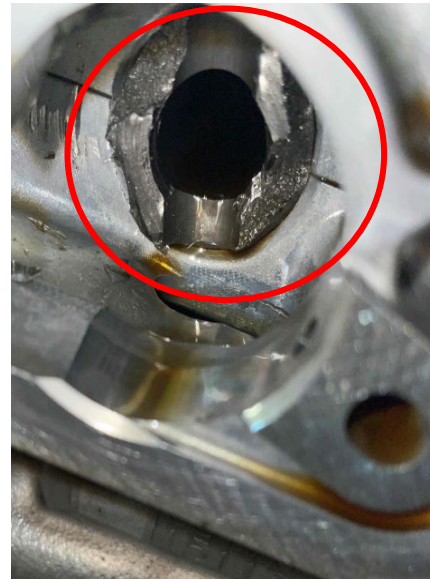
Example of a failed camshaft coupling connection

- a. If the camshaft coupling connection is in OK condition, proceed to **section XII – New Vacuum Pump Assembly Installation.**
- b. If the camshaft coupling connection is failed, proceed to **section XIII – Camshaft Coupling Connection Damage Present**
