RECALL 21V903 / 2021-710 REMEDY INSTRUCTIONS

Make(s): Impression Fifth Wheels Model(s): Many, See Below Model Year(s): 2021 - 2022	Repair Code: RC-057-09-00-004124 Allotted Time: .42 HRS Inspection Code: RC-057-05-00-004123 Allotted Time: .10 HRS
	Concern: The three rear identification lamps are not in a horizontal line as required.	Photo(s) Required: YES, BEFORE & AFTER Prior Authorization Required: YES Part(s) Kit Number: F100302085 Part(s) Return: NO

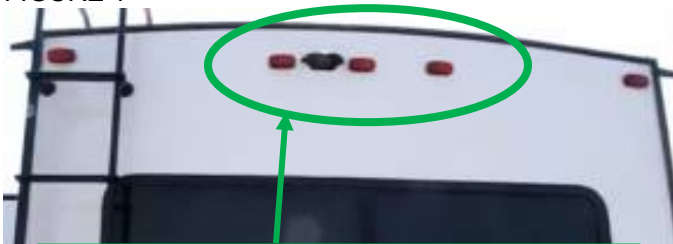
THIS IS AN EXAMPLE OF A **GOOD** INSTALL: INDICATOR LAMPS IN A HORIZONTAL LINE

STEP 1: INSPECT THE REAR OF THE UNIT – ARE THE REAR CENTER INDICATOR LAMPS IN A HORIZONTAL ROW AS SHOWN IN FIGURE 1 OR ARE THEY MISALIGNED AS SHOWN IN FIGURE 2;

- IF THE LAMPS ARE REPRESENTATIVE OF FIGURE 1 – CLAIM THE INSPECTION CODE AND RELEASE THE UNIT AS NO FURTHER ACTION IS REQUIRED. TAKE A PHOTO AND SUBMIT WITH THE INSPECTION CLAIM OF THE INDICATION LAMPS.
- IF THE LAMPS ARE REPRESENTATIVE OF FIGURE 2 – CONTINUE ONTO THE SECTION LABELED “REMEDY” – DO NOT CLAIM THE INSPECTION CODE. TAKE A PHOTO OF THE LAMPS PRIOR TO MAKING ANY REMEDY. ONCE THE REMEDY IS COMPLETE, TAKE A PHOTO OF THE REMEDY AND SUBMIT BOTH PHOTOS WITH THE REPAIR CODE.

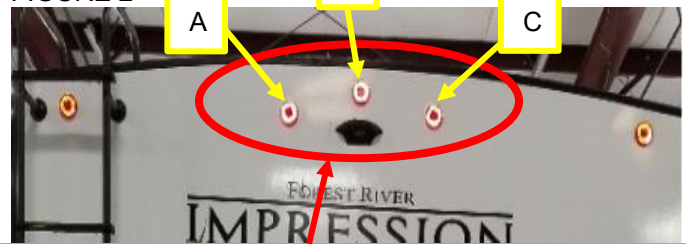
FIGURE 2

THIS IS AN EXAMPLE OF A **BAD** INSTALL: INDICATOR LAMPS ARE NOT IN A HORIZONTAL LINE

- STEP 1: REMOVE THE CENTER TOP LAMP FROM THE REAR WALL. EXPOSE THE WIRING AS IT IS CONNECTED TO THE HARNESS (*TAKE A PHOTO FOR HOOKUP PURPOSES LATER*);
- STEP 2: ALIGN THE CENTER LAMP HORIZONTALLY BETWEEN LIGHT “A” AND “C” AND DRILL A NEW HOLE IN THE CENTER OF THE VEHICLE AND IN THE MIDDLE OF LIGHTS “A” AND “C”;
- STEP 3: EXPOSE THE CLEARANCE LAMP WIRES IN THE REAR WALL THROUGH THE NEW HOLE AND CONNECT THE CENTER INDICATOR LAMP BACK TO THE HARNESS, MATCHING THE COLORS FROM STEP 1 (PHOTO TAKEN);
- STEP 4: ATTACH THE RED REFLECTOR TO THE REAR WALL, COVERING THE “OLD” EXPOSED HOLE WHICH THE CENTER INDICATOR LAMP LEFT OPEN BEFORE IT WAS MOVED;;

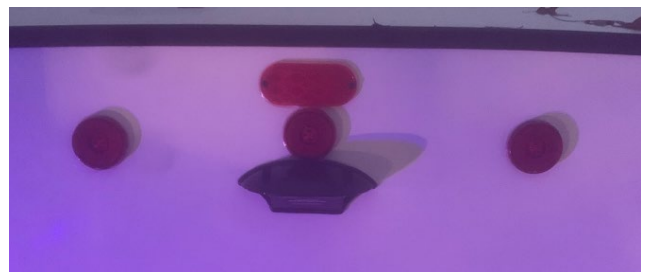
REMEDY – THIS IS HOW THE REAR INDICATOR LAMPS SHOULD NOW LOOK AFTER THE REMEDY IS COMPLETE.
