SIB 11 08 21

## Recall 21V-907: Exhaust Gas Recirculation (EGR) Cooler – N57T High Temperature

## RECALL 21V-907: EXHAUST GAS RECIRCULATION (EGR) COOLER – N57T HIGH TEMPERATURE

### PROCEDURE 1: REPLACE THE EGR COOLER

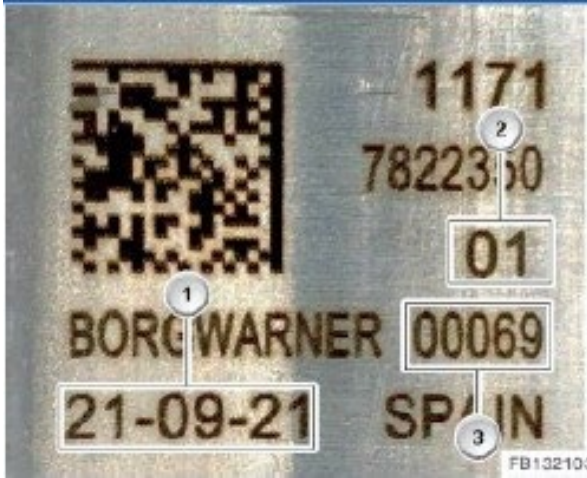
Record or take a photo of the following numbers on the new EGR cooler (1,2 and 3). These numbers will be required later to register the new cooler in ISTA.

1. Production date [YY-MM-DD]
2. Revision index
3. Serial number

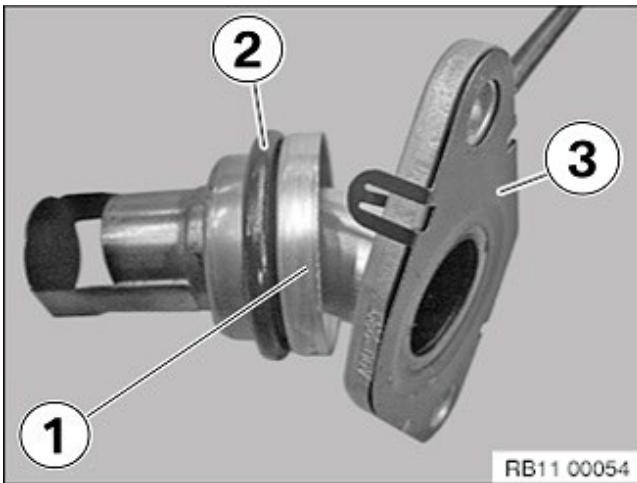
- Remove the EGR pipe from the intake venturi pipe (replace O-ring (2) and gasket (3)).

- Inspect and clean (if needed) the EGR pipe. Wear protective equipment (eyes and hands) and clean out the excessive carbon using a degreasing agent and a brush (suitable brushes can be found in wheel brush kit 83 19 2 298 237).
- Reinstall the EGR pipe with new gasket and O-ring before installing the new EGR cooler.

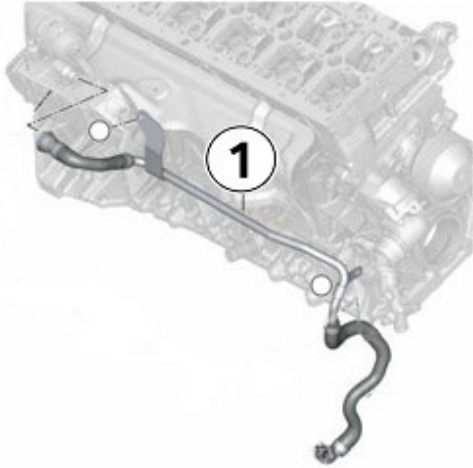
- Replace the coolant pipe from the Auxiliary EGR cooler to the coolant pump distribution block (1)

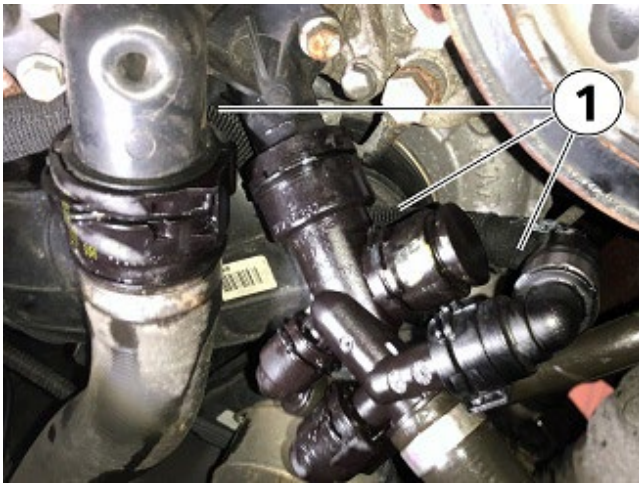
- NOTE: The new coolant line PN 11 14 7 827 410 is routed in a different location than the original line (1)
